# Woodbank House, Balloch Inspection Report

*v01. 08/06/2017*

Barham Glen Architects Ltd

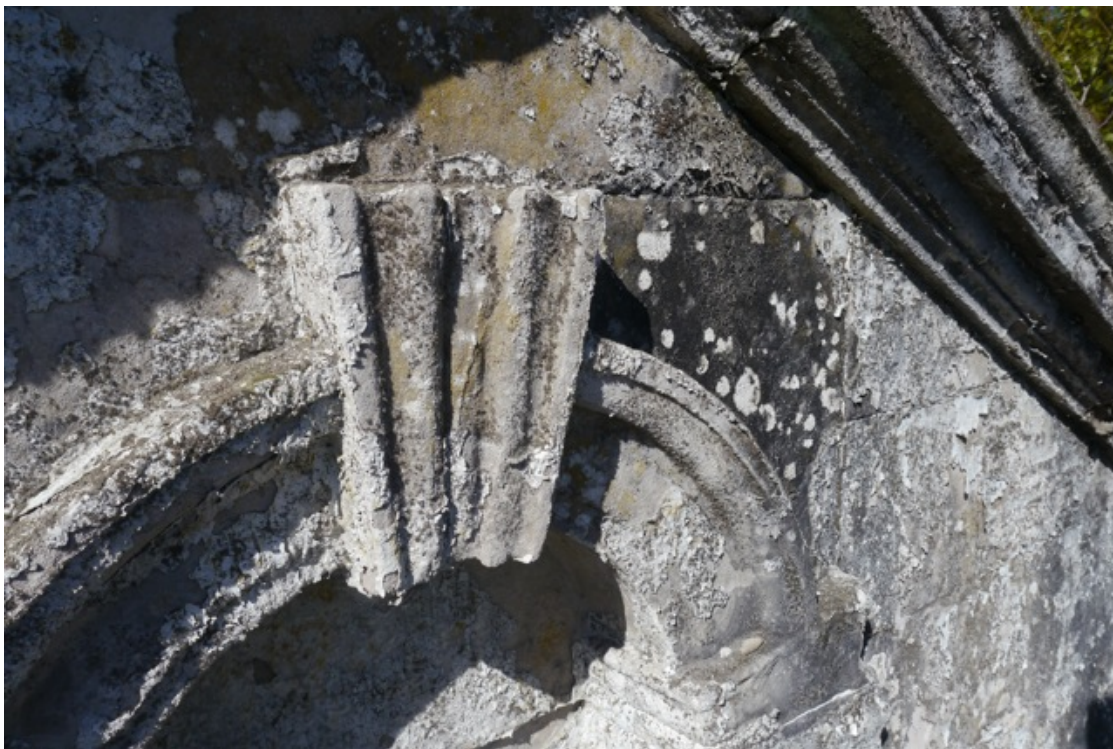
The surviving areas of finished store and render appear to have been coated with masonry paint. This is flaking off in many places and should be carefully removed to retrieve the fine detail of the stonework. Any surviving render should be stripped off anyway.

*Lichen and flaking masonry paint on stone pediment.*

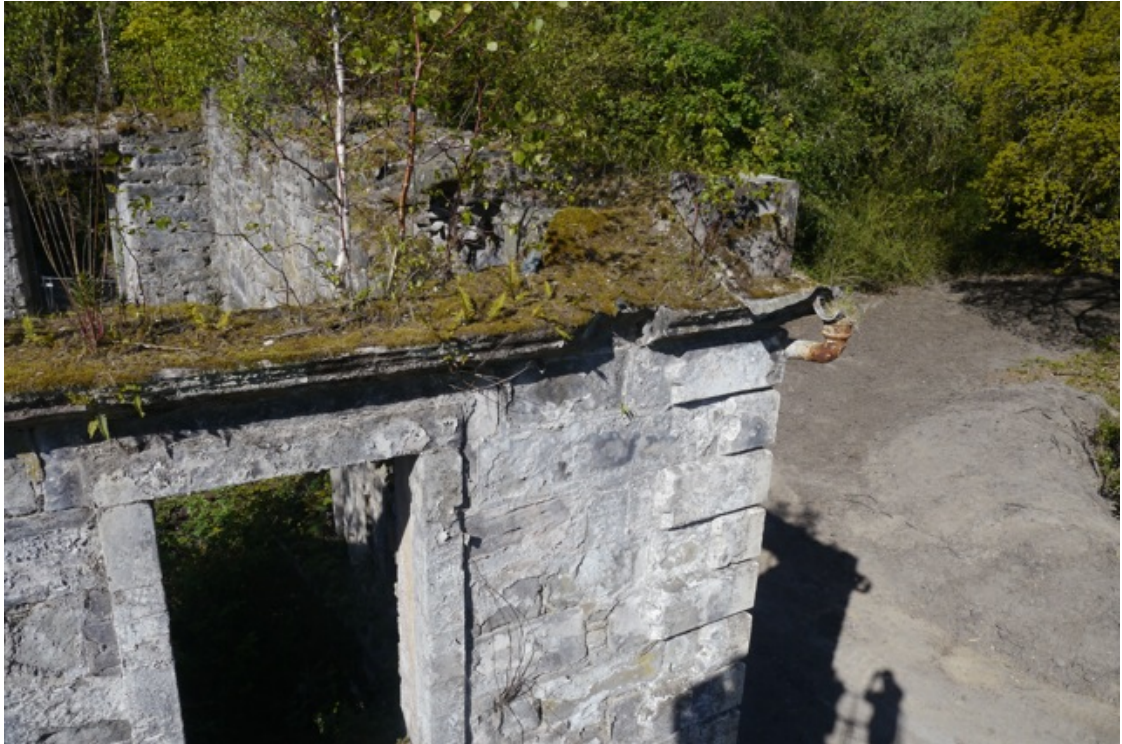
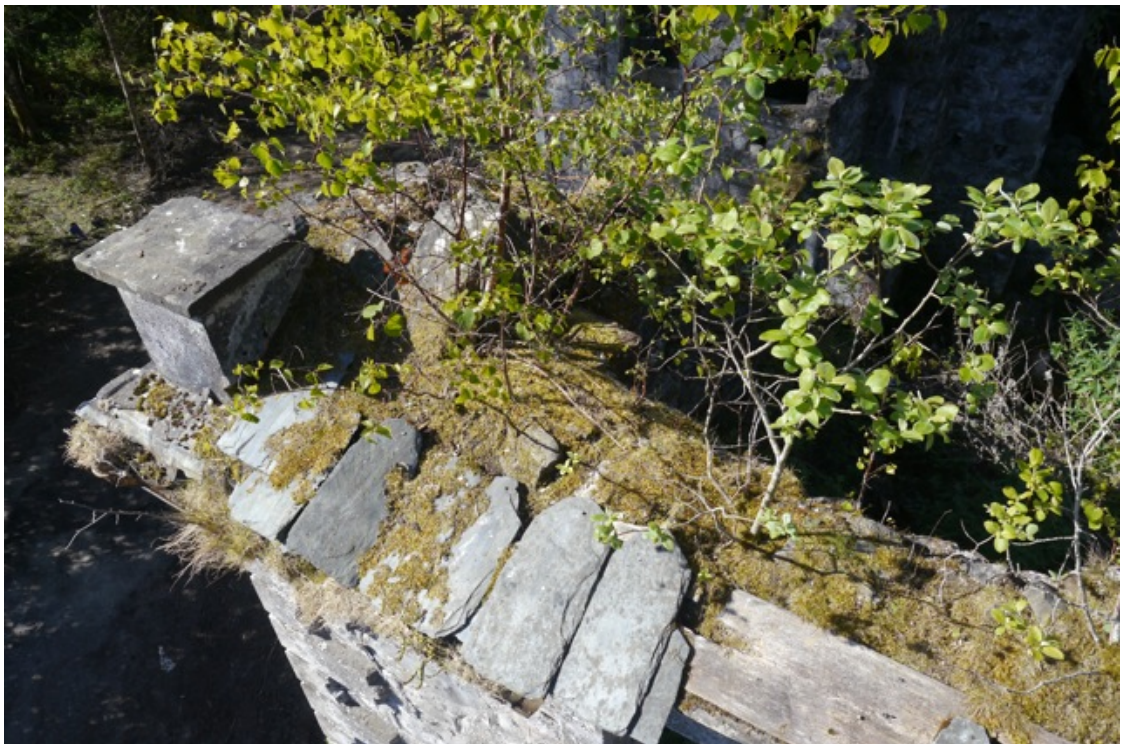
The Structural Inspection Report identifies the entire front wallhead as requiring replaced. The problem and the solution will be different along the eaves and along the base of the pediment. The eaves should be cleared of (extensive) vegetable growth, old slates and loose infill material to re-establish a horizontal wallhead. The detailing of this will depend on the shape of any new structure behind, however the wallhead should be rebuilt to the its original profile.

*Above and below - vegetation, loose slates and damaged wallhead stonework - the timber boarding is the old sarking - any wallplate would have been set further back.*

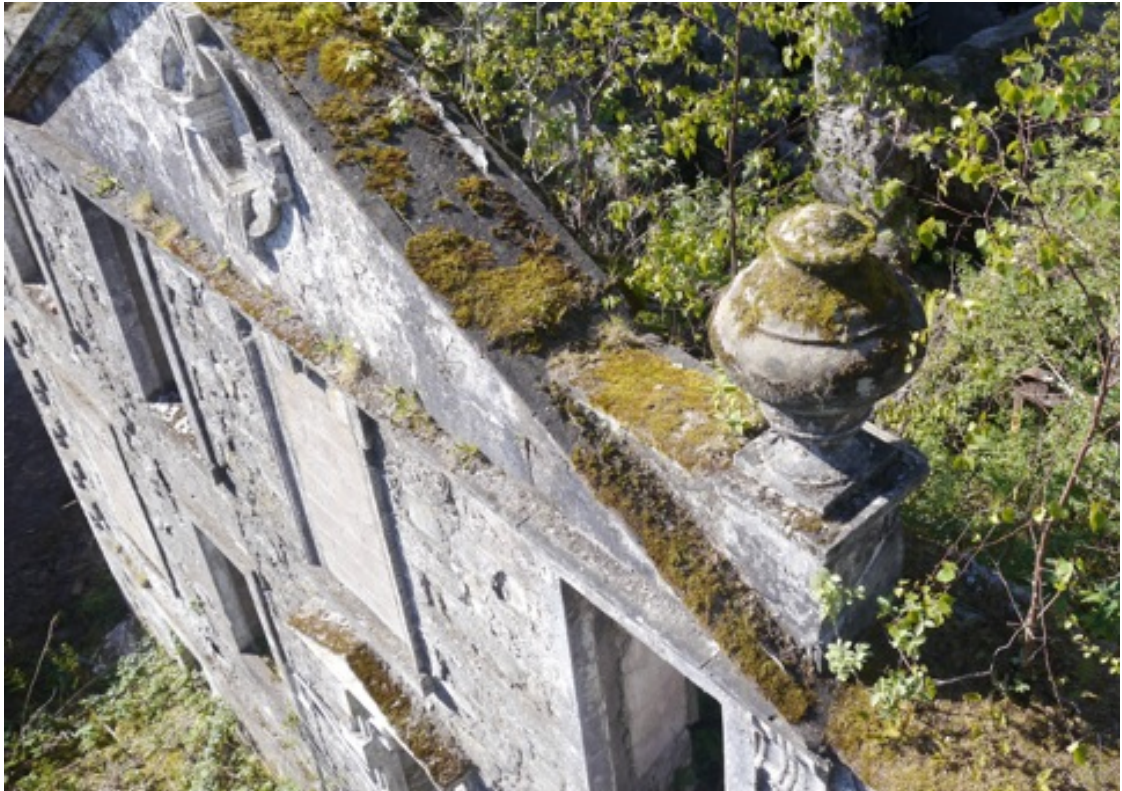
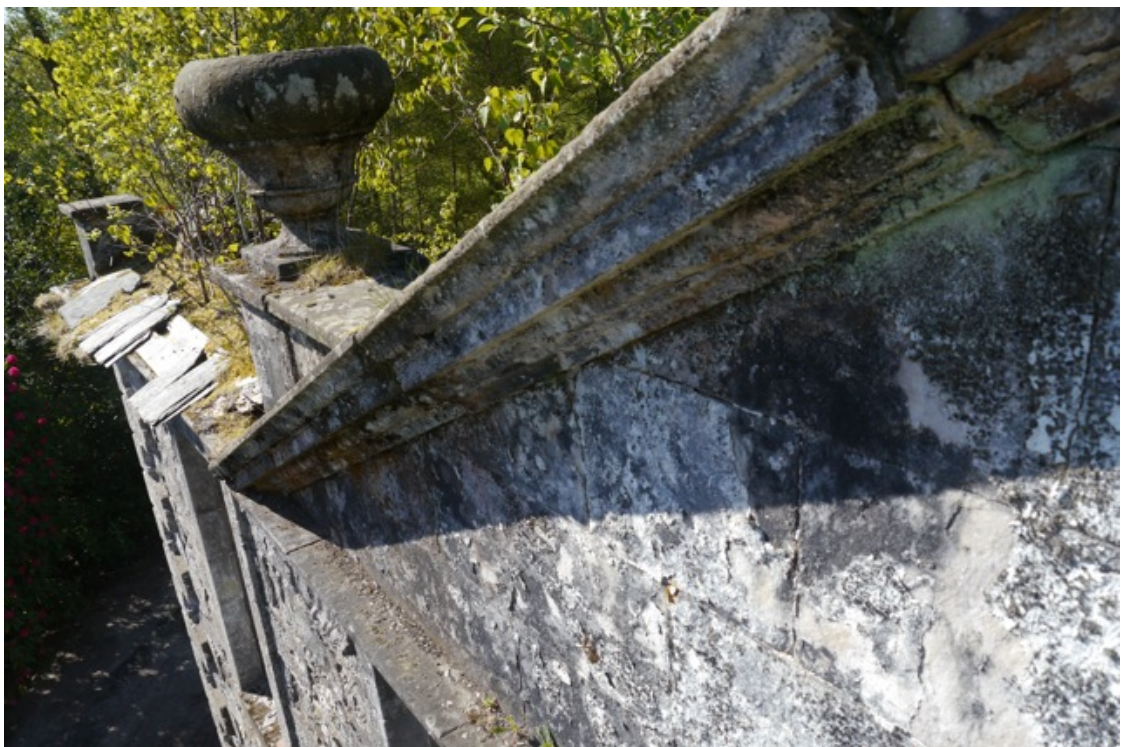
*Above and below - pediment stonework is relatively sound.*

The base of the pediment presents a different case and should be revisited when works progress - if possible, if the stones in this area are in salvageable condition every effort should be made to retain them in-situ as they provide the base to the pediment above.

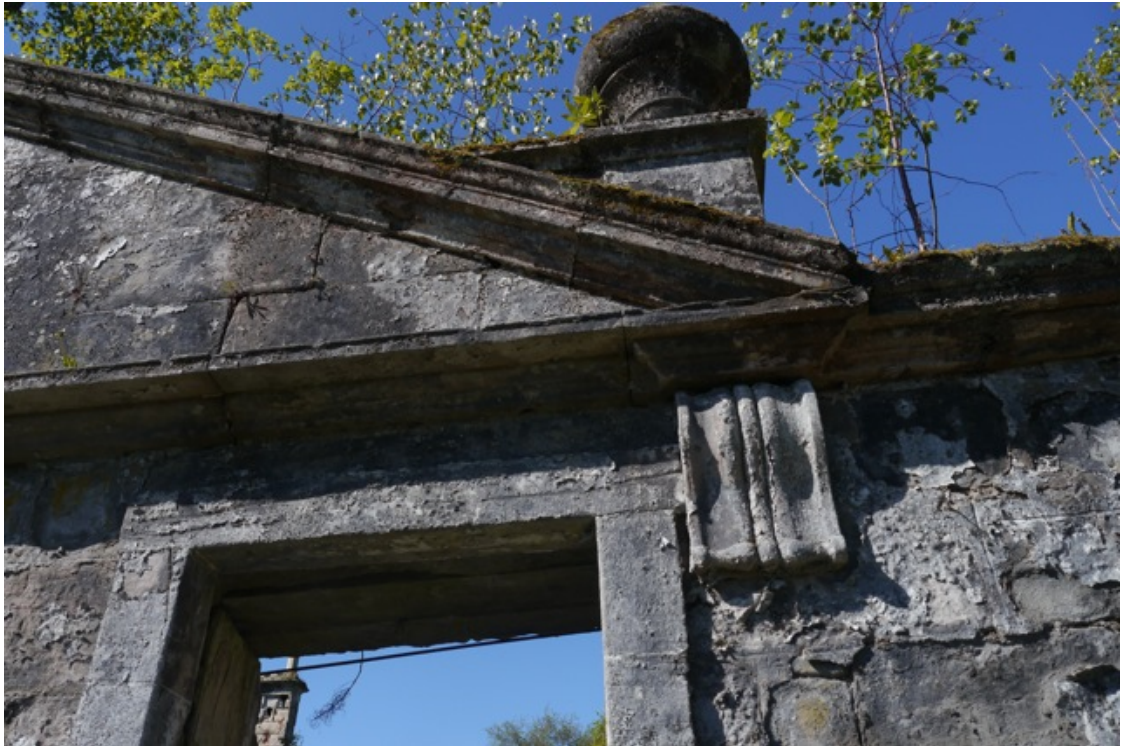
While all of the internal lintels have failed, the external stone lintels are sound and should be retained and protected while temporary works and inner lintel replacement are carried out.

*Above - sound stone outer lintel and failed concrete inner lintels; open joints in tympanum should be repointed (these show only minor signs of movement)*

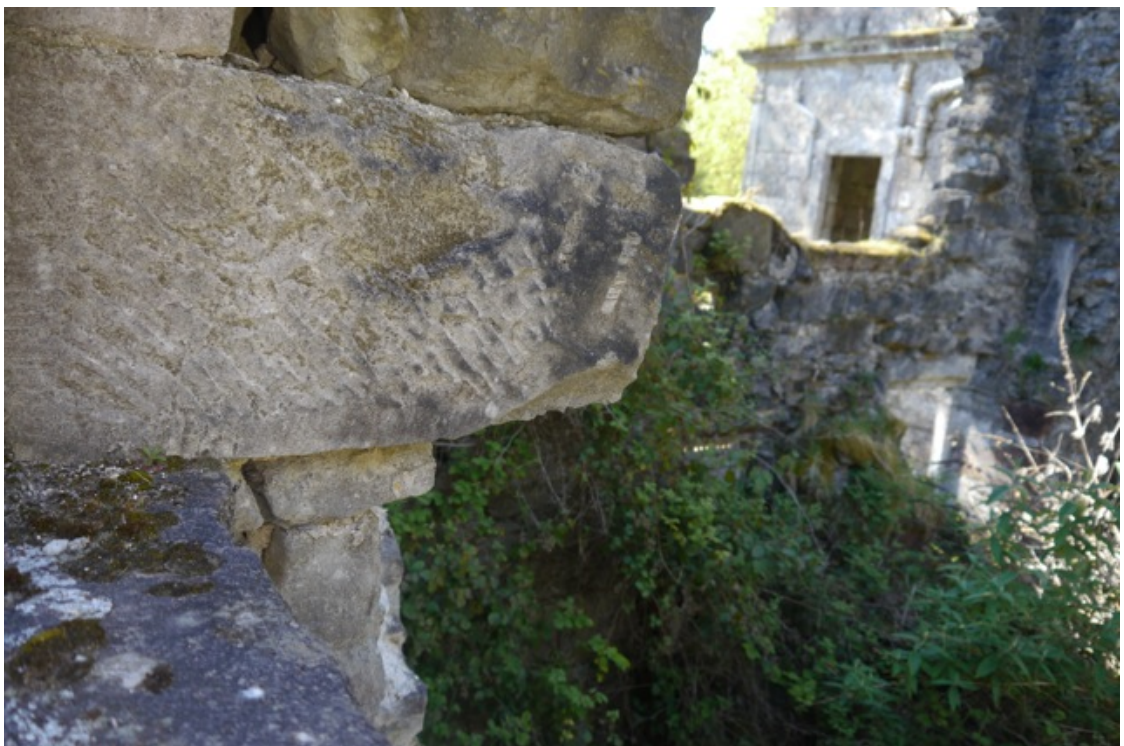
The weakness of the structure in the areas between ground and first floor windows is exacerbated by the failure of a number of internal ingo quoin stones below cill level. These would appear to have been dislodged when the first floor collapsed.

*Below - failed stonework to internal ingo at cill level of first floor window.*

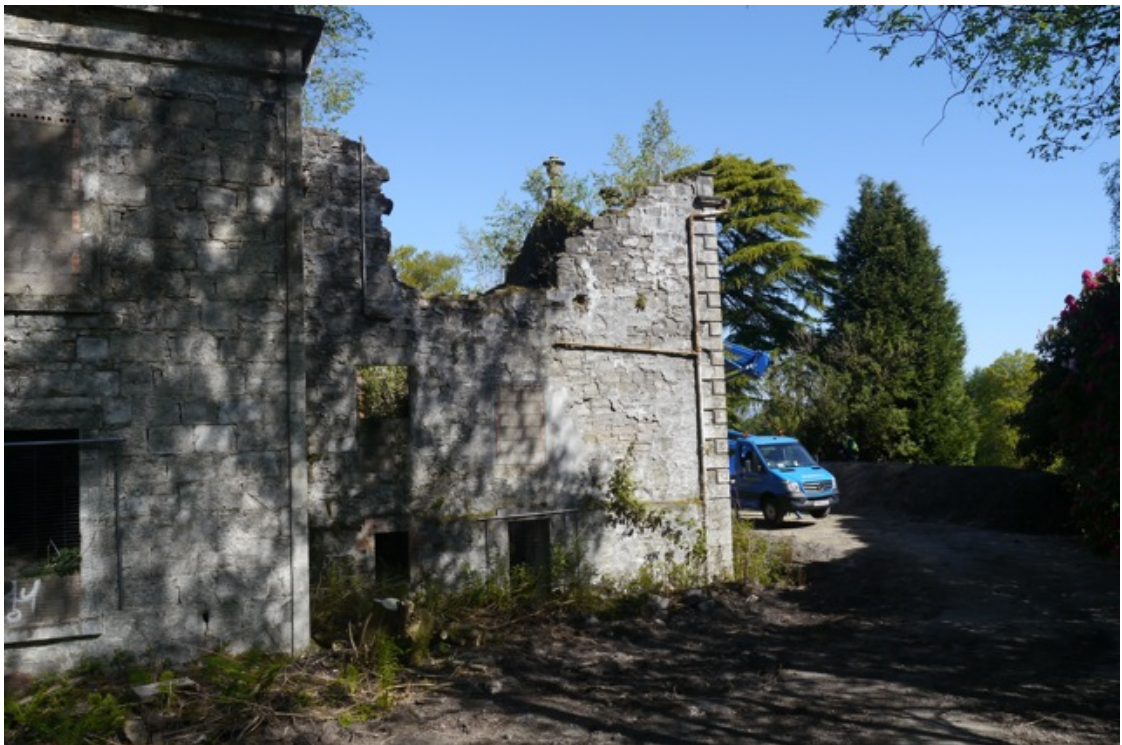
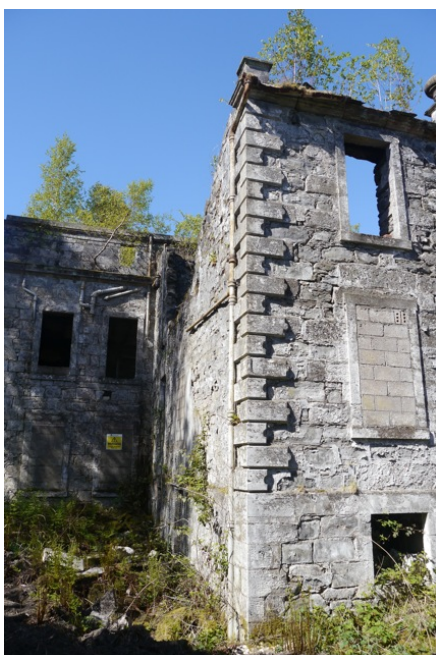
Old photographs show a steep roof to the original house, with high gables. What remains of this wall contains little of architectural value, including patch repairs in a variety of materials, including brick, block and cement mortar.

*South-east corner and remains of south gable.*

Nevertheless, there will be many strong reasons for rebuilding this wall in its original position, if not for its full height. These include:

- (a) providing lateral stability to a retained and repaired main elevation;
- (b) maintaining the architectonic link between the two main elements of the the structure, the east and south façades.

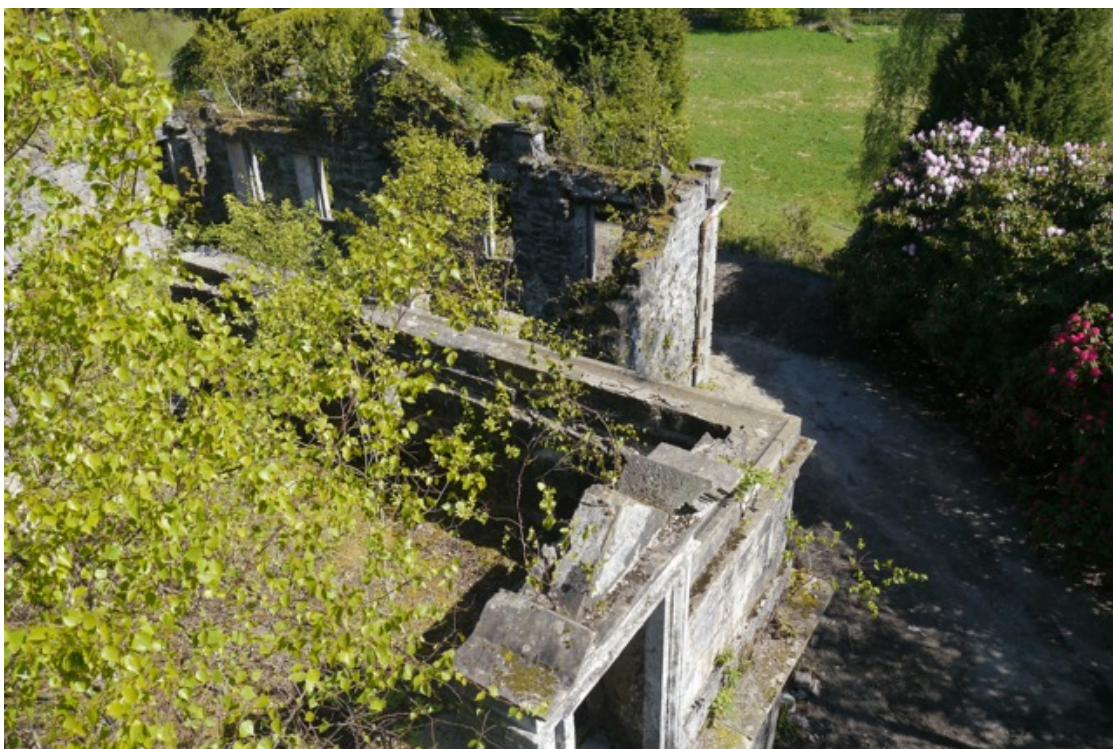
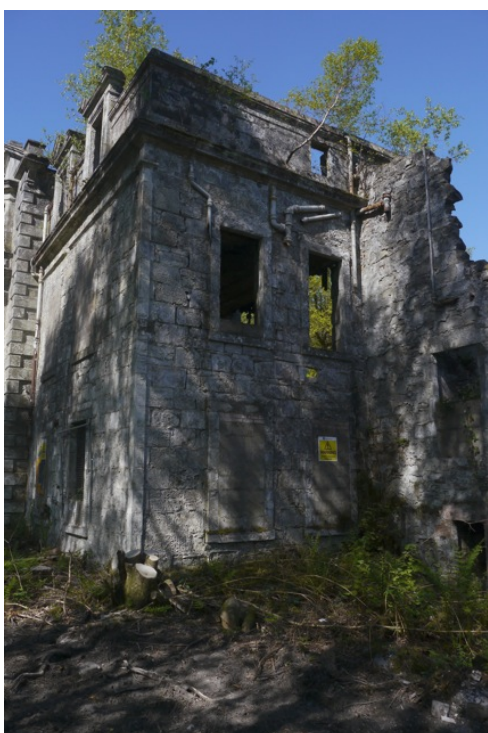
The 1880s extension is described as having slated piends and platform room (presumably leaded). This wall remains substantially intact and provides an architecturally satisfactory transition from the scale and proportions of the older part of the building to the newer, grander south elevation.

*Rear east gable and parapet.*

For this reason this wall should be retained and repaired to match as closely as possible its original form, including the re-bedding of cope stones (if sound) or their replacement (if not).

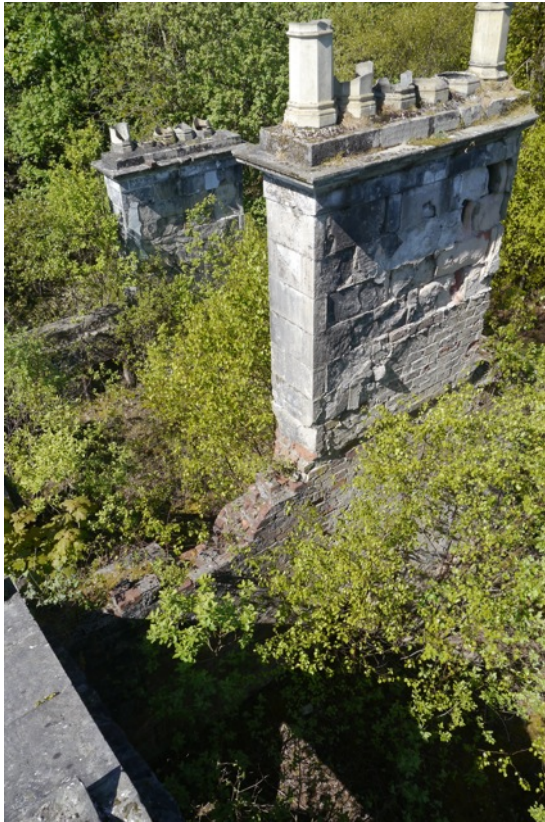
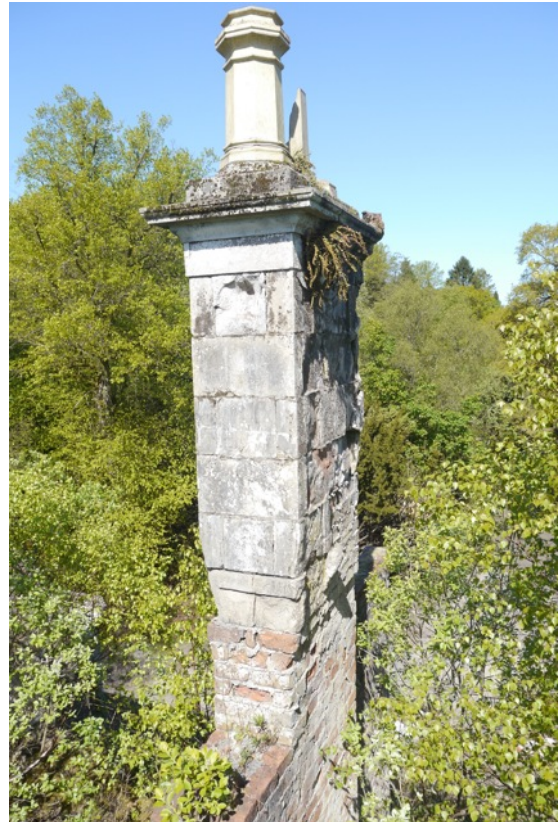
While the two central chimneys formed an intentional part of the original design of this elevation, their reinstatement could severely restrict options for the replanning of the building. It should follow that if the lost gable chimneys of the old house are not being replaced, then there should be no insistence on the replacement of the internal chimneys of the later extension. This should free up considerably the possibilities for the interior redesign.

*Above - structurally unstable central chimneys and vegetation growing off concrete second floor.*

Particular care should be taken during the removal of defective steel and concrete second floor, on account of its large spans and unusual construction, and the lack of knowledge of how this floor is supported on or gives support to the wall.

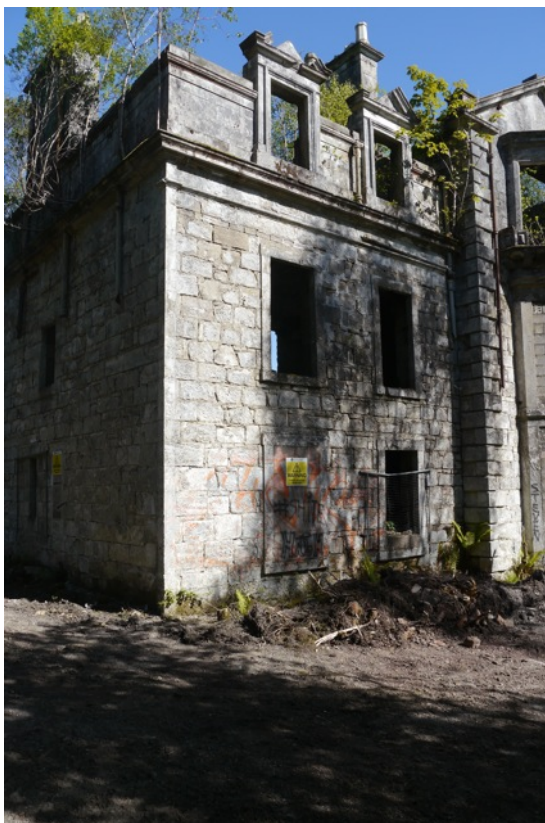
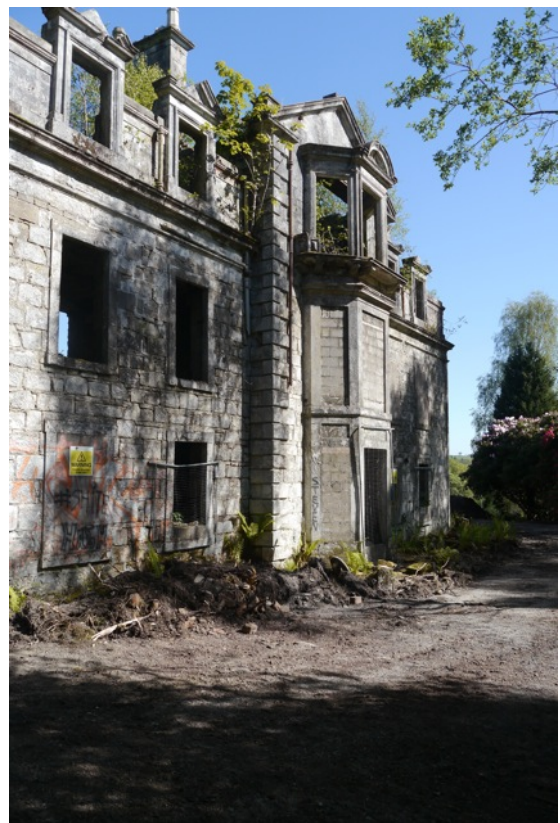
*Below - Eclectic detailing to 1880s façade.*

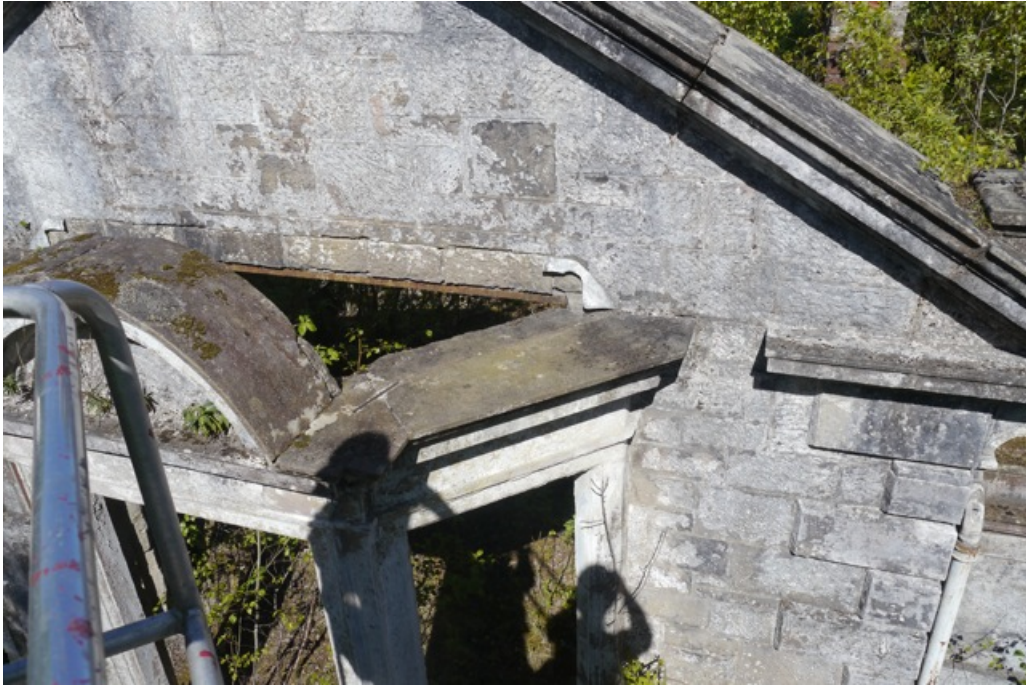
There is also a partially concealed steel or iron girder supporting the pediment over the central bay. This appears to be corroded and is likely to need replaced.

*Above - rusted iron beam supporting pediment.*

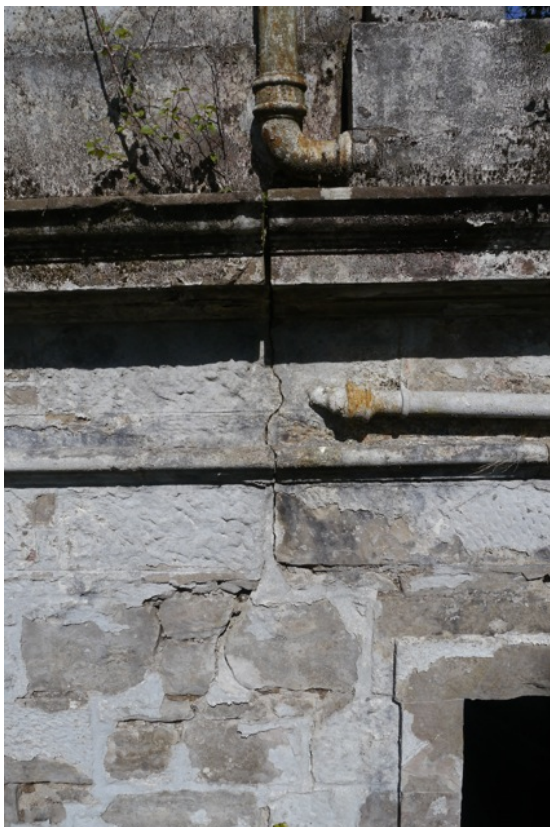
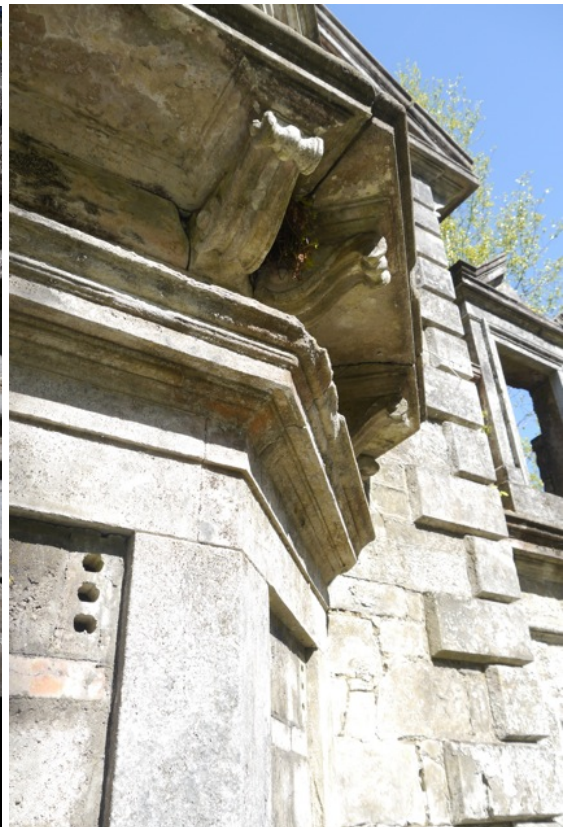
It appears from the detailing and the squared and coursed stonework that wall areas between the projecting dressed stone margins and string courses etc, may have been given a render finish. This should be investigated in greater detail as the detailing render to stone will be a key factor in restoring this elevation to its original appearance.

*Below - Cracks and open joints to be repointed and plain wall areas lime rendered.*

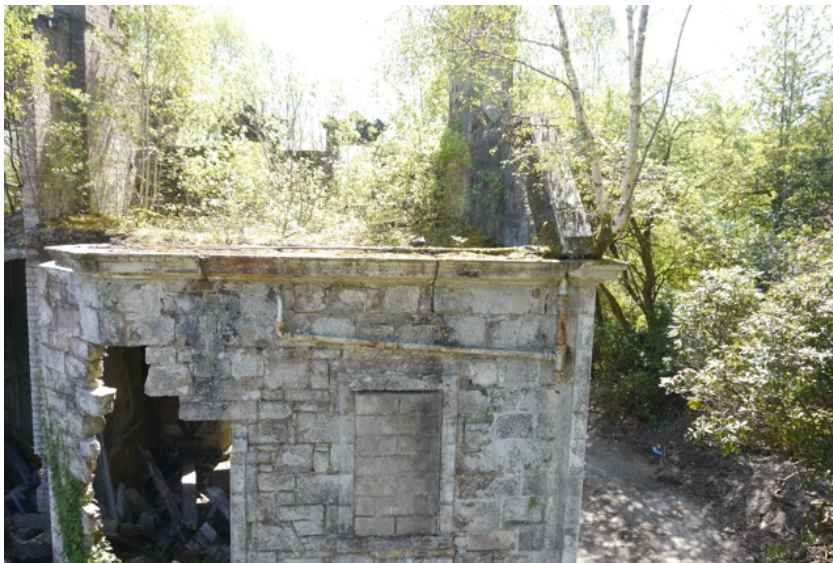
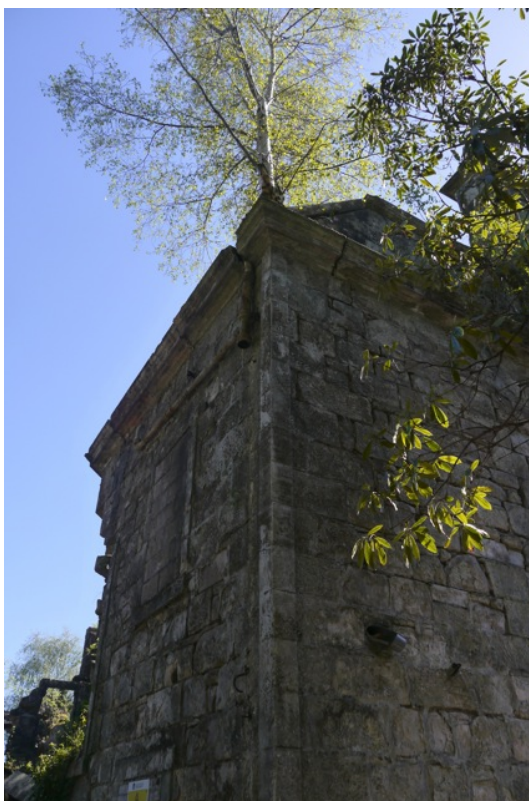
The gable wall is built of squared and coursed sandstone however it is difficult to tell whether it was originally pointed or rendered.

*Above - vegetation growing off concrete second floor behind west gable.  
Left - open mortar joints to west gable.*

While this wall is less visible there are two reasons why it should be retained and the defective upper section rebuilt:

The present positioning of the plaque would also point to the reconstruction of the gable chimney, which would also help give definition to the end of the building. Alternatively there may be scope for relocating the plaque elsewhere on the building, if this were acceptable to the planning authorities.

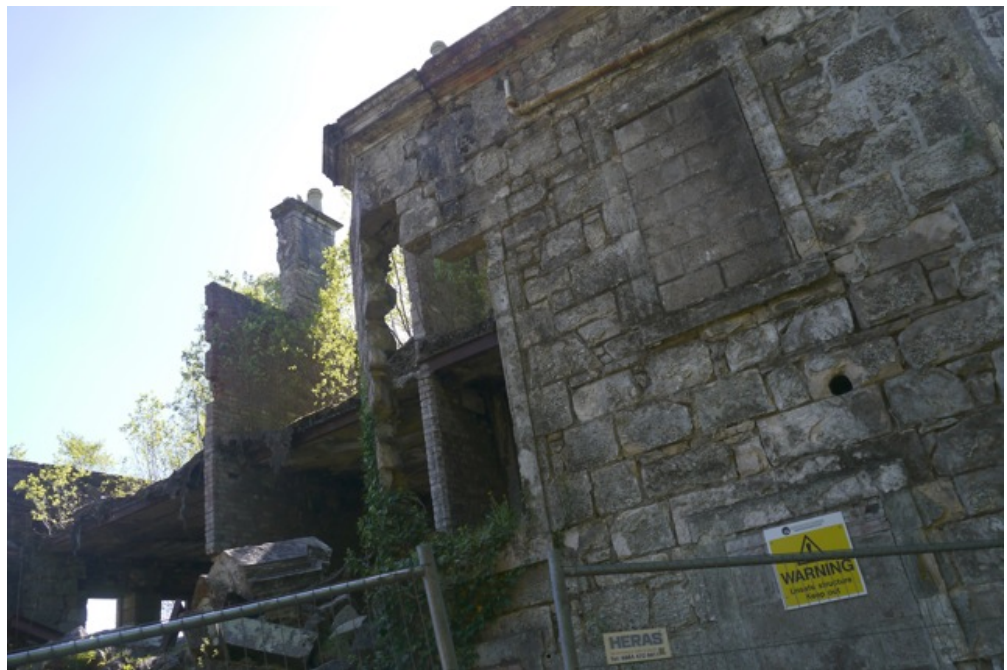
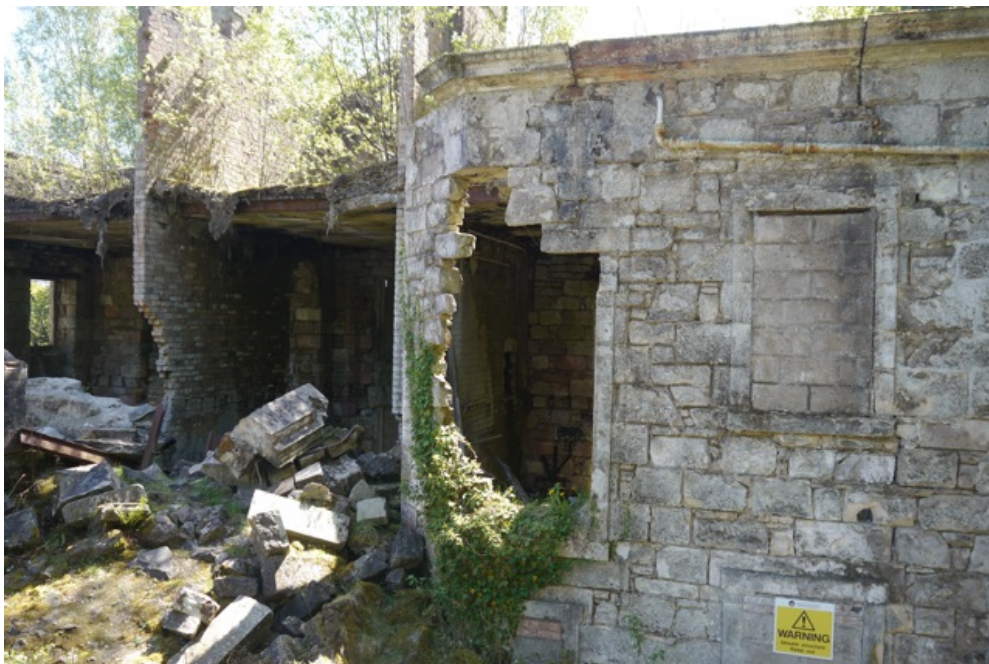
It would appear that there would be little benefit in rebuilding the section of defective masonry identified by the Structural Engineer, unless this formed part of the proposals for the new structure. The interior and the rear of the building is a rubble strewn mess with little left that is salvageable. The return at this gable and at the rear of the north gable of the original house could therefore mark the boundary between restoration and new intervention.

*Surviving rear projection - section on left structurally unstable.*

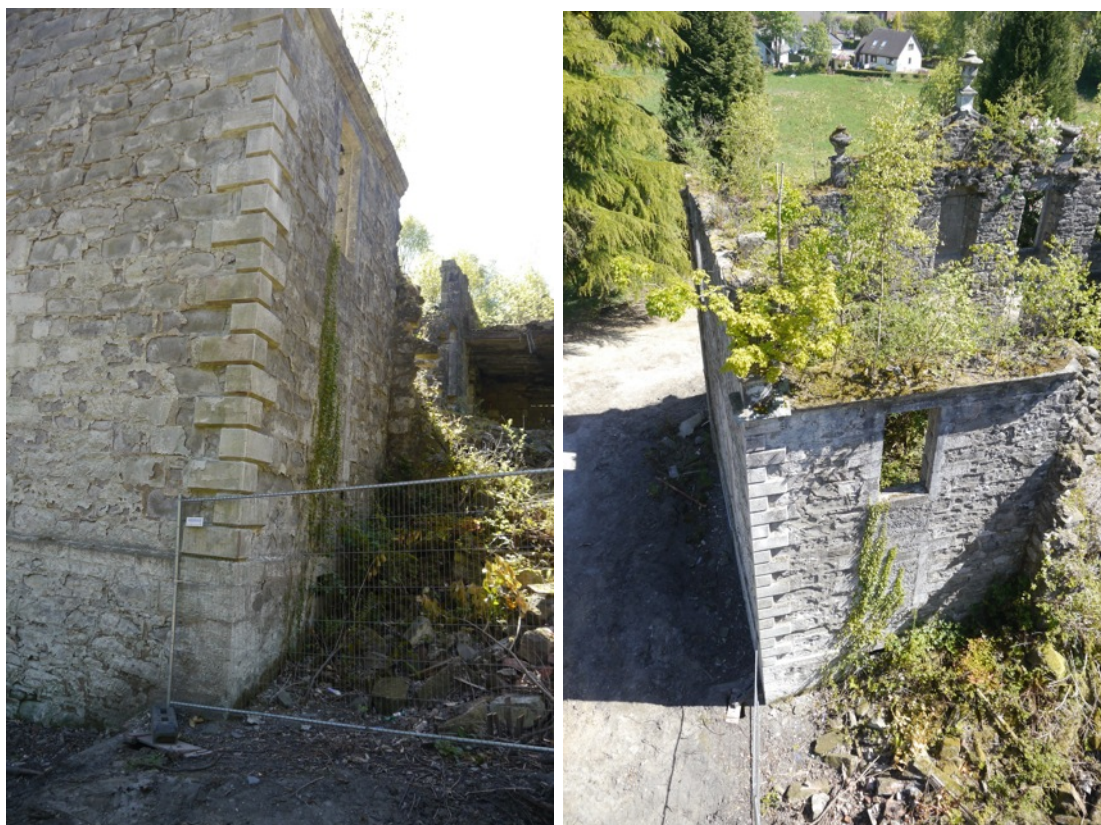
The gable has projecting quoin stones to front and rear and appears to have been lime rendered as the front elevation.

*North gable and surviving rear wall of original house.*

Old photographs show a steep roof to the original house, with high gables. This wall should be rebuilt, at least to eaves level:

The first bay of the wall returning along the back of the original house also remains intact and is similarly detailed. This short length of rear elevation should be retained - this return along with that at the west gable of the extension could then be conceived as bookends marking the boundary between the restored shell and new intervention.

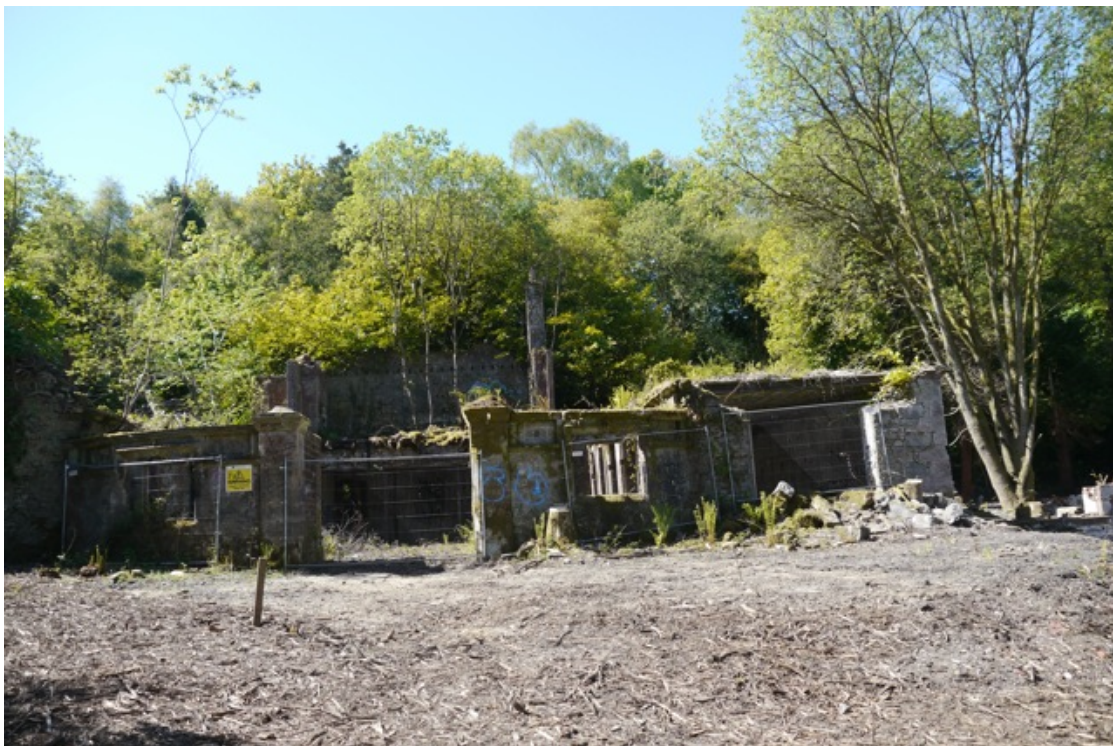
*Central entrance with curved wall to courtyard and collapsed gable to north block.*

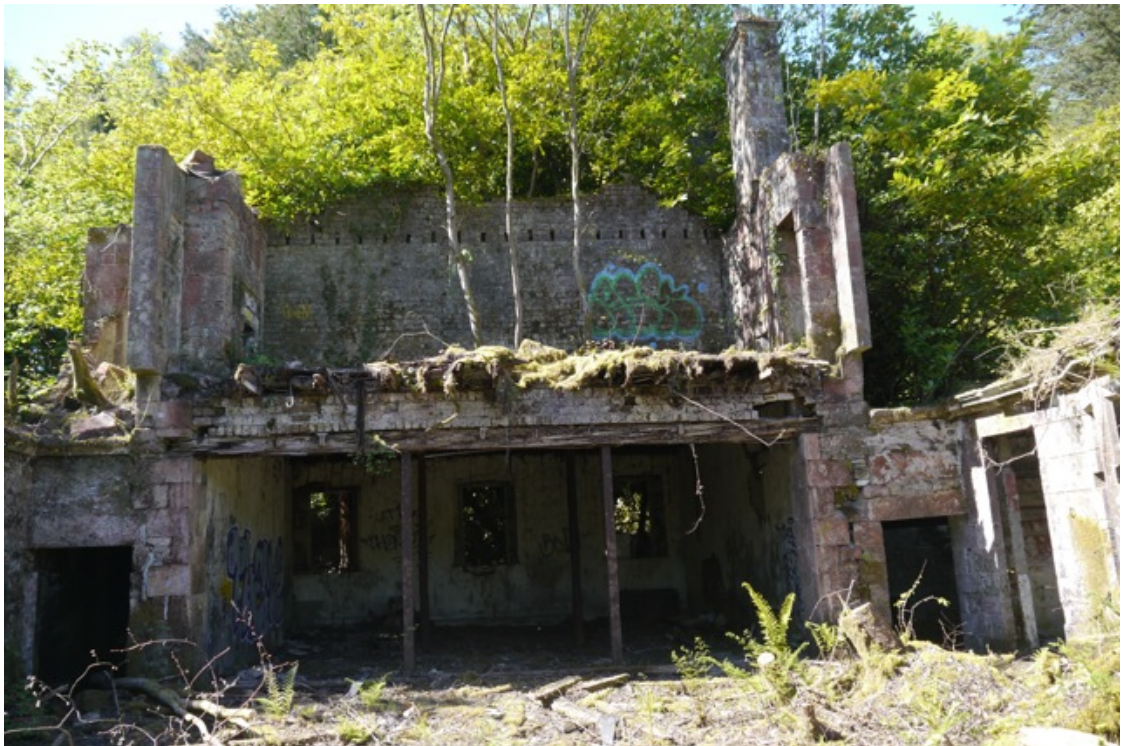
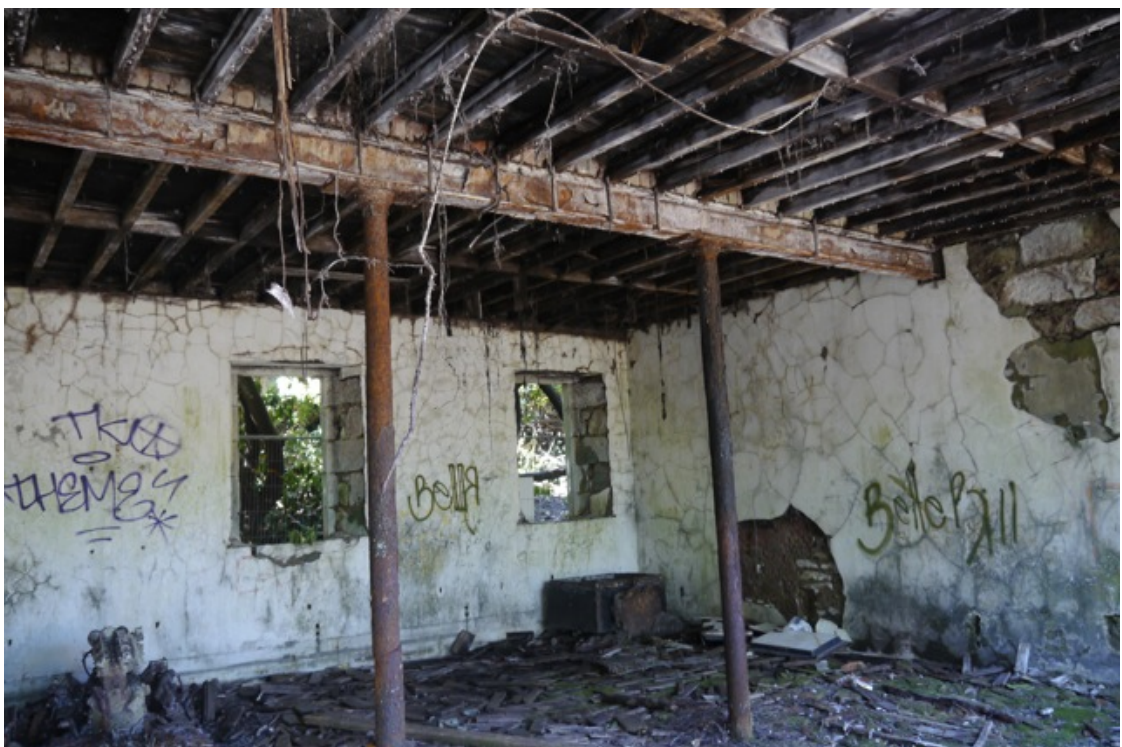
The two storey chimneyed structure is structurally unstable and should be taken down to first floor level. The rear wall appears to be repairable, although one of the internal cast iron columns has sheared.

*2-storey rear section: above - note mature trees growing out of first floor structure;  
below - note shear crack in left-hand column (supporting brick spine wall).*

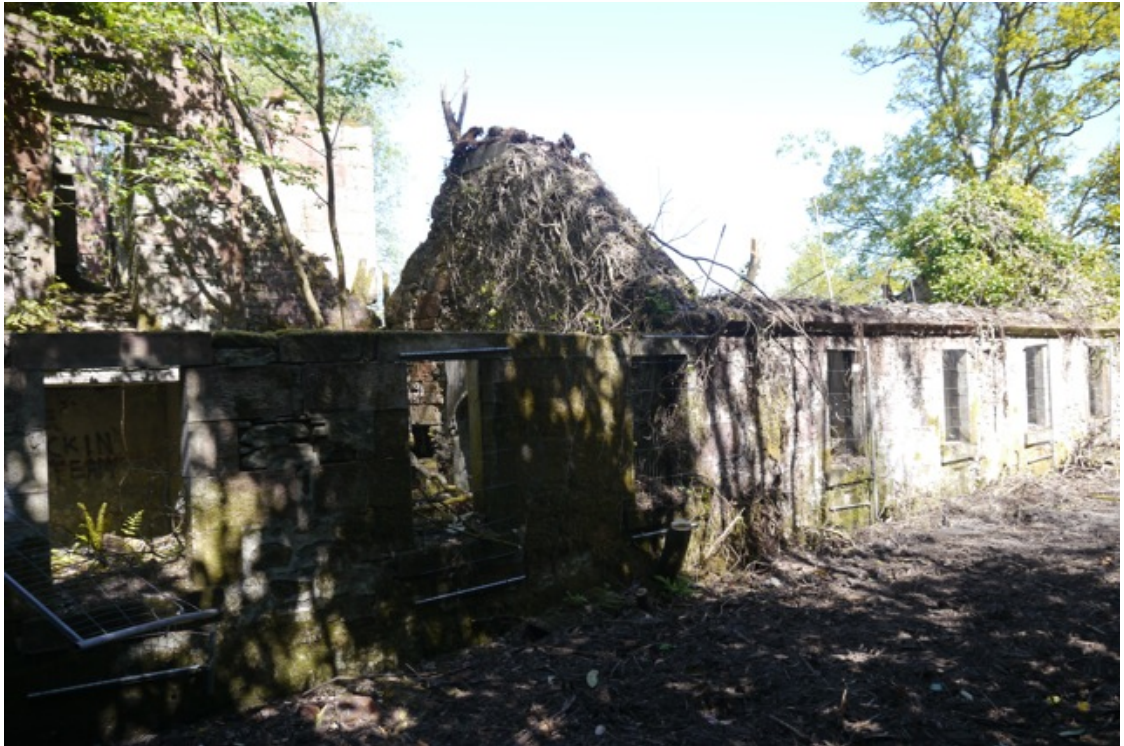
*South block - overgrown with vegetation.*

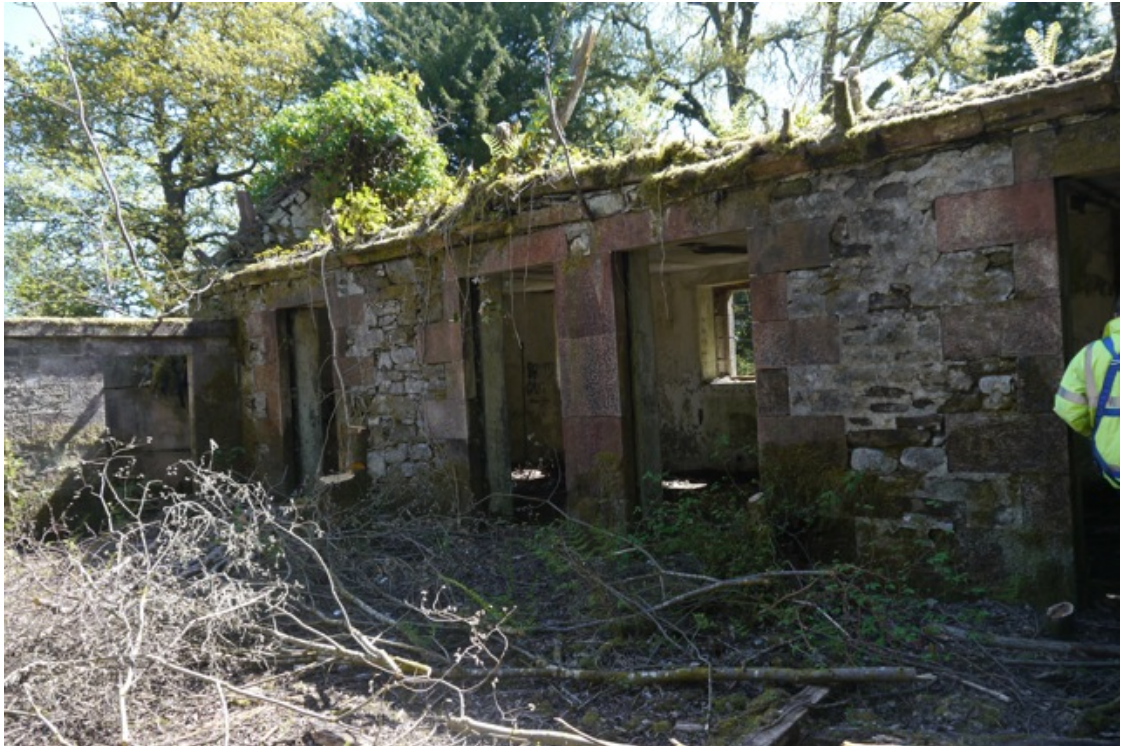
*Below - within south block - ceiling still intact despite collapsed roof.*

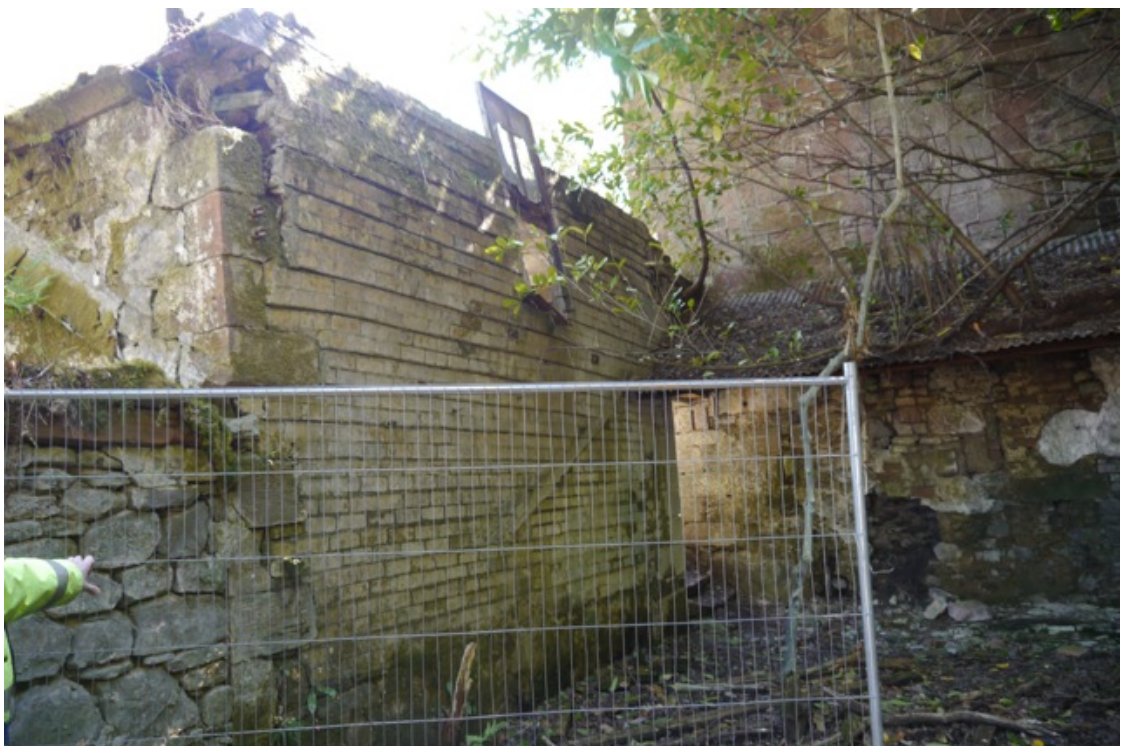
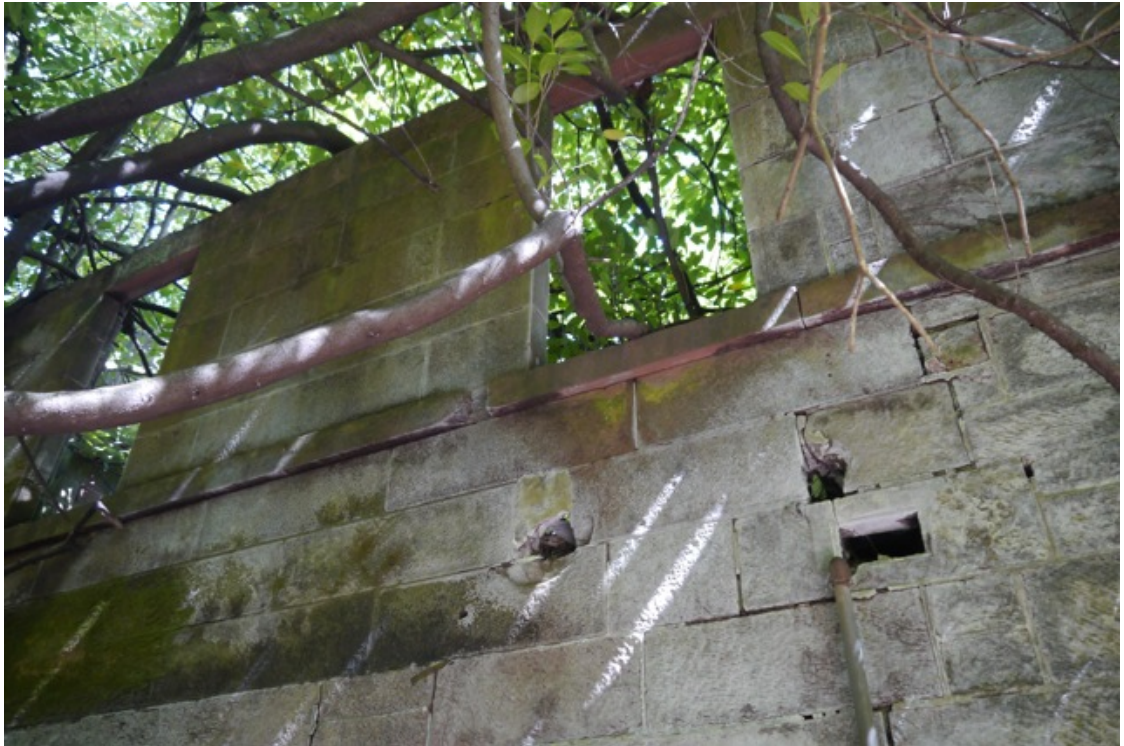
*Rear of rear section - overwhelmed by tree growth - now causing structural damage.*
