Structural Inspection Report Woodbank House & Stables Luss Road Balloch

On behalf of **TSL Contractors Ltd**

Project Ref: 35854 | Rev: 1 | Date: May 2017

Report Title: Woodbank House & Stables Structural Inspection Report

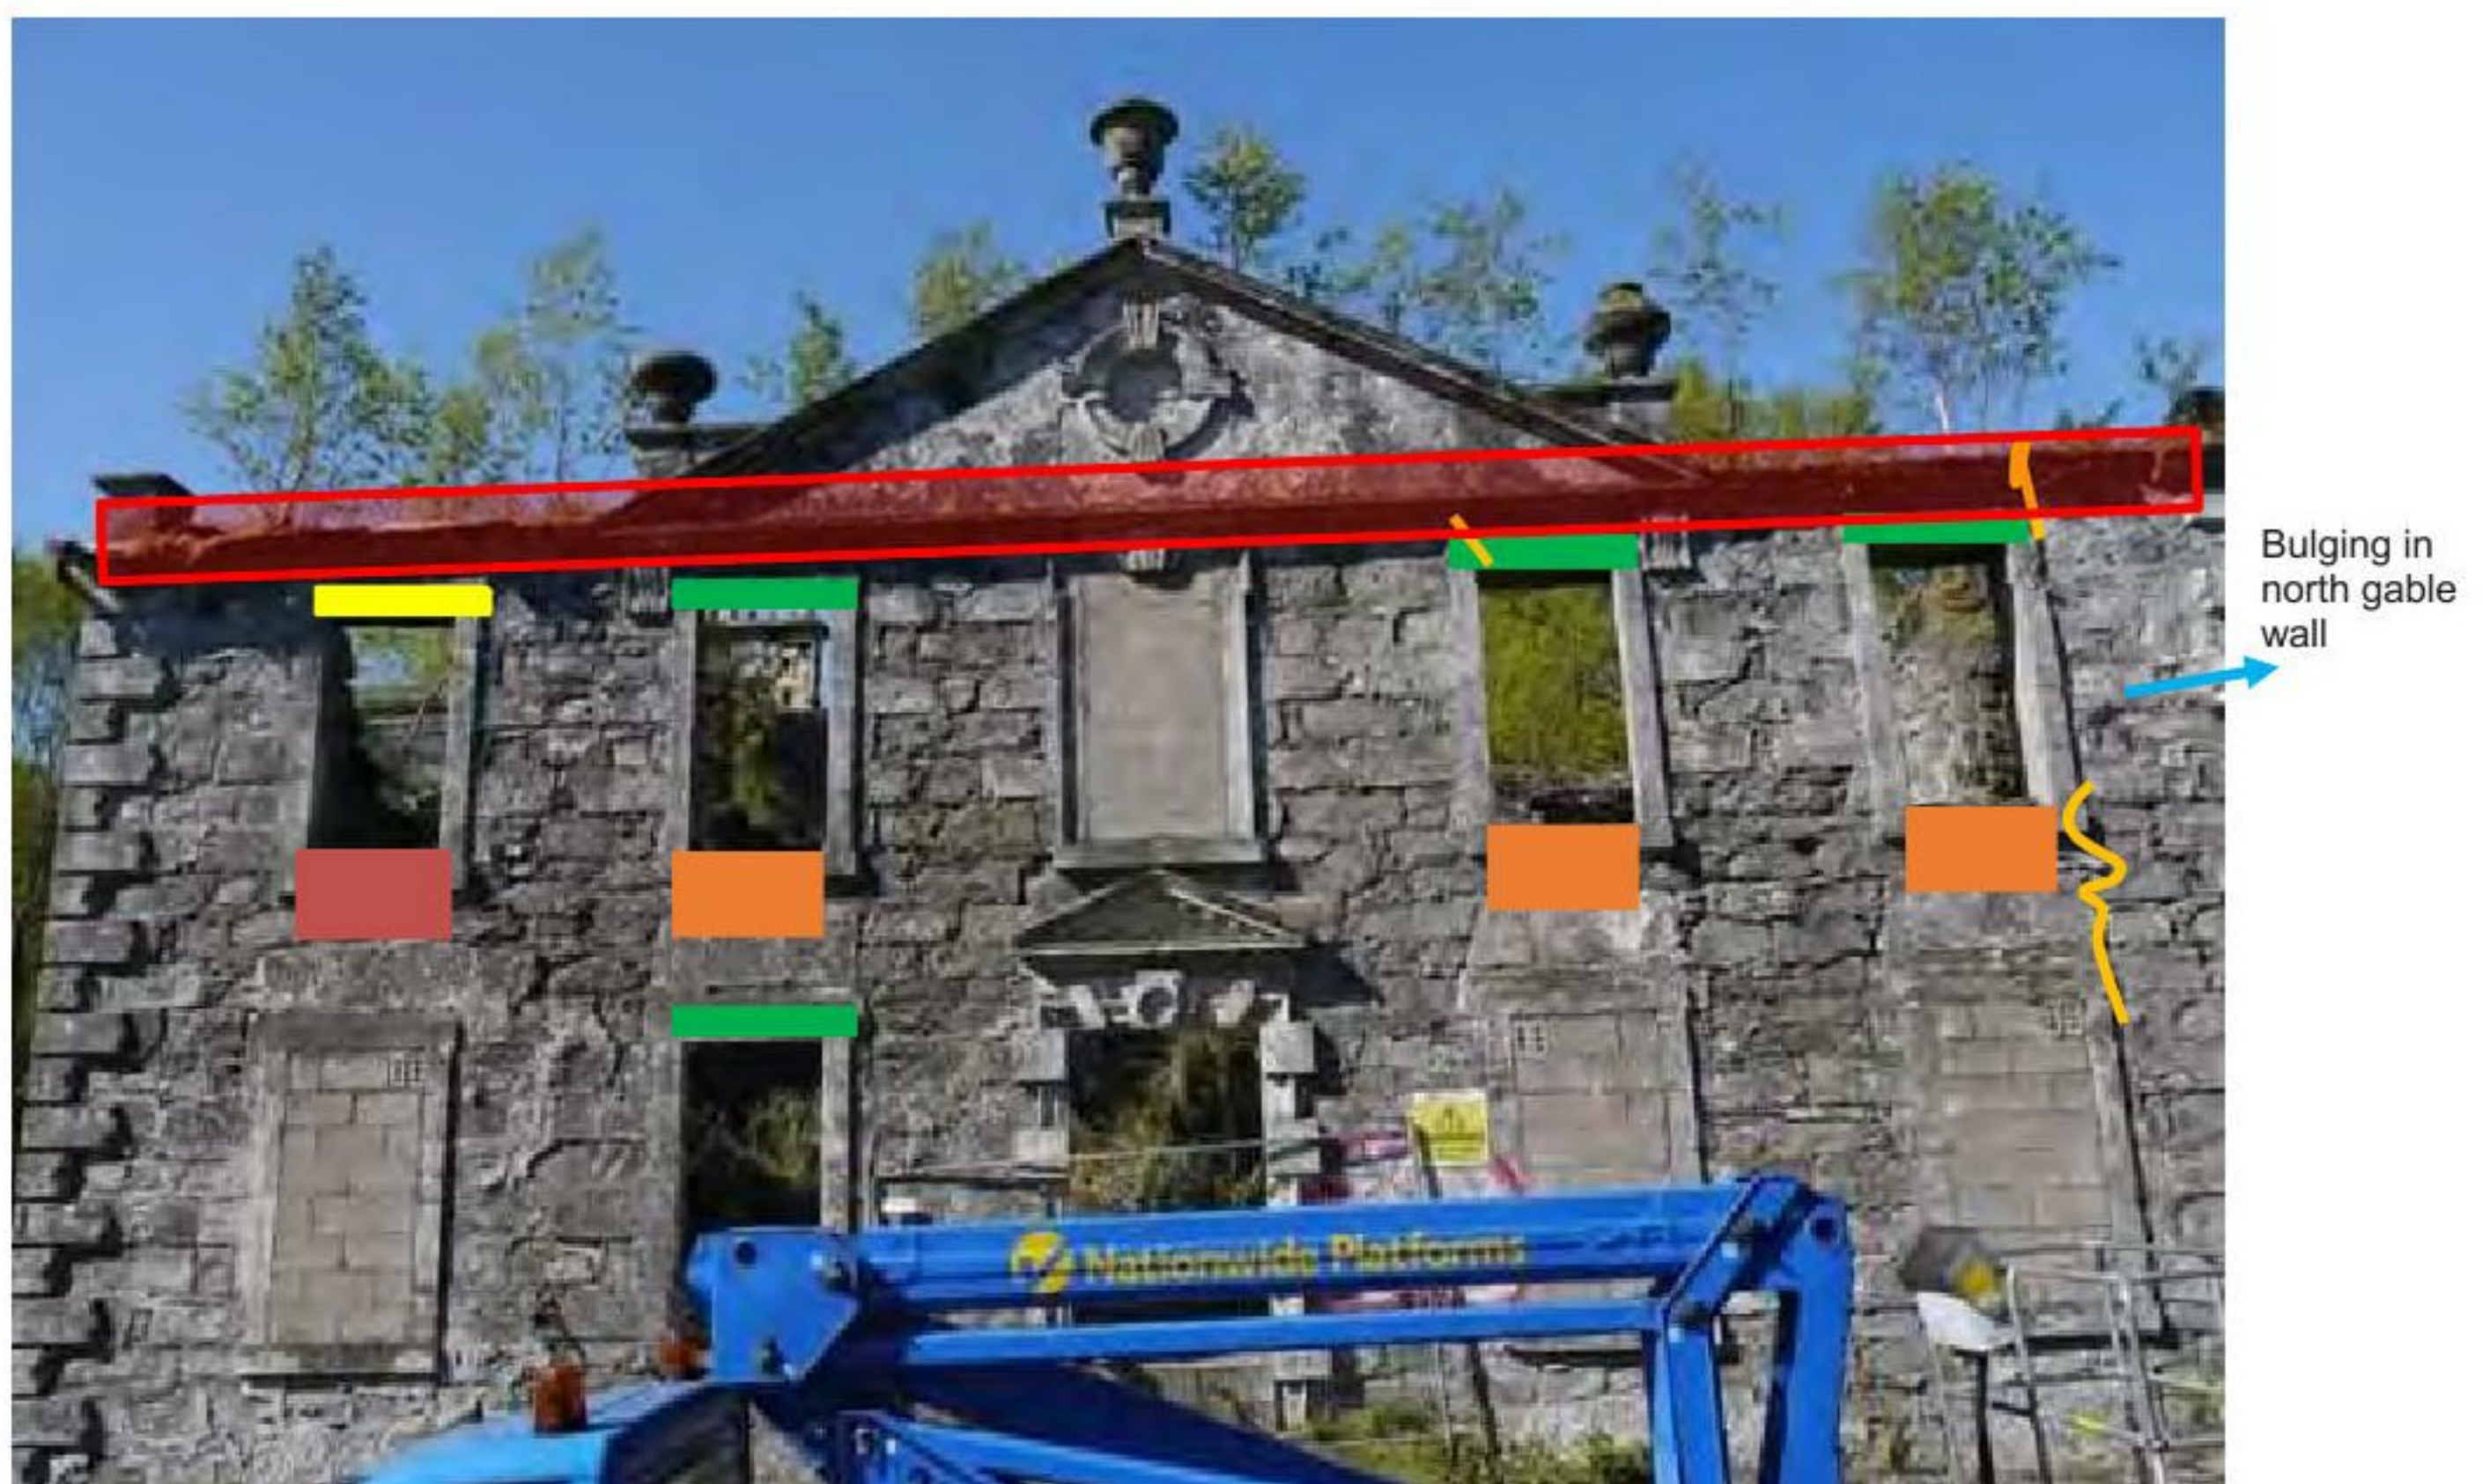
- 2.3.2 The dressed stone is in reasonable condition and the wall is generally plumb. However, the wall condition varies, there are areas of erosion and the mortar joints are failing. The cope stones are badly eroded and need replaced, as highlighted below in red.

- 2.3.4 Some cracks are evident to the north, as highlighted in orange on Photograph 2 below: related to bulging of the north gable, as highlighted below.

- 2.3.5 This elevation must be propped from outside, utilising the window openings, throughout the demolition clearance and proposed works.
- 2.3.6 All existing lintels are failing. The south first floor window has a timber safe lintel (shown in yellow) which needs replaced, as do the concrete lintels (highlighted in green) in the remaining windows as they are all cracked. All lintels need replaced in all elevations.

- 2.3.8 The floor has collapsed, as such only the external stone skin remains between the ground and first floor windows, as highlighted in orange. This occurs throughout all elevations.

Photograph 2 – East Elevation
Down takings for safety shown in red.

- 2.3.7 The squared random rubble between the window mullions is of varied quality and is eroded in some areas. The wall is to be repaired and joints raked and pointed with a suitable lime mortar prior to rendering the walls with a suitable lime render.

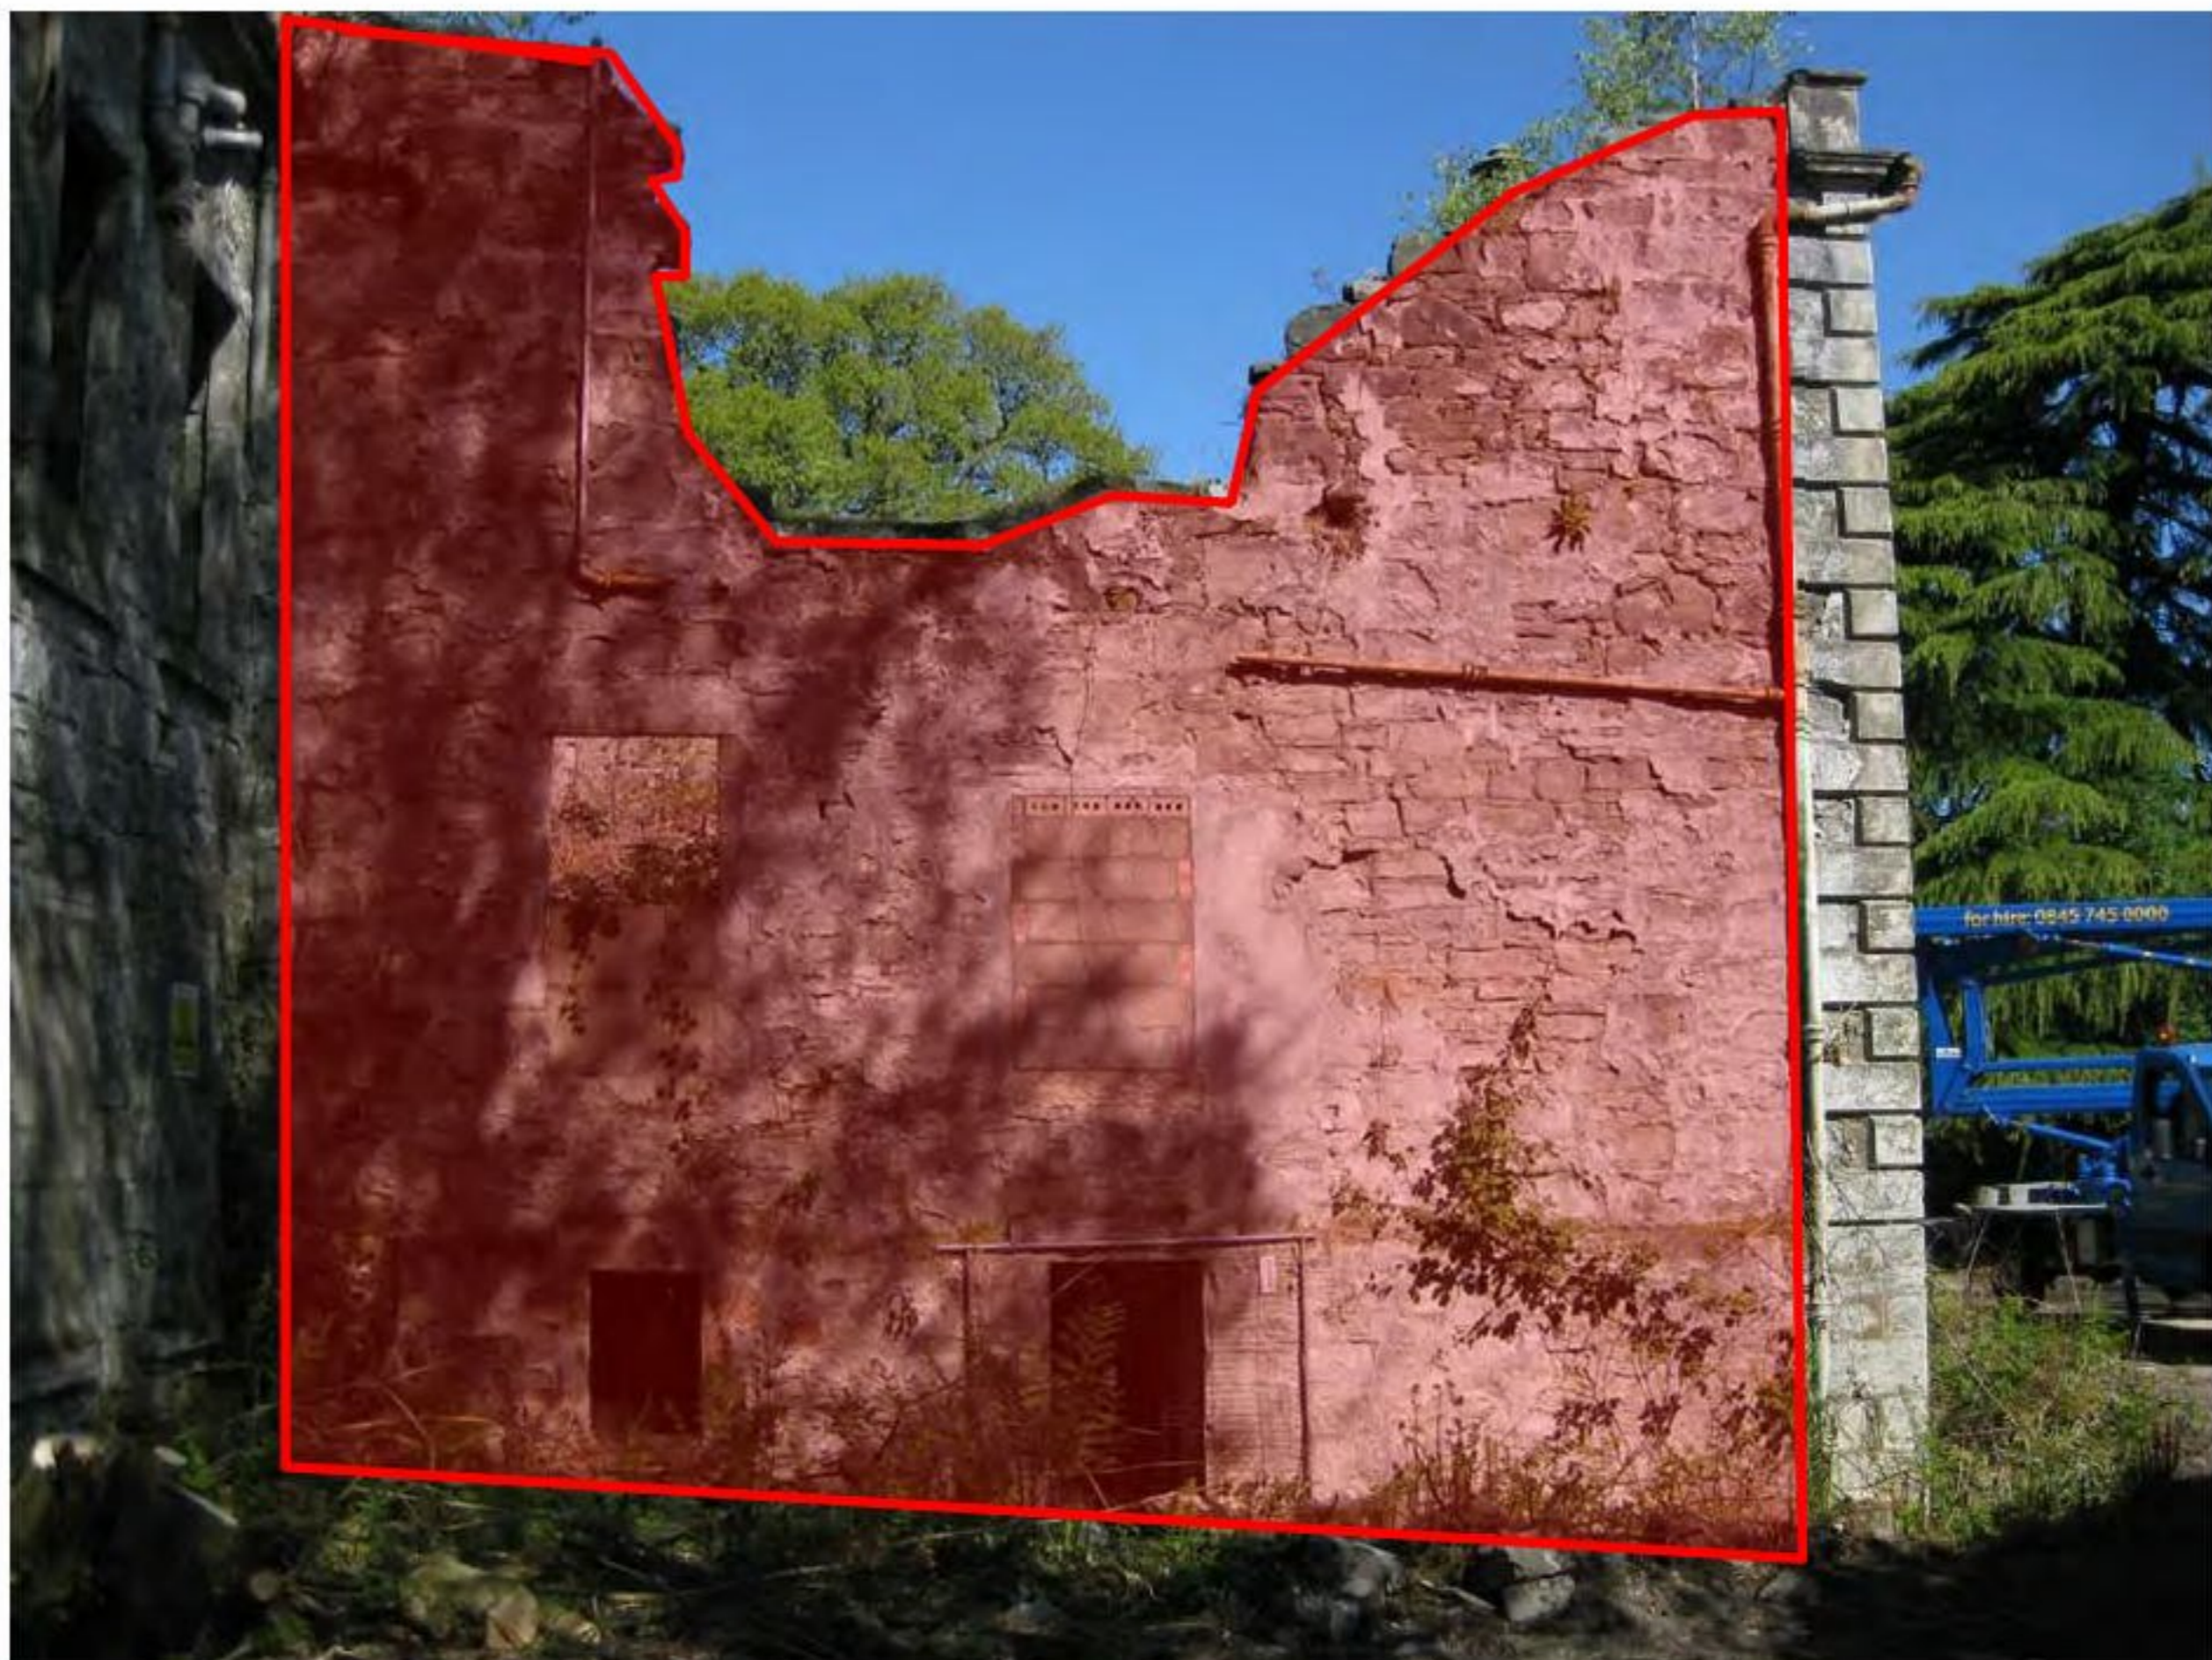
- 2.4.1 This gable elevation appears to originate from the 1774 building.
- 2.4.2 The wall is in poor condition following a partial collapse. A large area of the internal stonework skin has collapsed and the remaining wall is unstable. We recommend that this wall is demolished down to ground level, as highlighted red on photograph 3. The stone can be set aside for re-building.
- 2.4.3 As the wall is not visible out with the site due to trees, this elevation may have less historic significance and may be able to be removed. Future proposal and the conservation architect will inform the decision of whether this wall is to be re-built.
- 2.4.4 The East elevation and Rear East elevation will need to be propped prior to this demolition of the south wall, for stability.

Photograph 3 - South East Elevation
Down takings for safety shown in red.

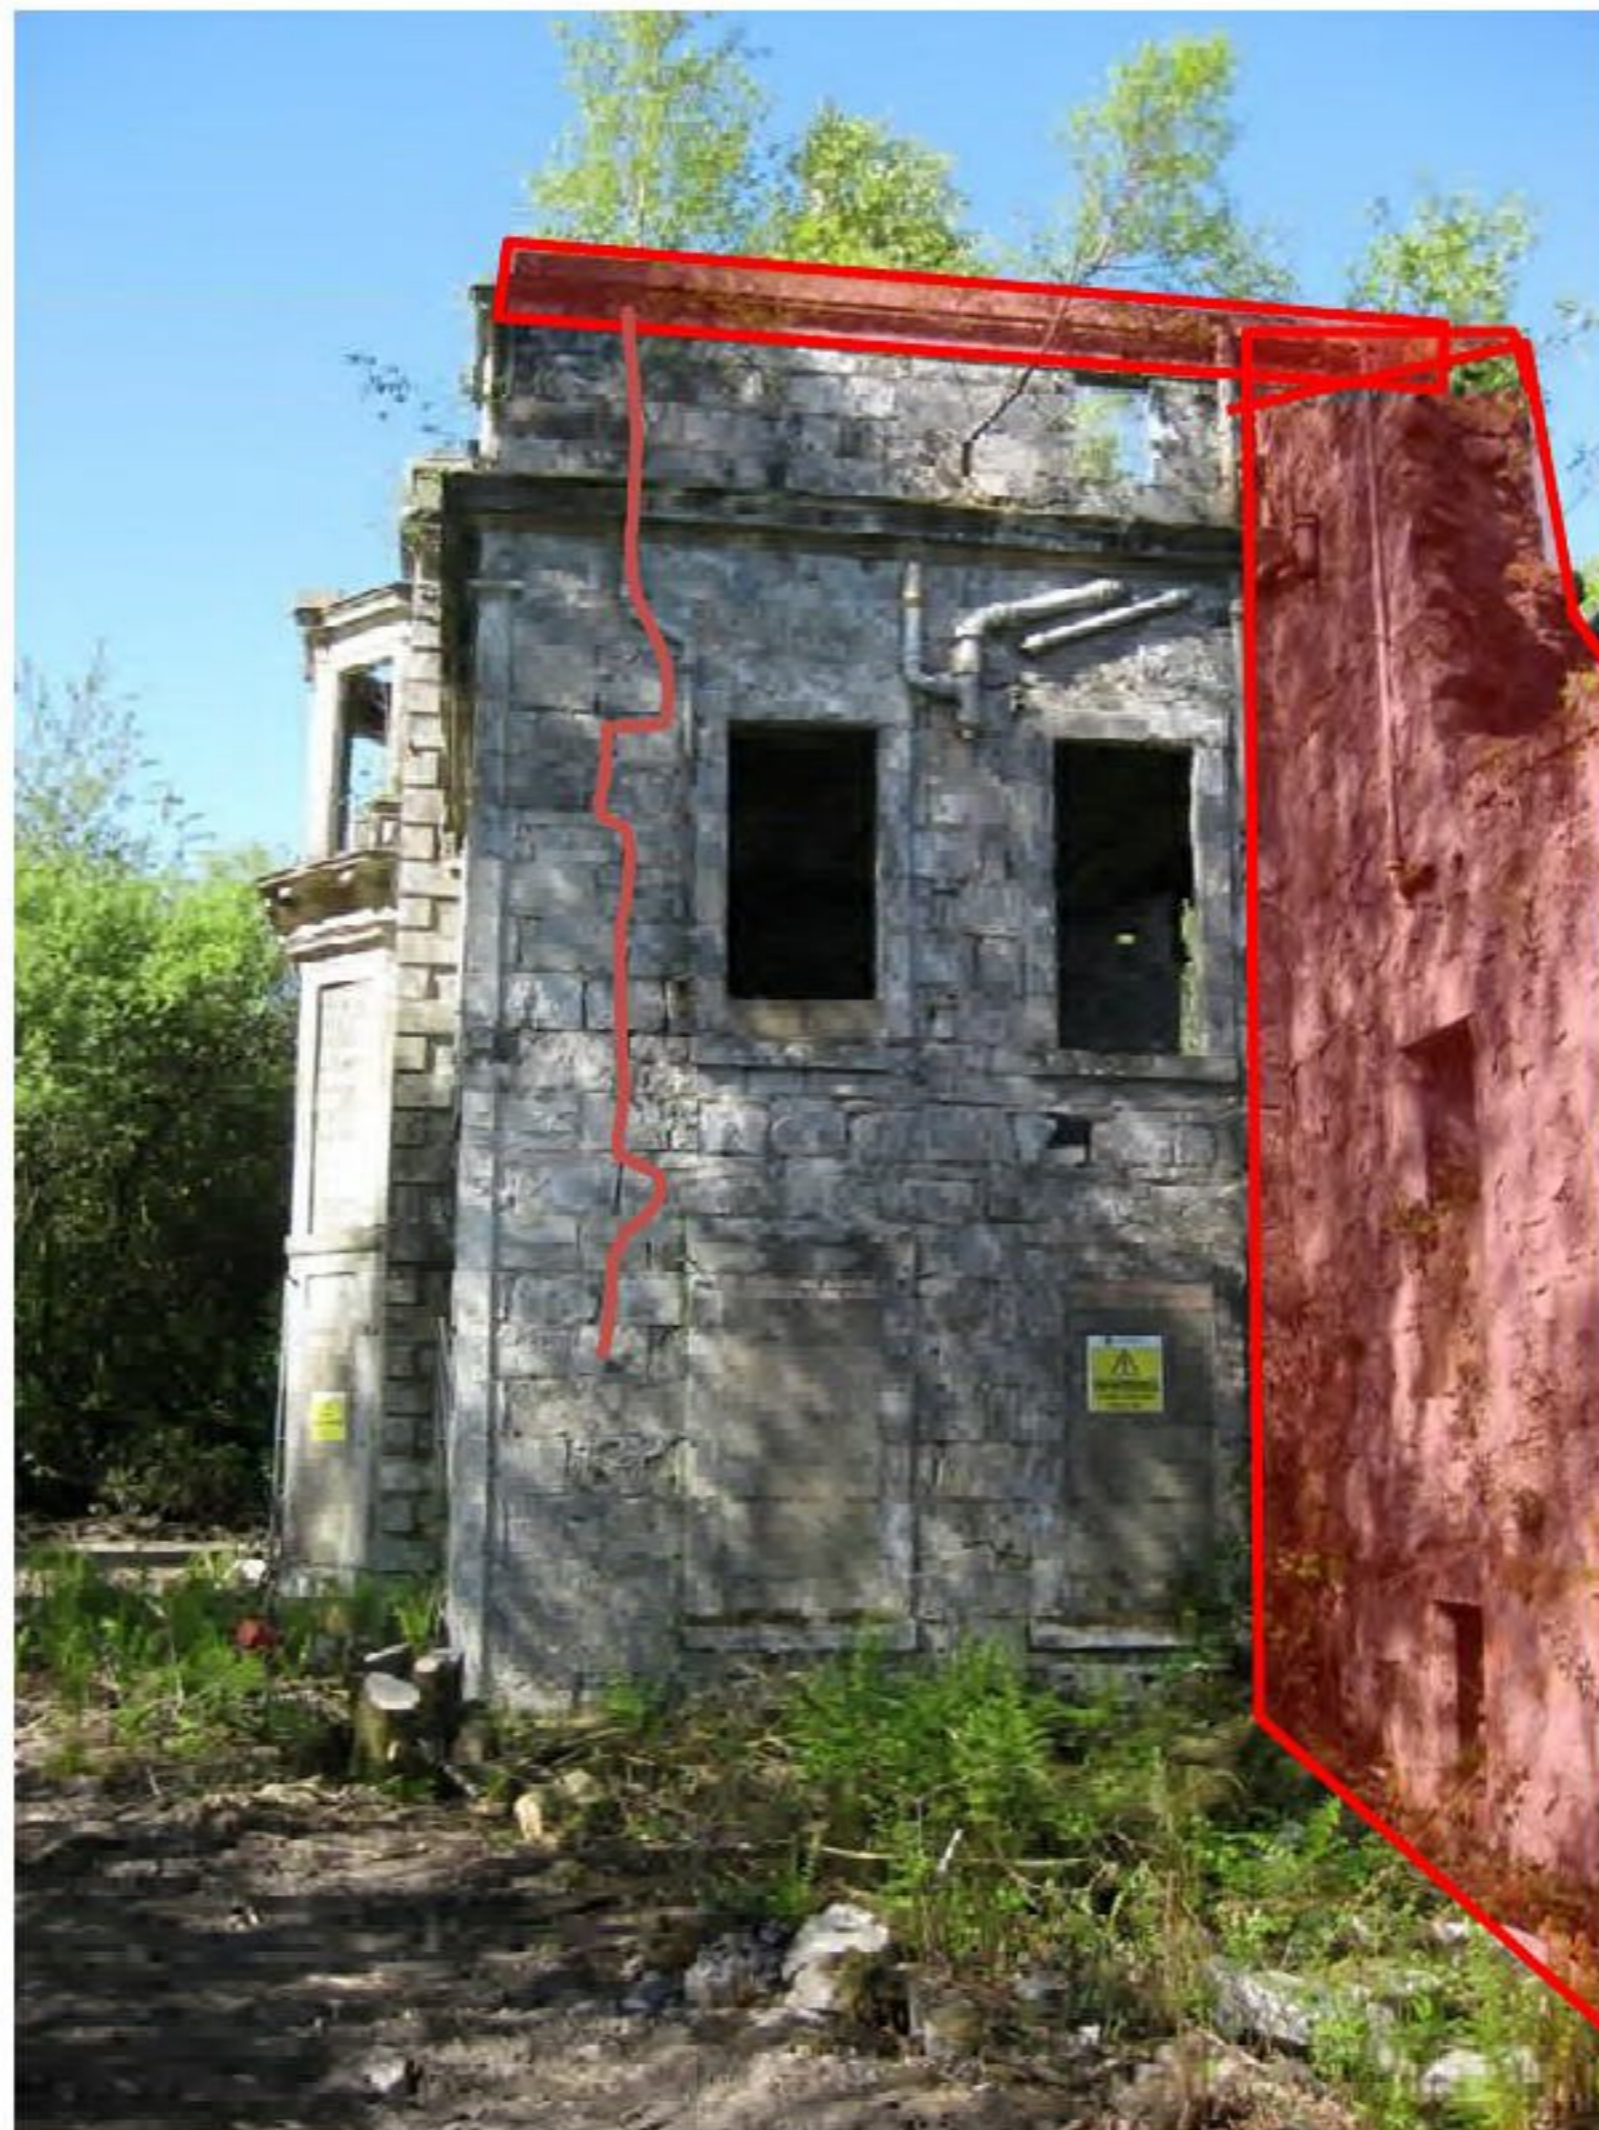
- 2.5.1 This elevation appears to originate from the 1880s extension.
- 2.5.2 The walls are in good condition. Cope stones are missing. The crack to the south indicates rotation of the southern wall outwards. We recommend that loose stones are removed and that the wall heads are remediated, highlighted below in red.

Photograph 4 – Rear East Elevation
Down takings shown in red

- 2.5.4 The south-east wall should be demolished for safety reasons; the rear east elevation must be fully propped prior to any demolition.
- 2.5.5 If this wall is to be kept, it will need to be propped for stability throughout the demolition, clearance and proposed works. If the wall is to remain, the stone should be repaired and joints raked and pointed with a suitable lime mortar prior to rendering the walls with a suitable lime render.

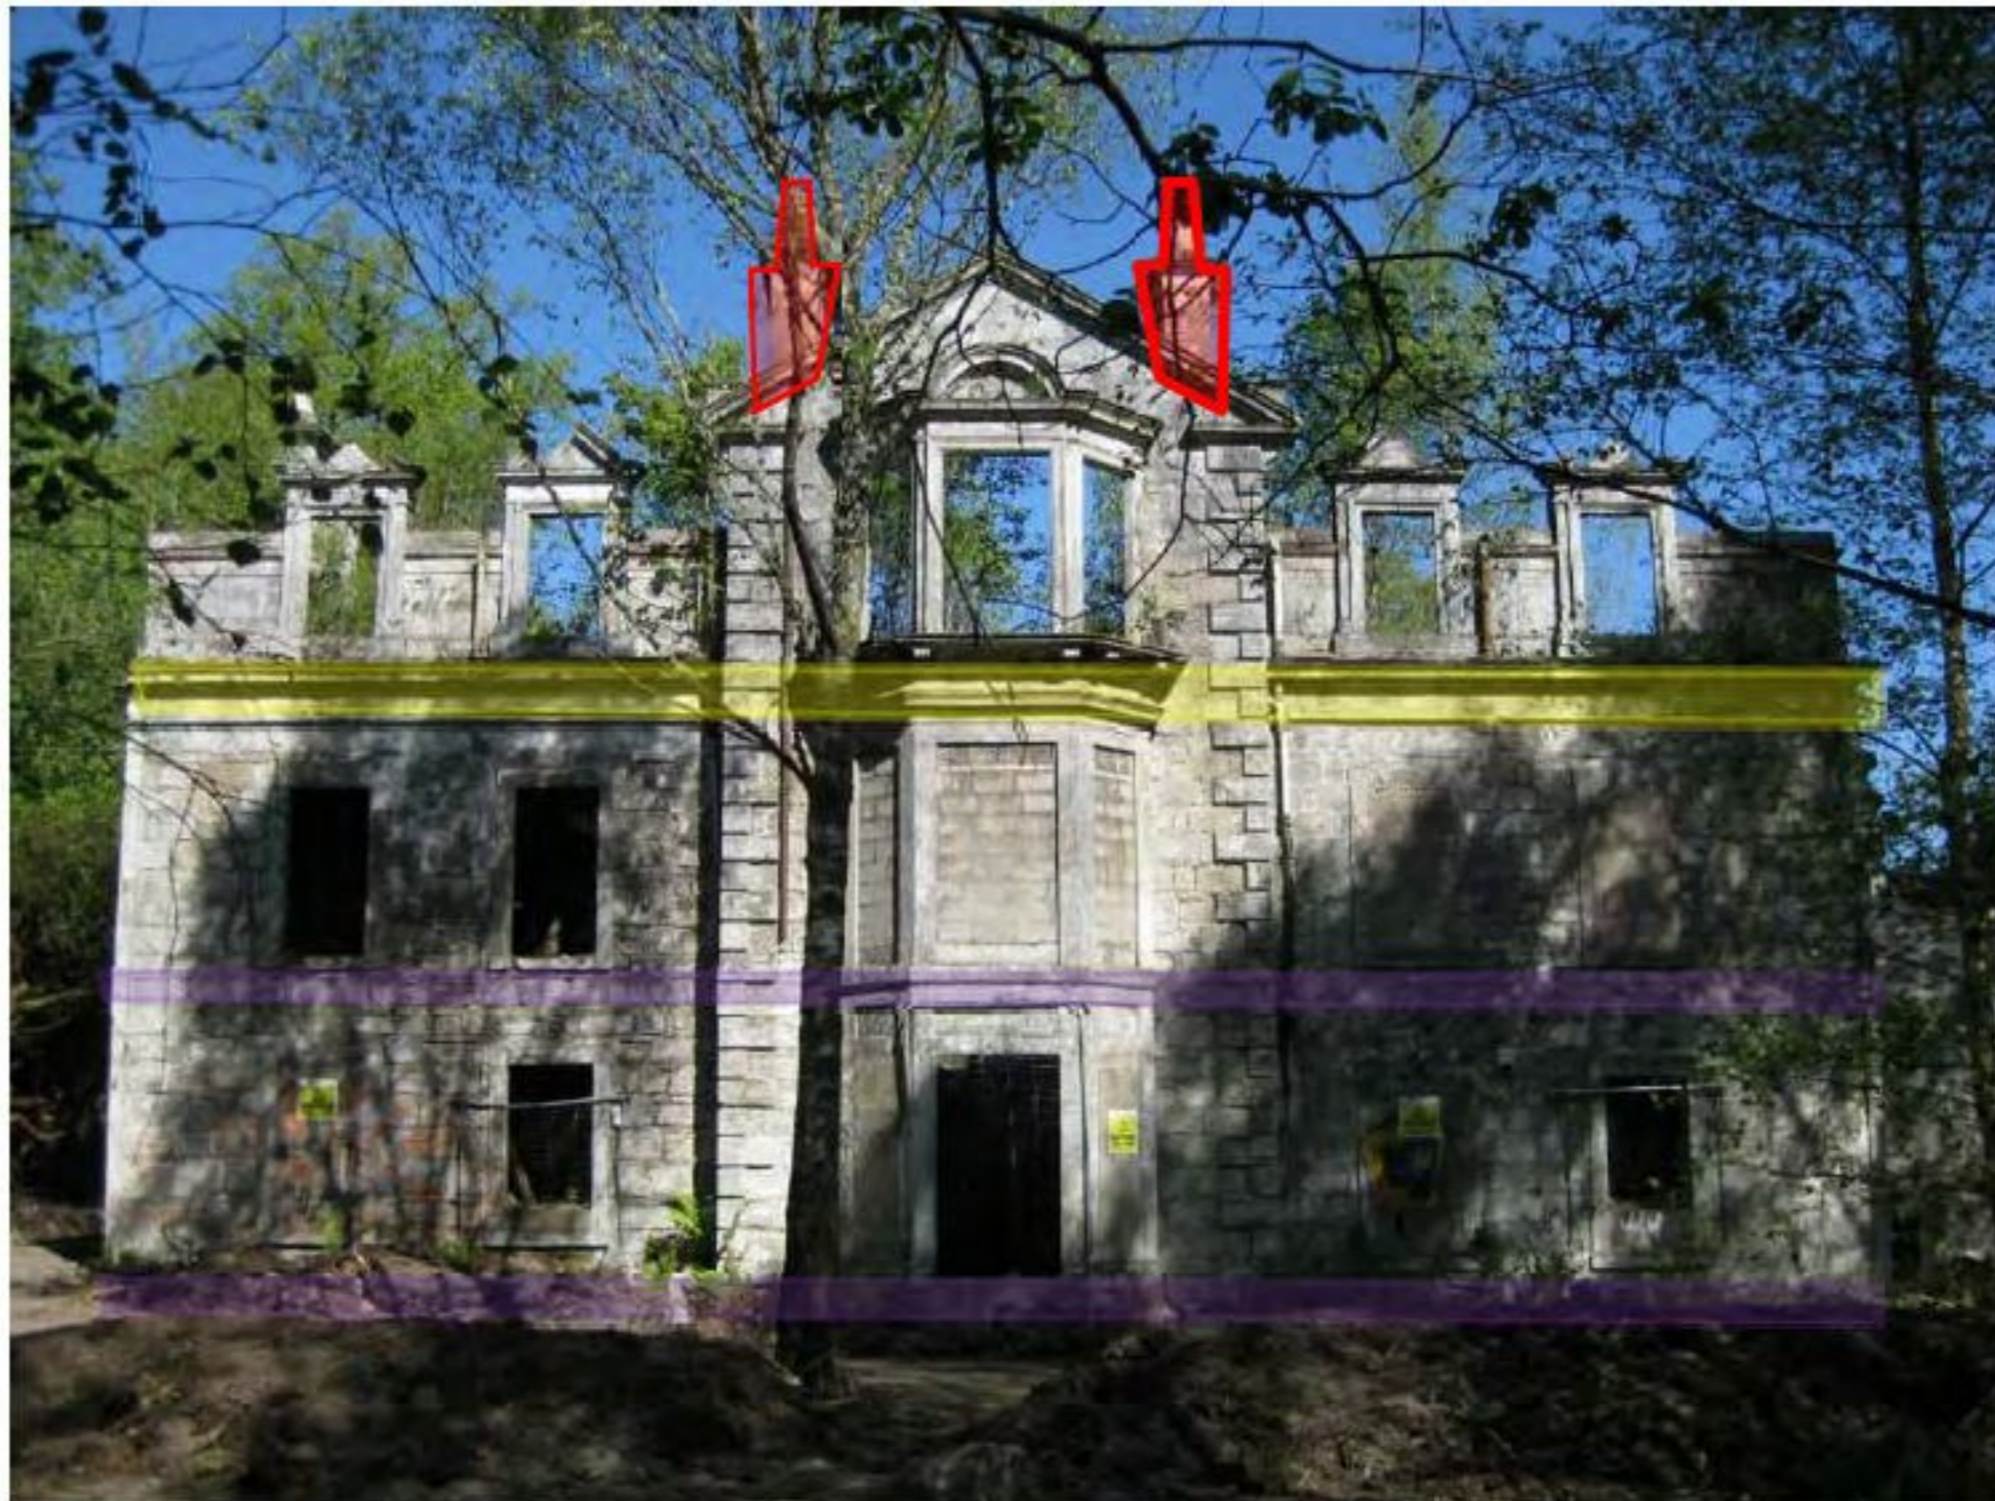
- 2.6.3 The two central chimneys are unstable. The walls supporting the chimneys are slender and the floors which originally provided restraint have collapsed. These chimneys should be demolished down to first floor level in the first instance, as highlighted in red on photograph 5 below.

Photograph 5 – South elevation
Down takings for safety highlighted red, unstable floors behind highlighted yellow and missing timber floors highlighted in purple.

- 2.6.6 Behind the south elevation the concrete second floor is constructed of concrete deck spanning within the steel beam depth, shown in yellow on Photograph 5. The floor cannot be safely accessed/inspected due to the debris from the partial demolition and past collapses. Visual inspection from ground level at the North appears to show large deflections in the East span. The steelwork supporting the floor appears to be very corroded. This floor and internal spine walls should be demolished down to ground level. Photograph 6, taken from the east, shows the extent of the walls and floors.

- 2.6.7 The timber ground and first floors, highlighted purple on Photograph 5, are no longer in place throughout the building, highlighted in purple. Wall restraint is missing in these areas as such the wall requires to be propped.

- 2.6.5 If the wall is to remain, it will require to be propped throughout the demolition, clearance and proposed works. If the wall is to remain the stone is to be repaired and joints raked and pointed with a suitable lime mortar prior to rendering the walls with a suitable lime render.

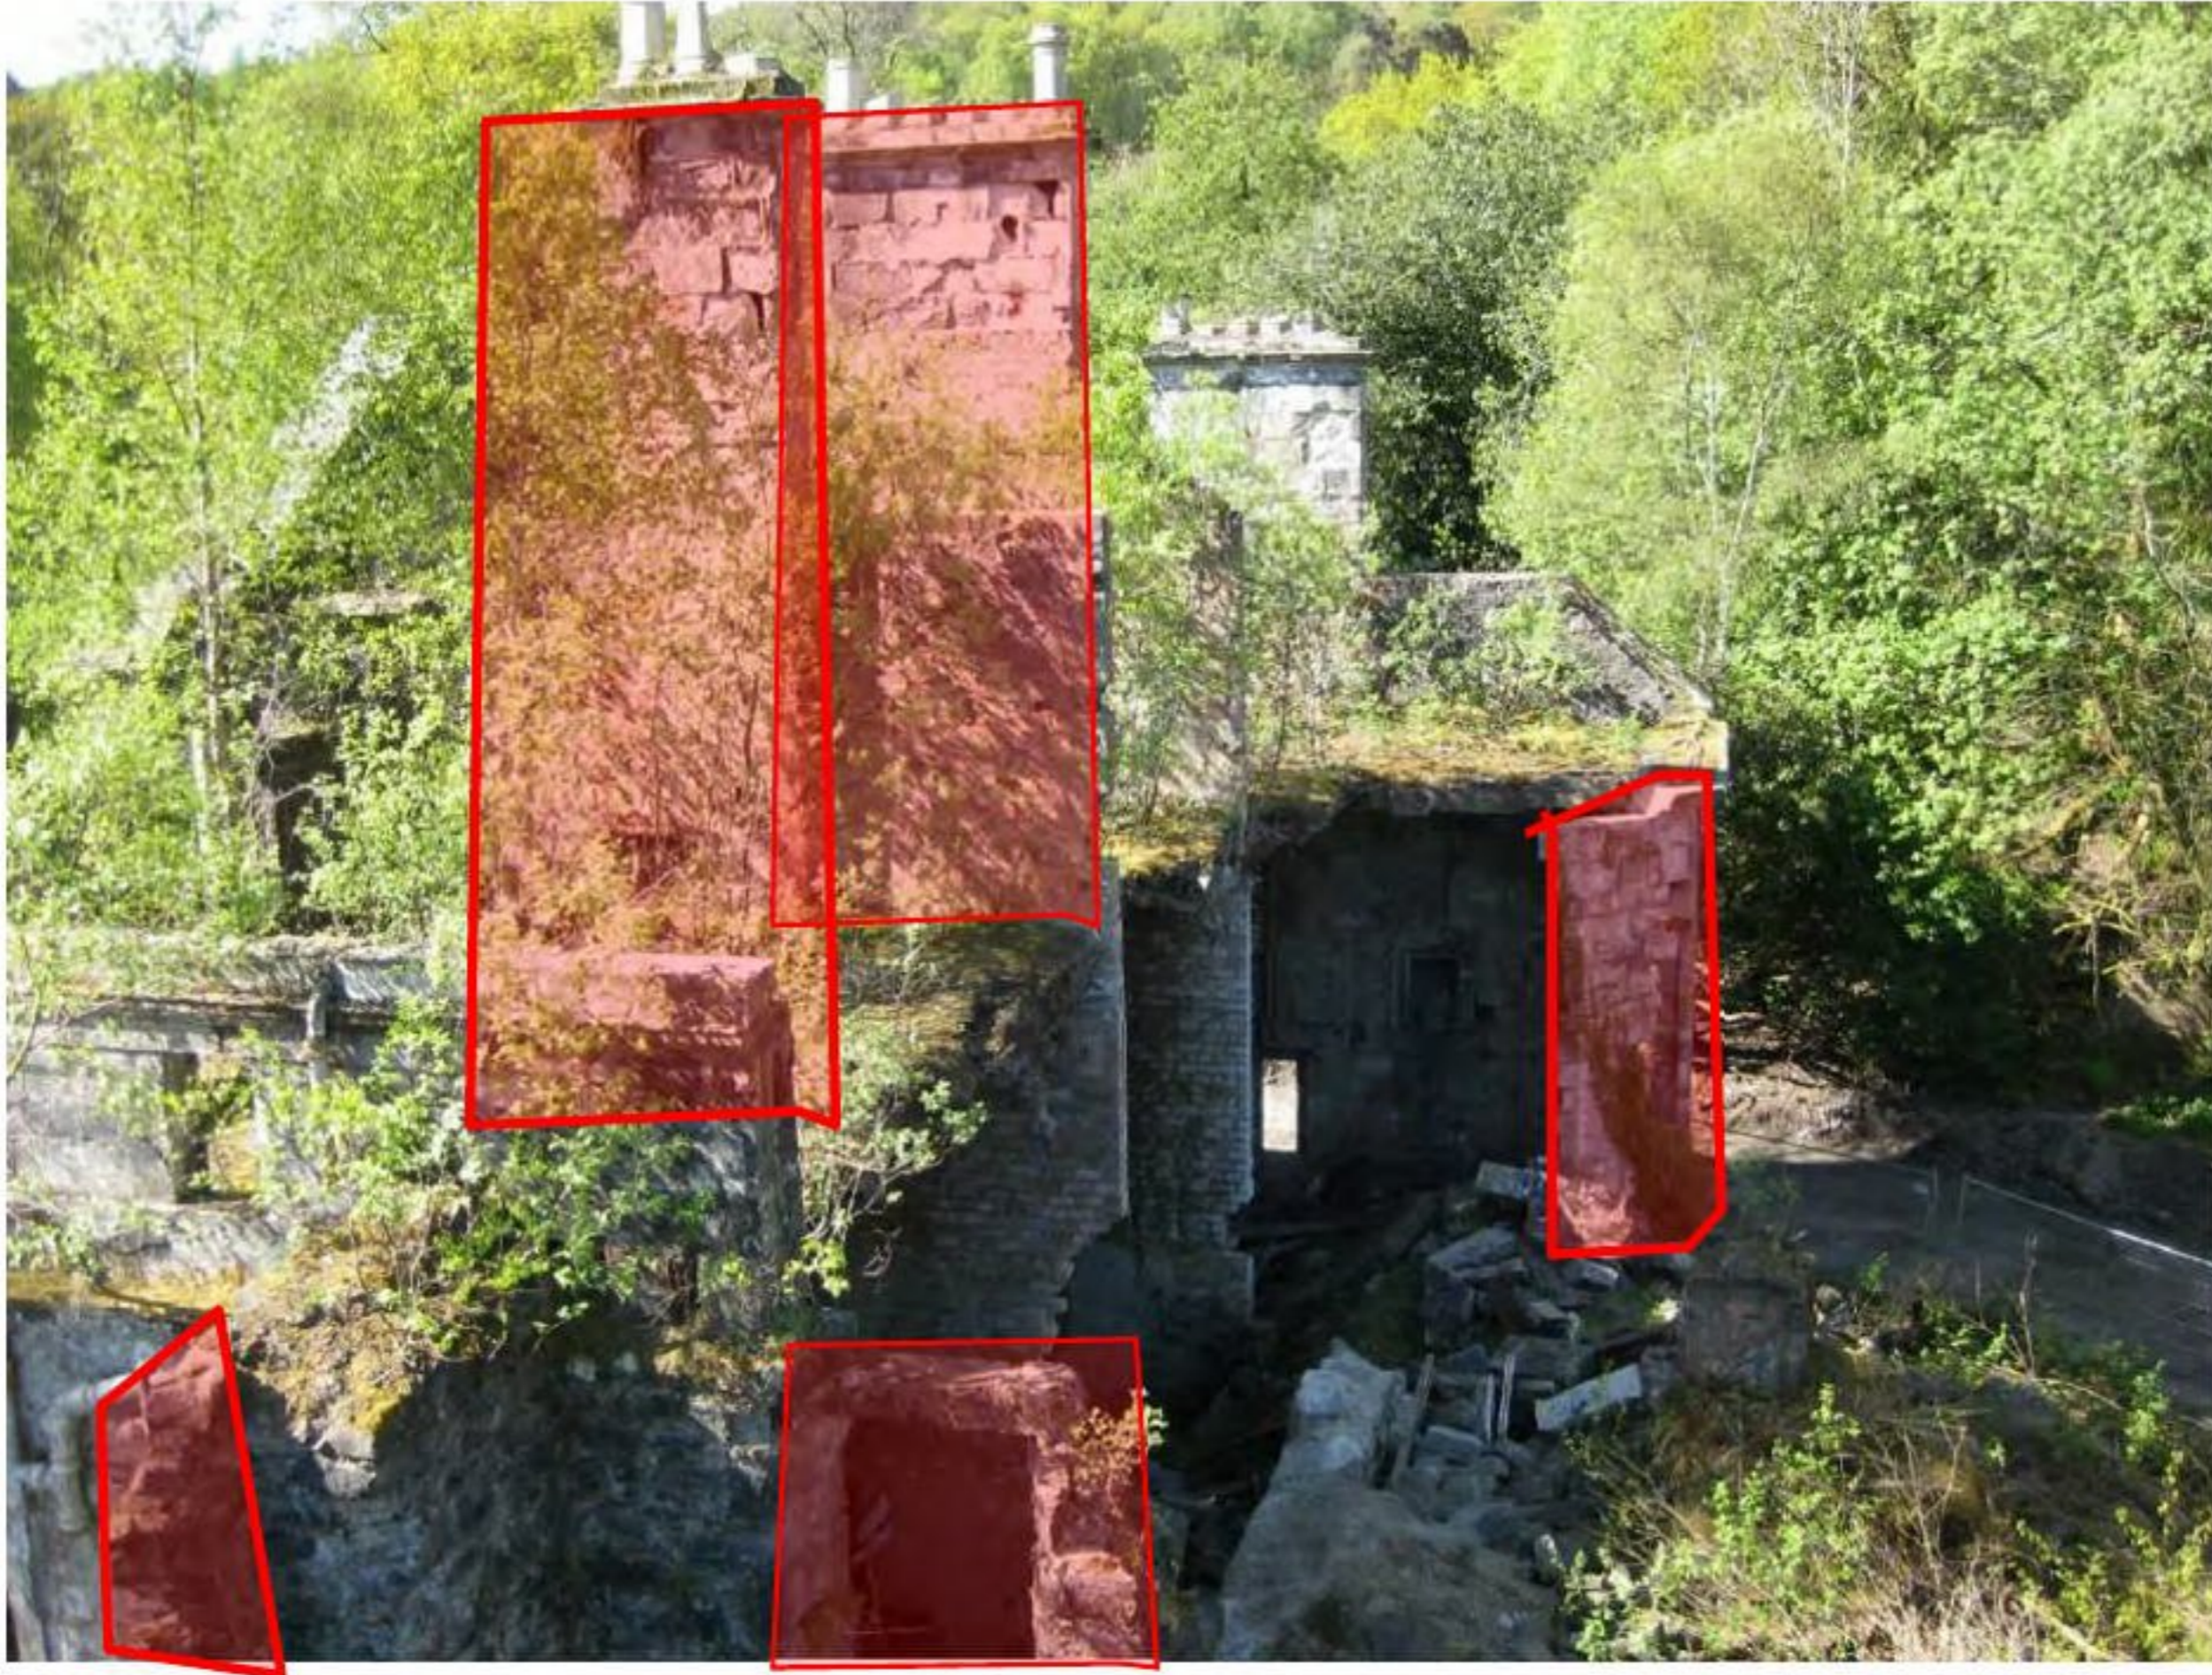
Photograph 6 – View of the walls and slab behind the south elevation (taken from the east)
Priority down takings for safety shown in red

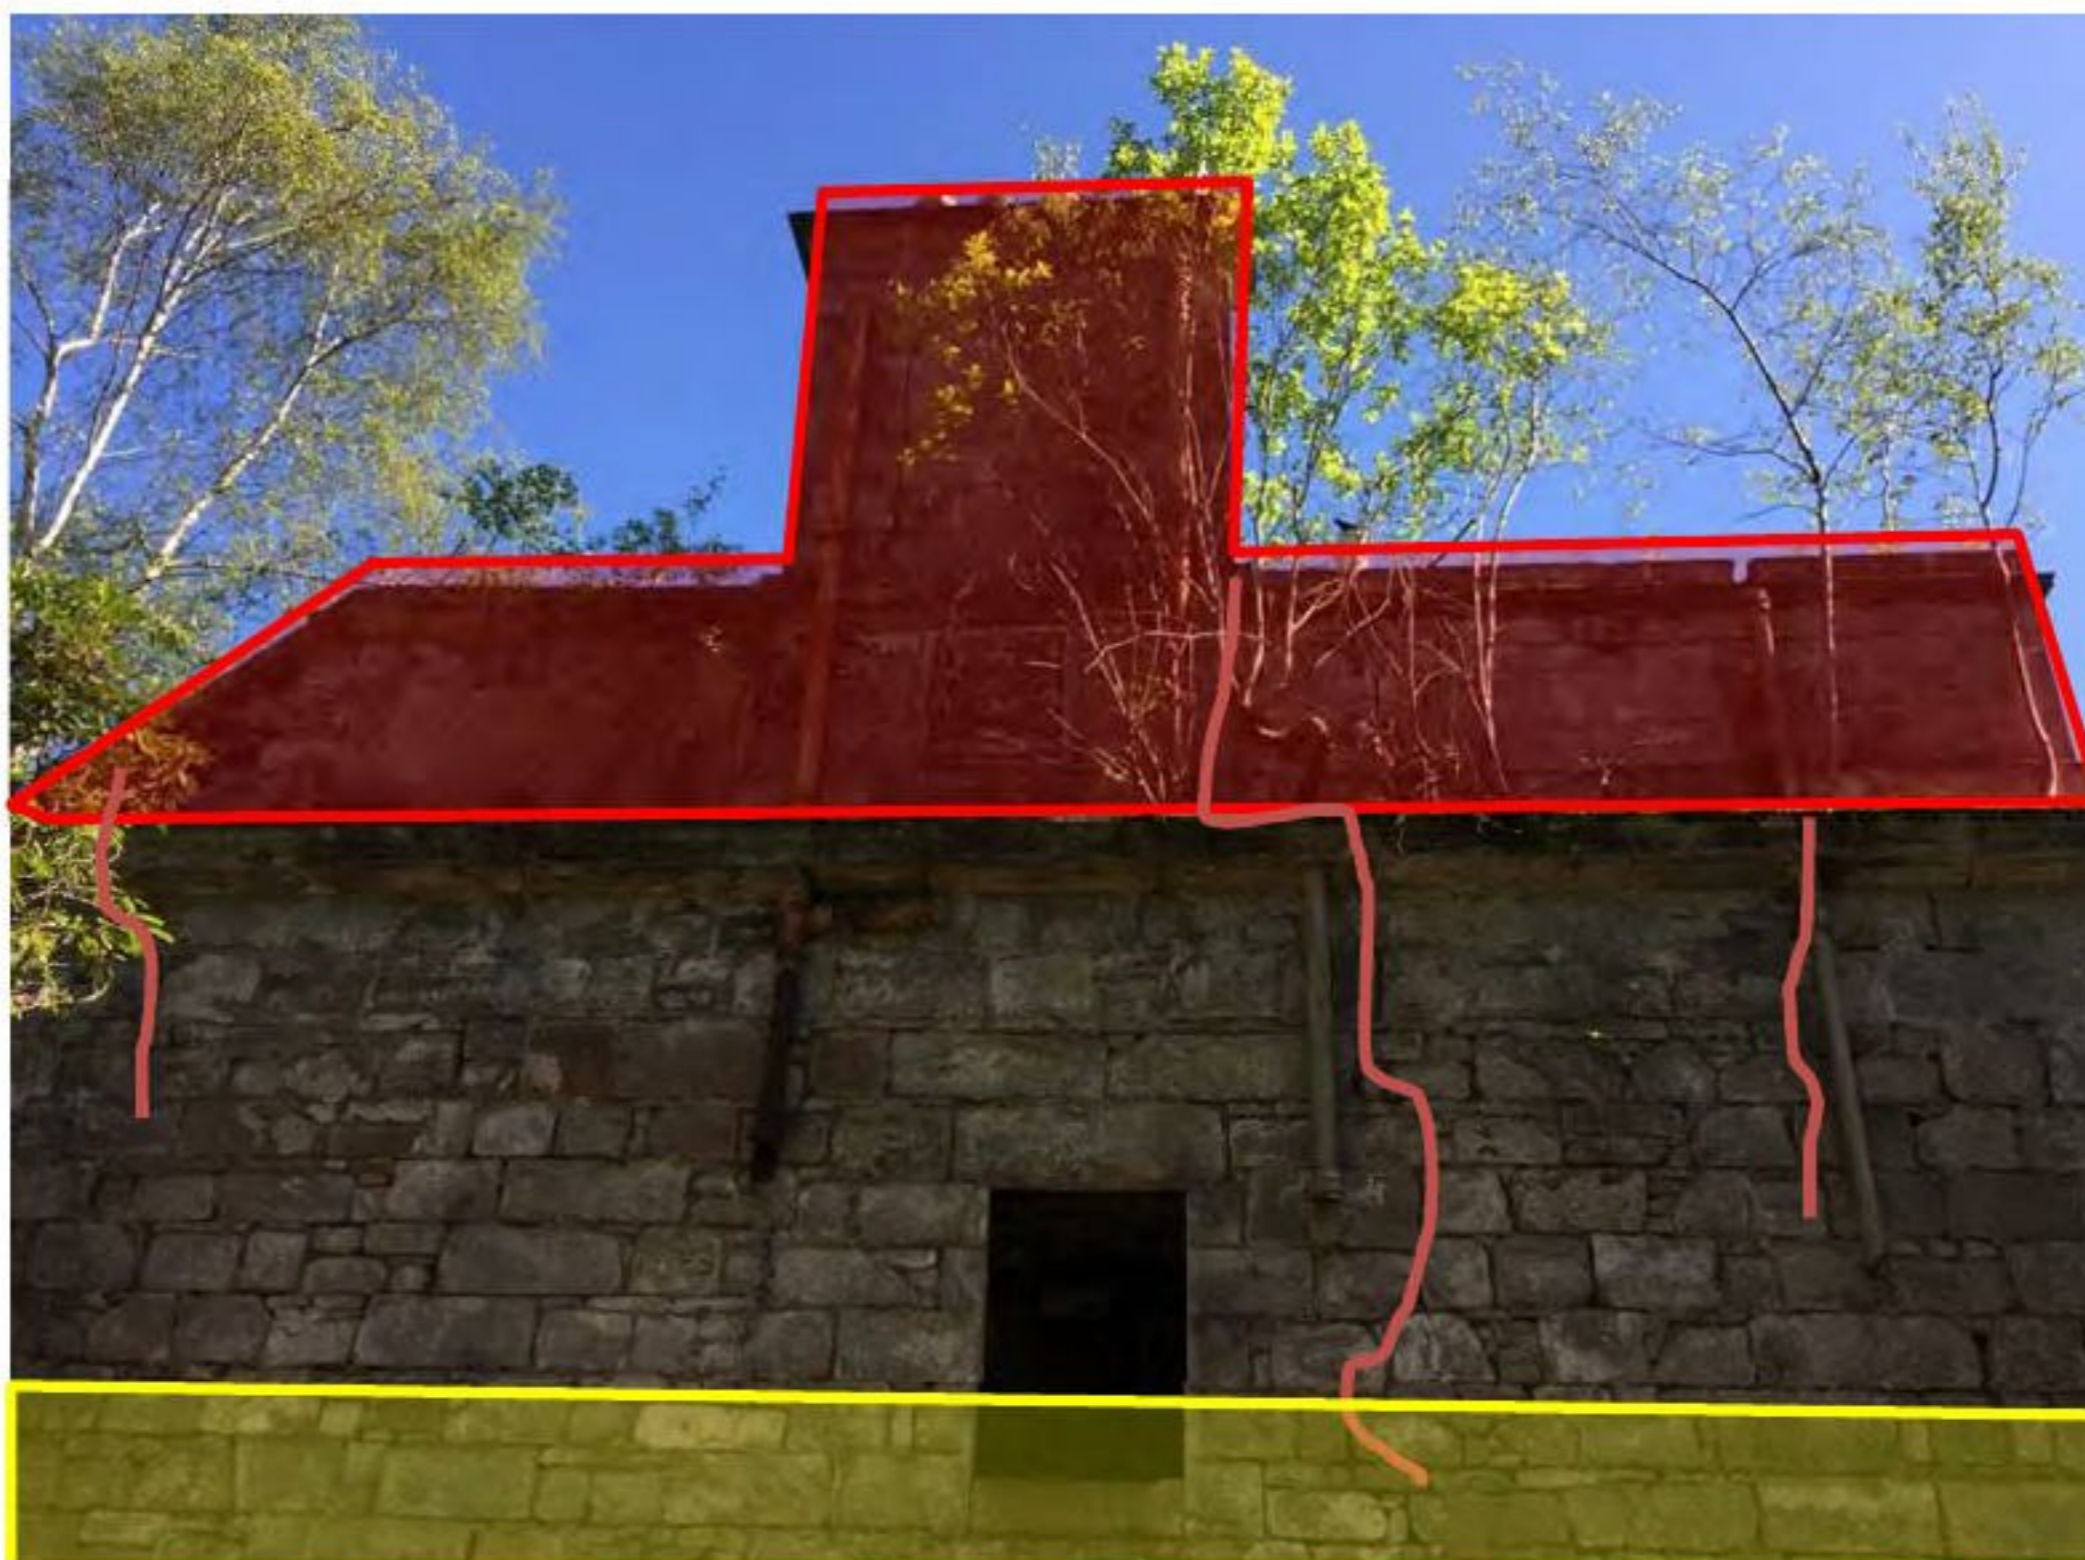
- 2.7.6 The stonework forming the external wall on this elevation was badly weathered and joints were open and loose. There appears to be some areas of cement render repair which should be removed. The cope stones are damaged /missing and need to be replaced/repared, as highlighted on Photograph 7. Due to the poor condition of the stone and the copes on this elevation, the high-level wall should be removed.

- 2.7.7 There are some large bushes/trees growing at gutter/cope level on this wall. This vegetation should be removed as soon as possible to avoid a collapse on site.

Photograph 7 – West Elevation
Demolition highlighted red and badly corroded stone highlighted yellow.

- 2.7.8 If the wall is to remain, it will require to be propped throughout the demolition, clearance and proposed works. If the wall is to remain, the stone is to be repaired and joints raked and pointed with a suitable lime mortar prior to rendering the walls with a suitable lime render.
