Structural Inspection Report Woodbank House & Stables Luss Road Balloch

On behalf of **TSL Contractors Ltd**

Project Ref: 35854 | Rev: 1 | Date: May 2017

Report Title: Woodbank House & Stables Structural Inspection Report

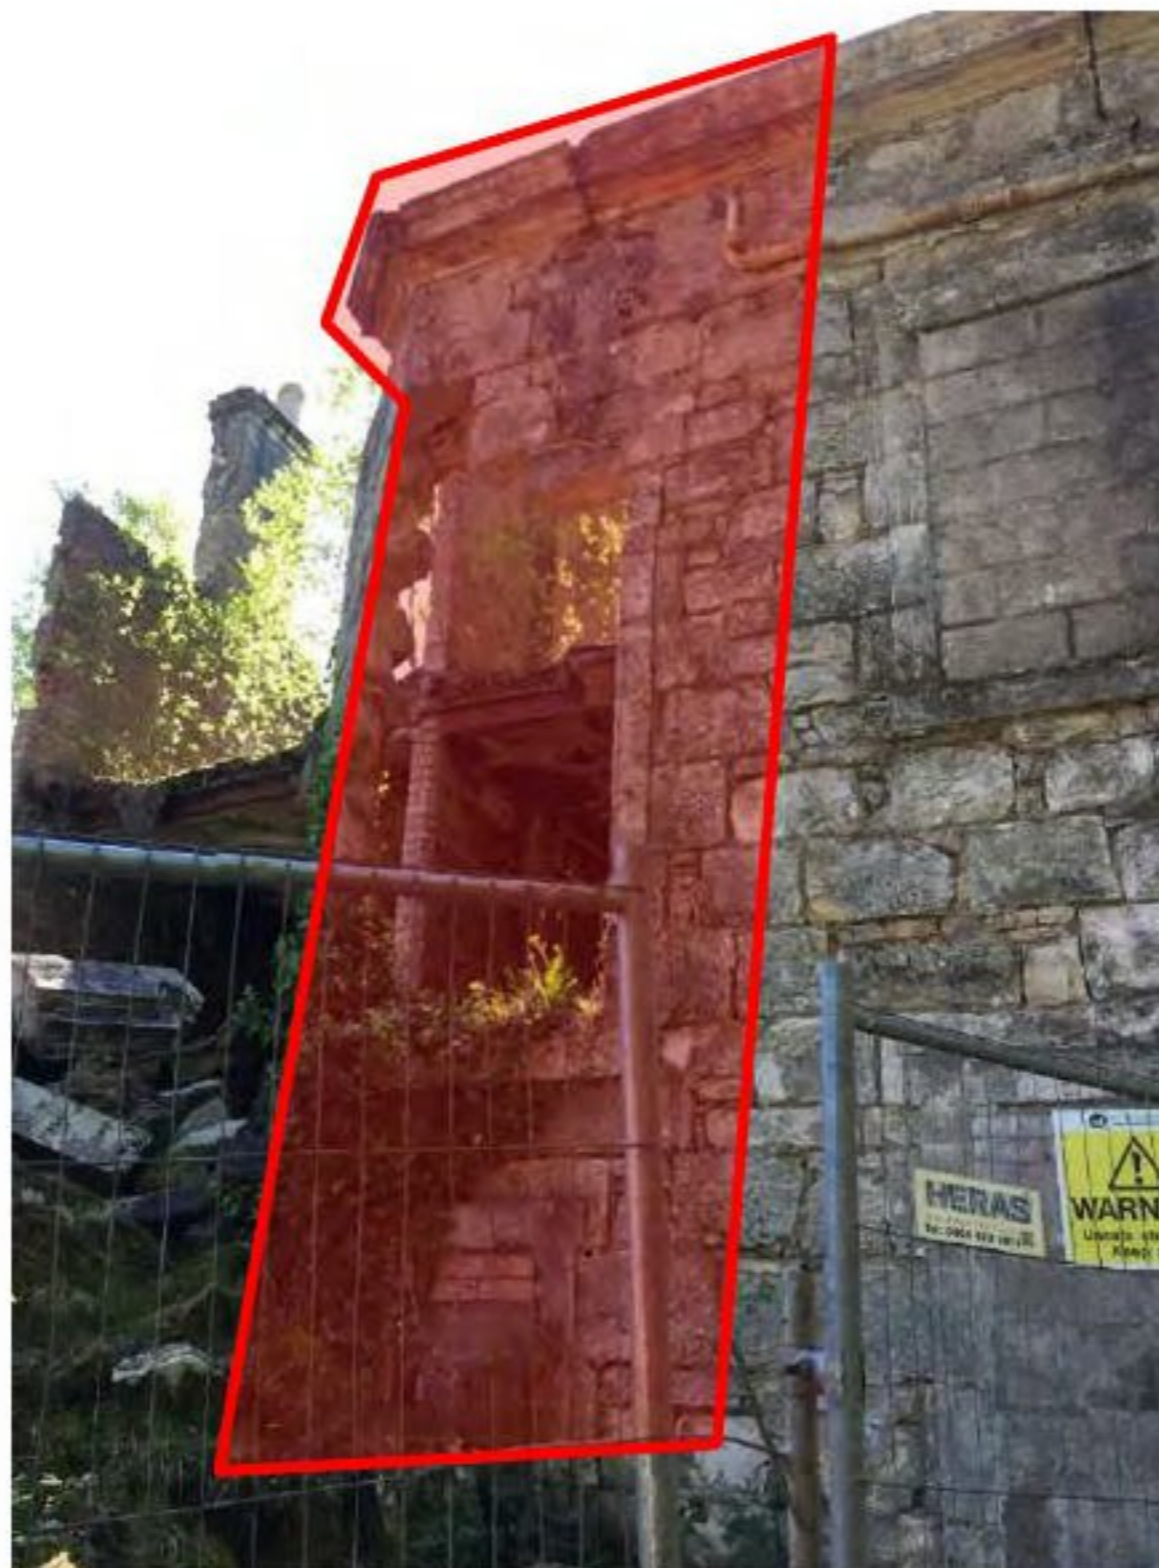
- 2.8.2 This wall is in poor condition, the east corner of the wall has partially collapsed, leaving a large area of unstable wall. This section of wall should be demolished as soon as possible to avoid collapse and is highlighted on photographs 7 and 8.

Photograph 8 – North (Rear) Elevation – East section
Priority down takings highlighted red.

- 2.8.4 If the wall is to remain, it will require to be propped throughout the demolition, clearance and proposed works. If the wall is to remain, the stone is to be repaired and joints raked and pointed with a suitable lime mortar prior to rendering the walls with a suitable lime render.

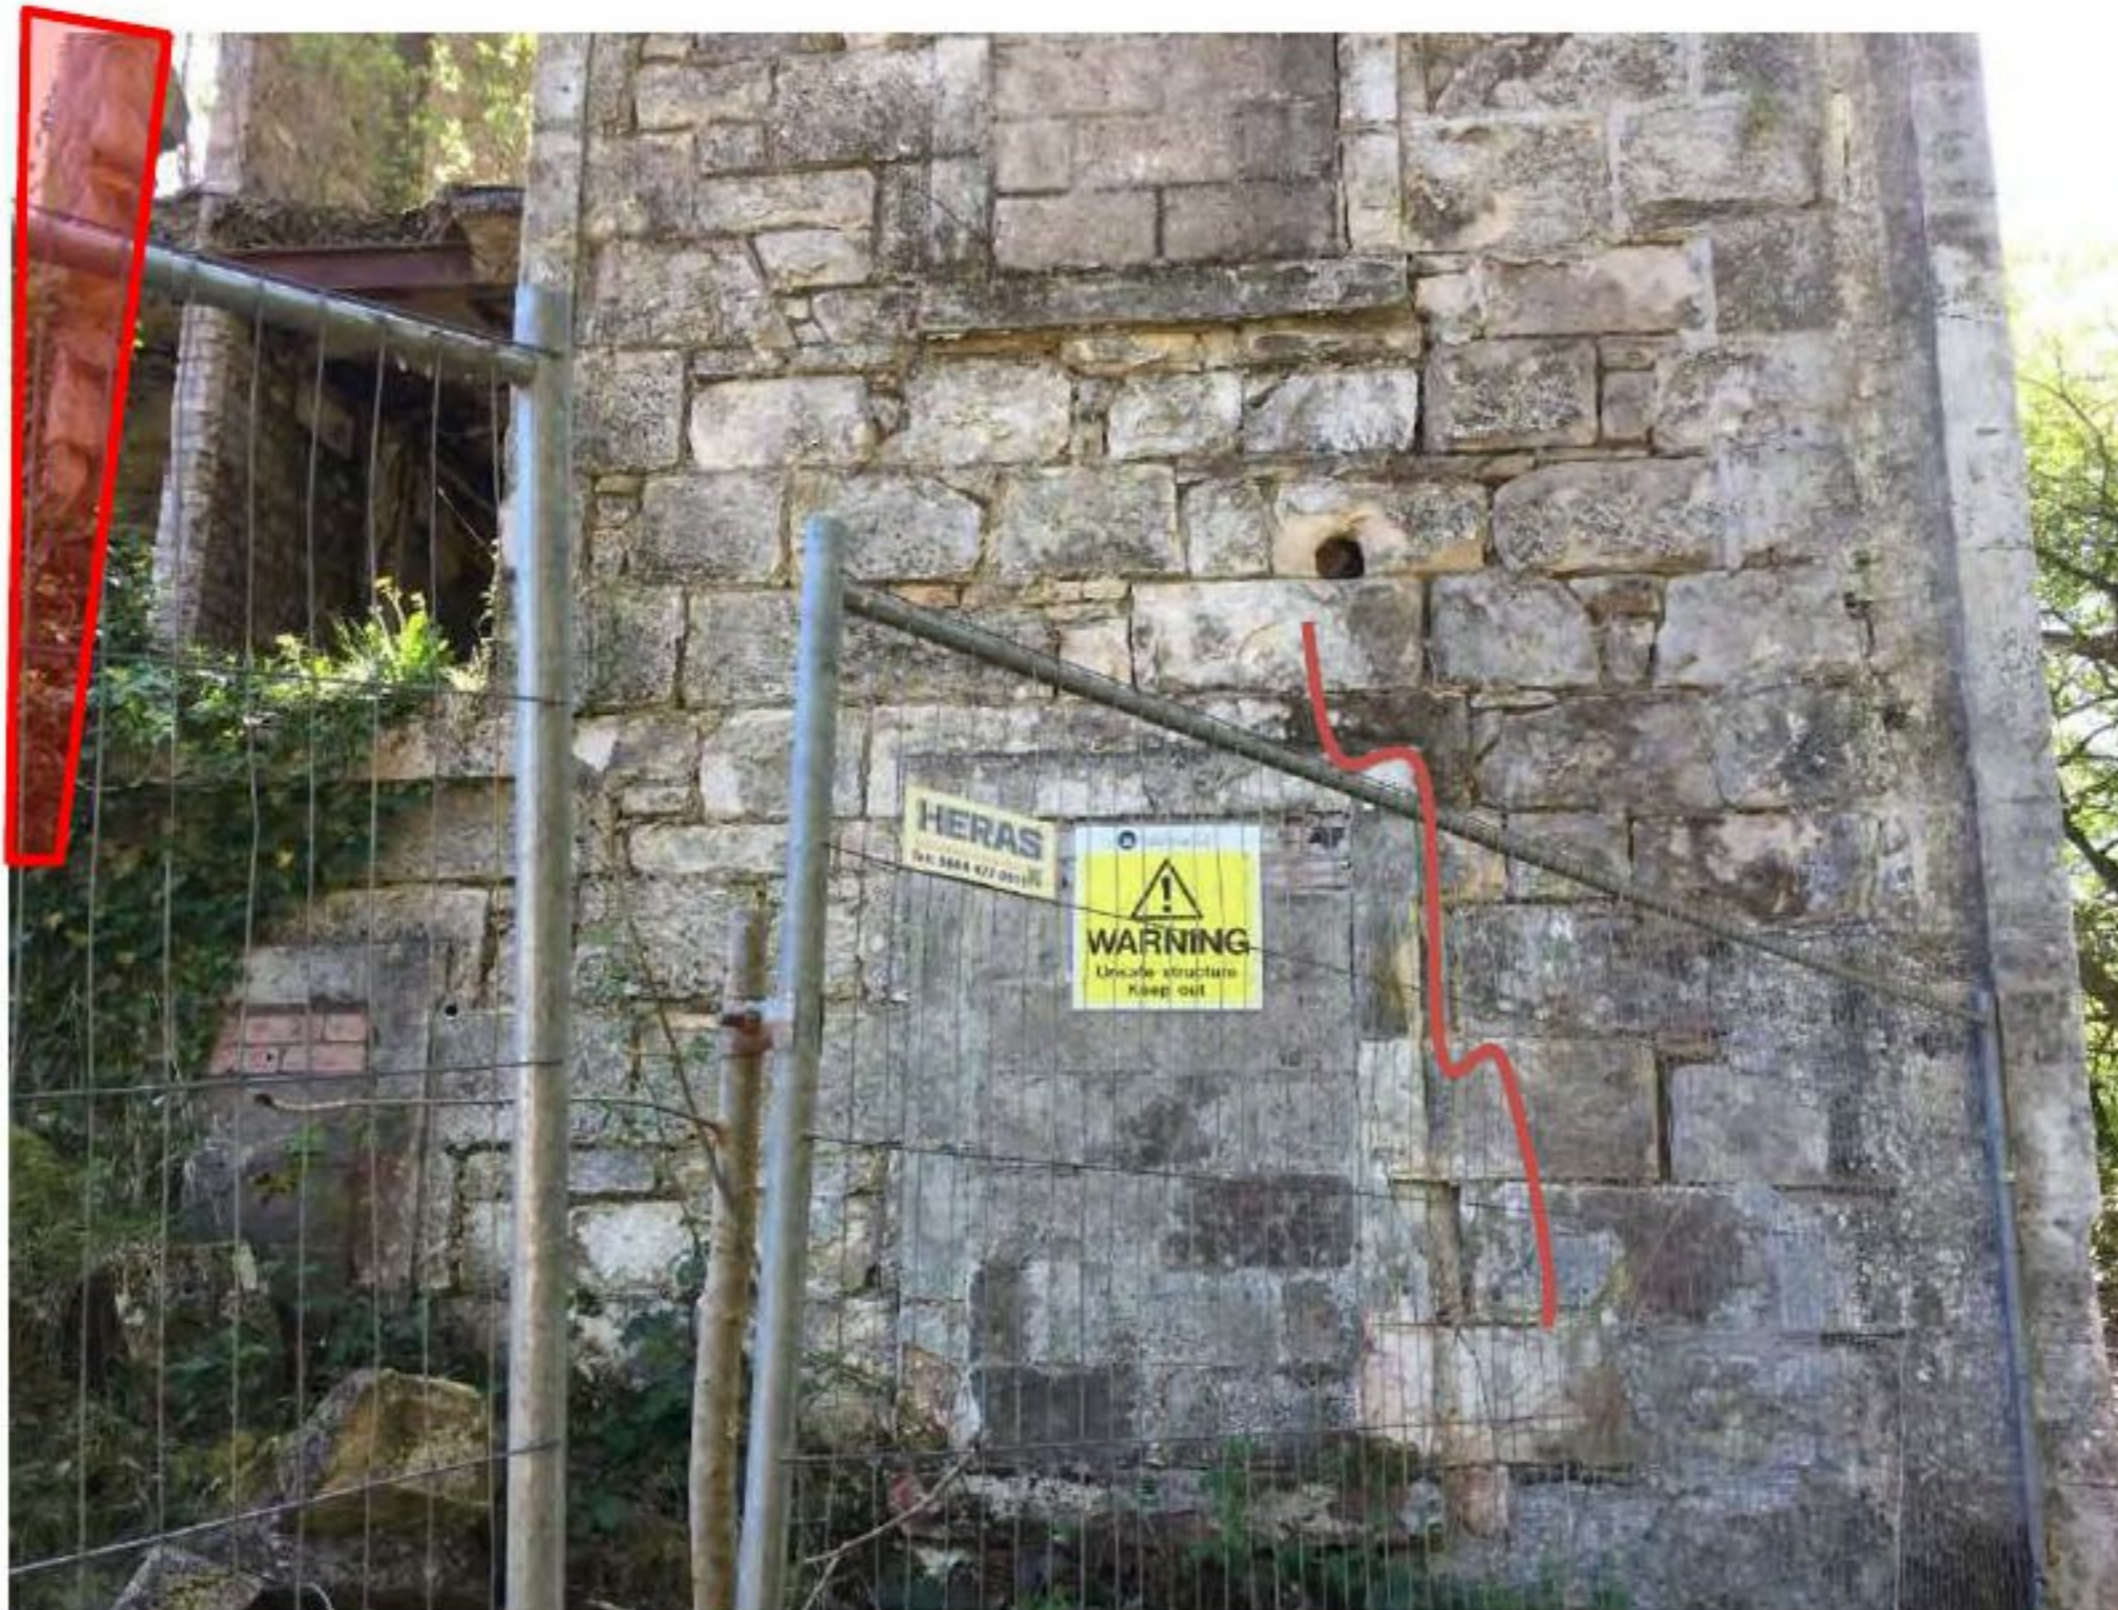
- 2.8.3 There are some large bushes/trees growing at gutter/cope level on the corner of this wall and the west elevation. The vegetation has lifted the copes and there is a gap between the copes and the wall below. The vegetation should be removed as soon as possible to avoid a collapse on site.

Photograph 9 – North Rear Elevation West low level
Priority down takings highlighted red, cracks highlighted in orange.

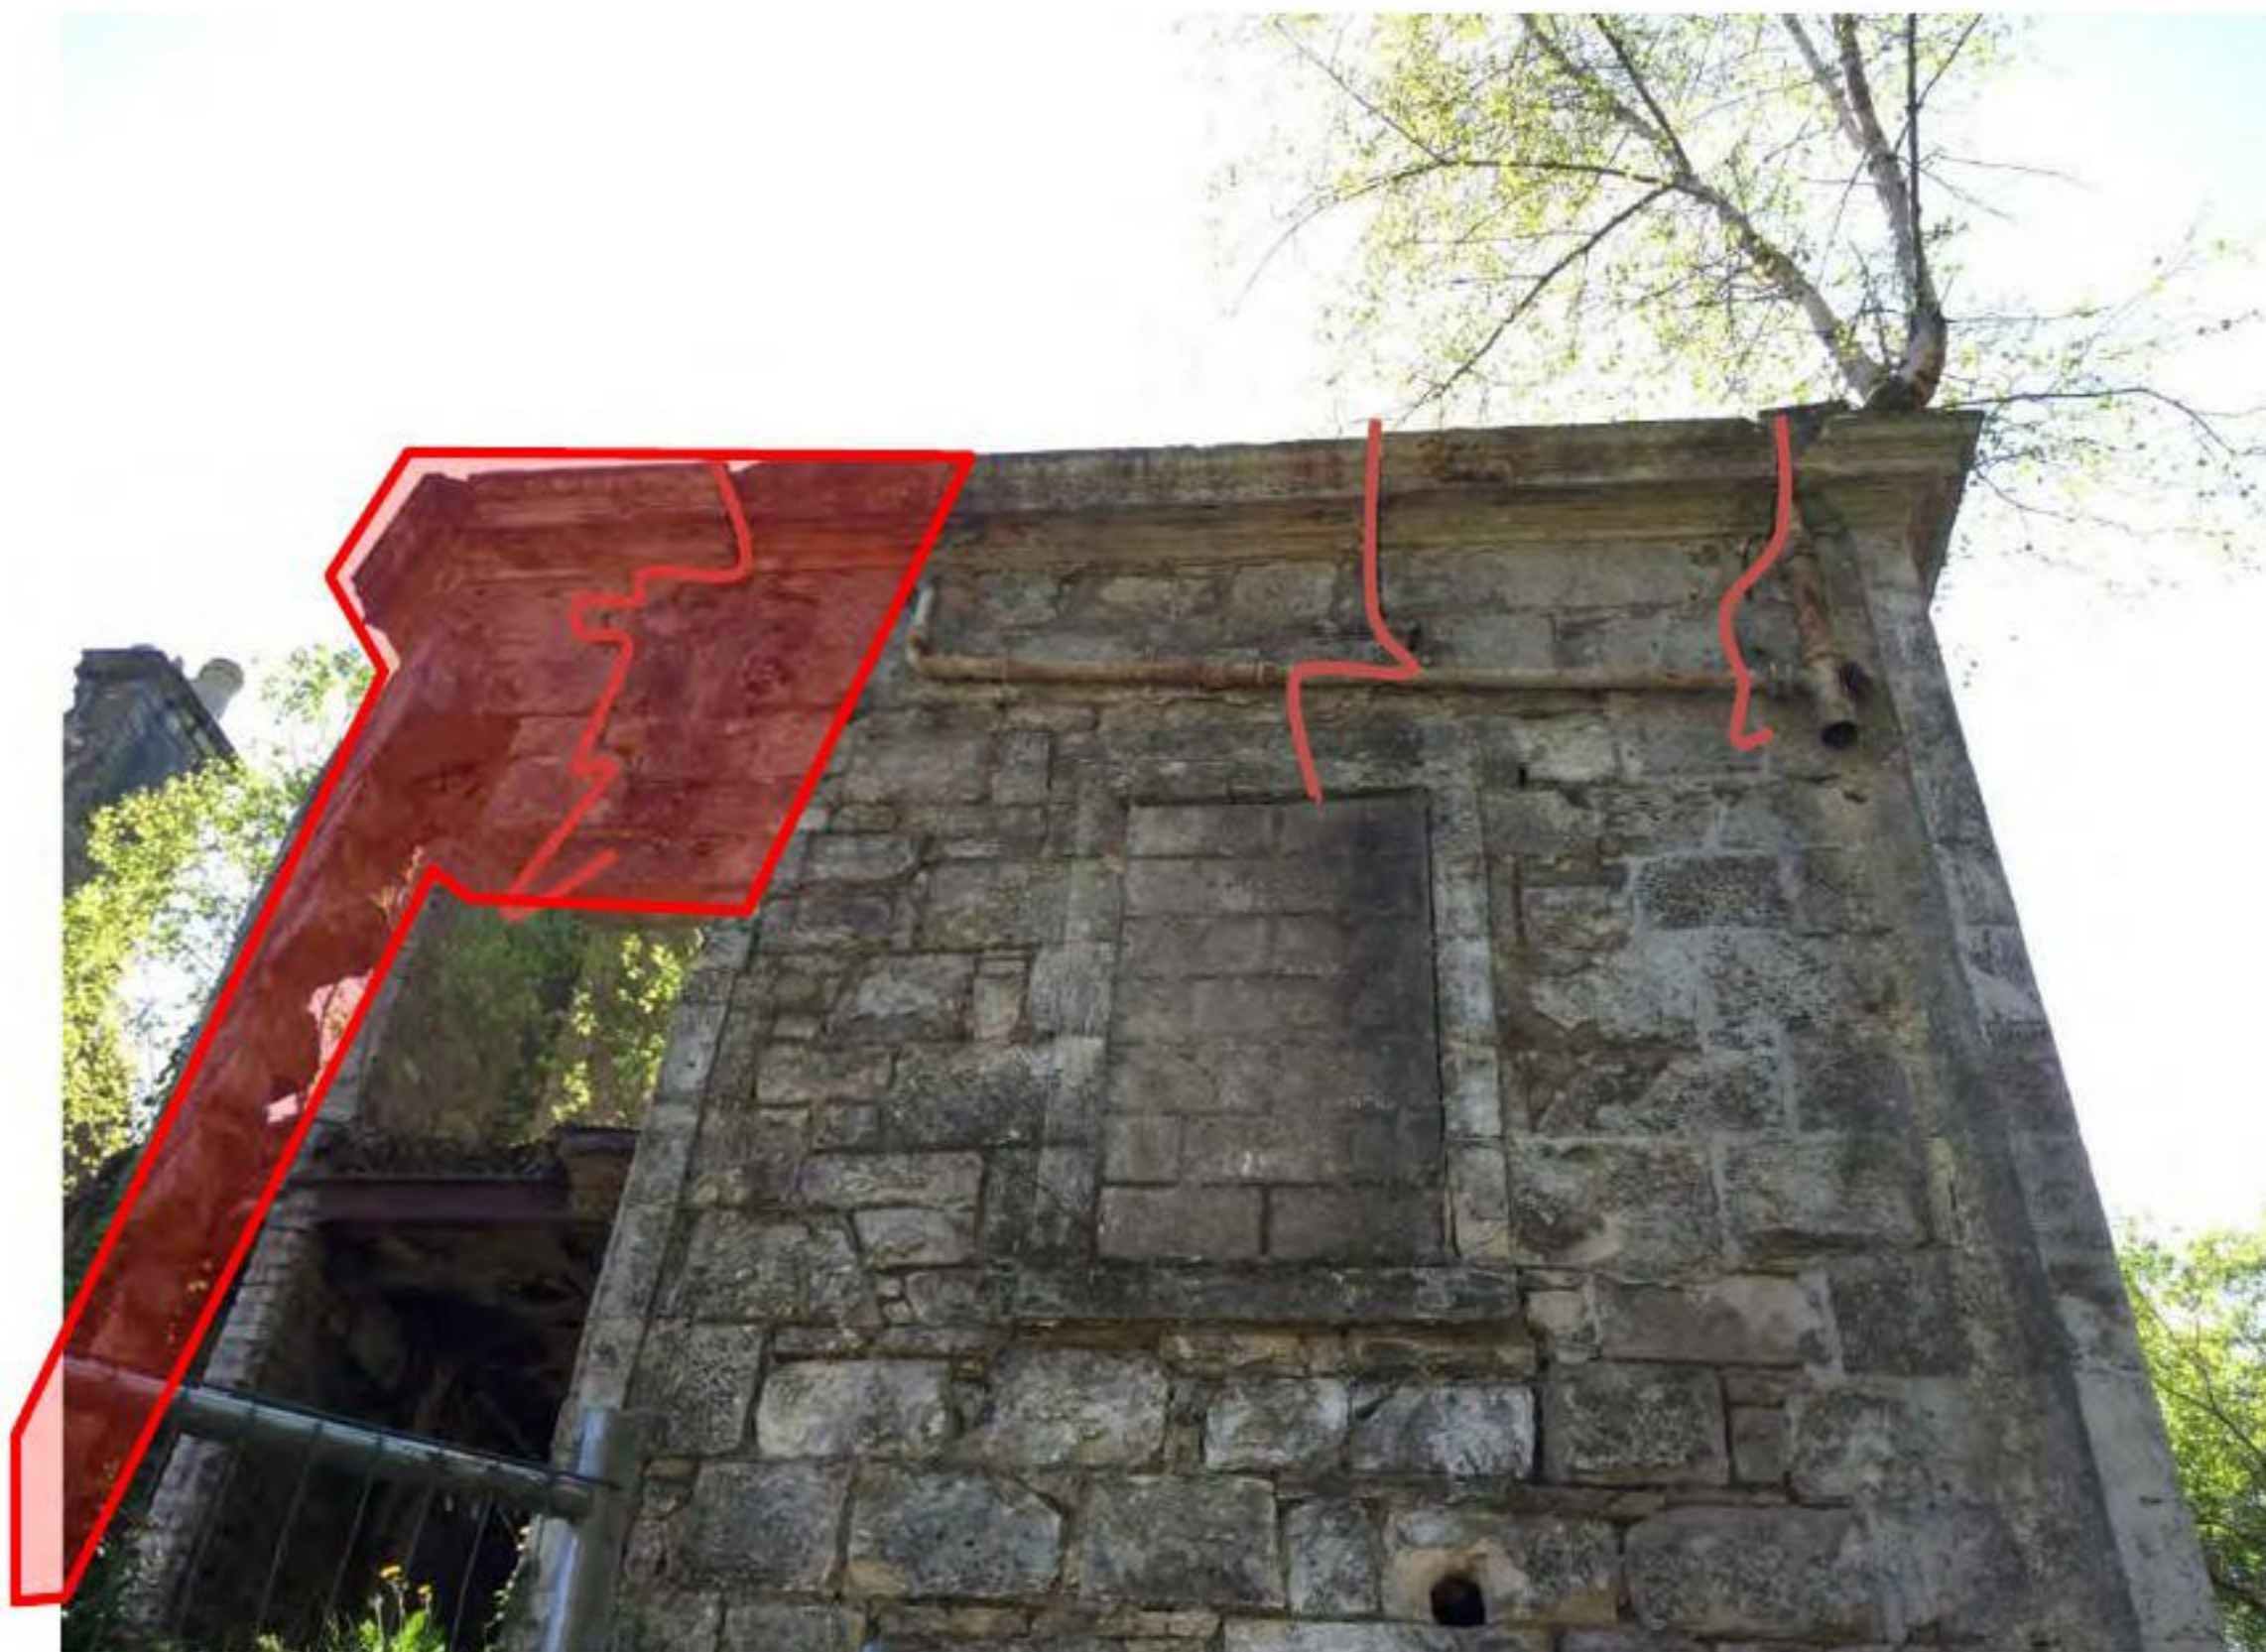
Photograph 10 – North Rear Elevation West high level
Priority down takings highlighted red, cracks highlighted in orange.

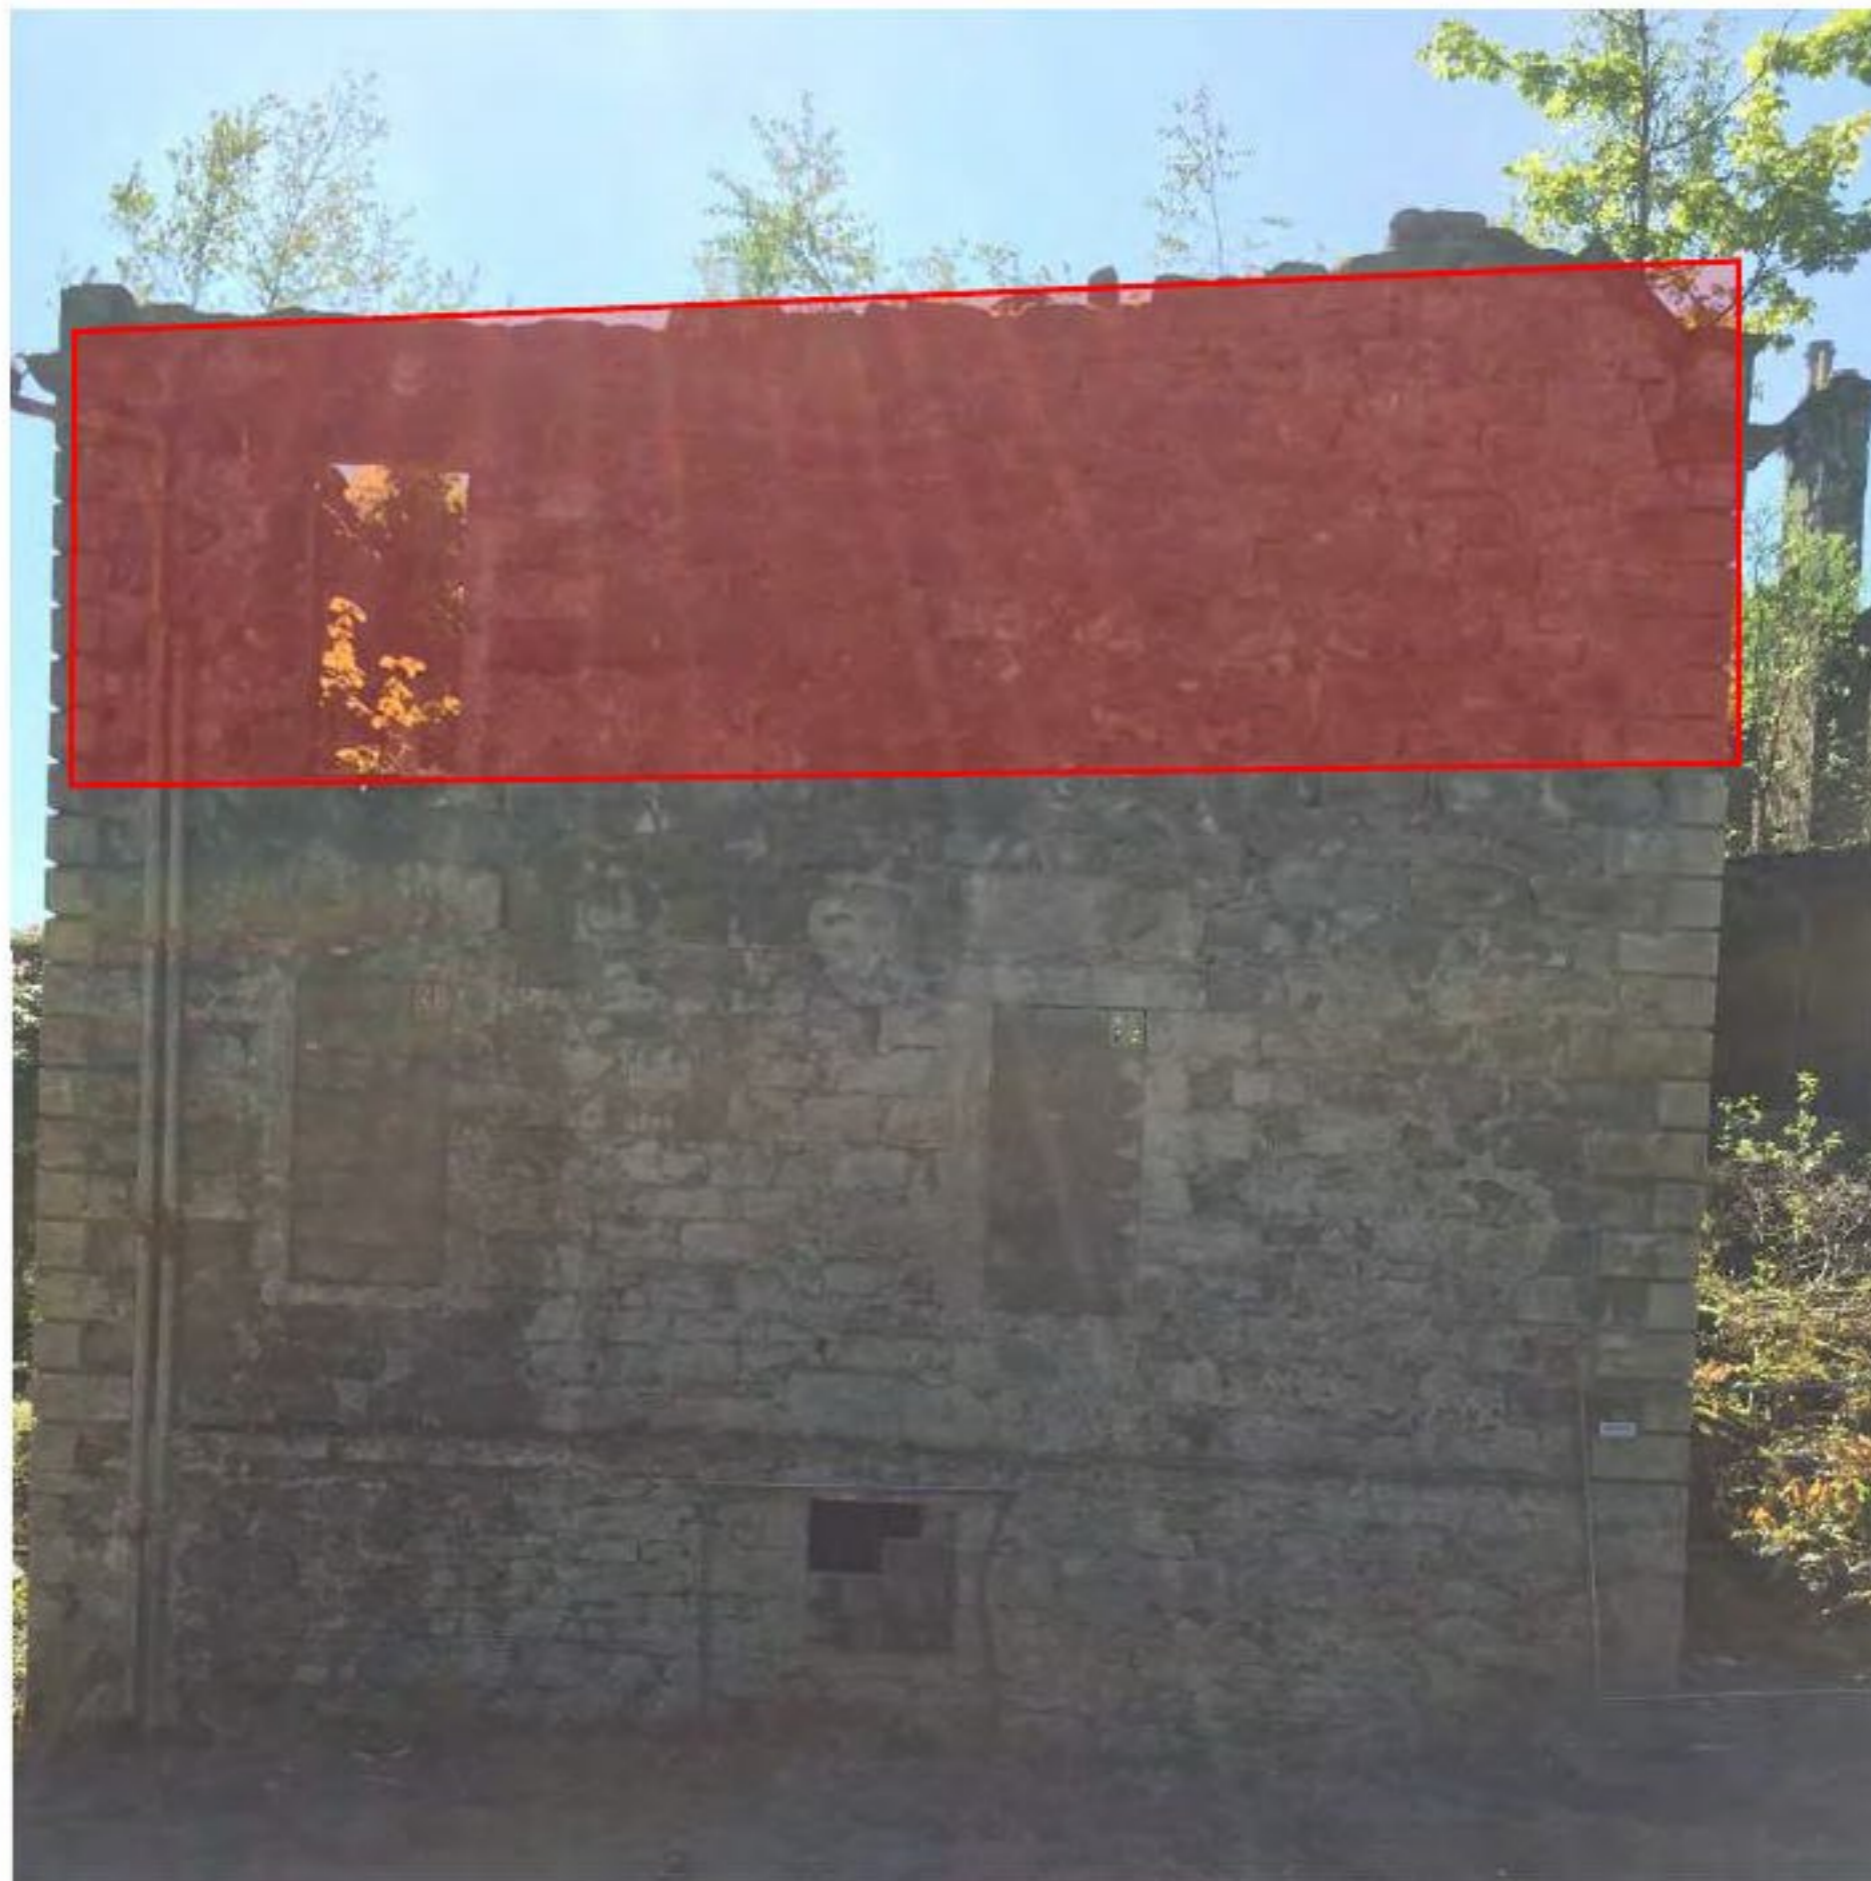
- 2.9.1 This gable elevation appears to originate from the 1774 building.
- 2.9.2 The wall is in poor condition following a roof collapse. The wall is leaning into the building and needs to be taken down to underside of first floor window level. The internal stone skin has partially collapsed and the wall is unstable. We recommend that this wall is demolished down to a safe level. The East elevation will need to be propped prior to this demolition to ensure stability.
- 2.9.3 If the wall is to remain, it will require to be propped throughout the demolition, clearance and proposed works. If the wall is to remain, the stone is to be repaired and joints raked and pointed with a suitable lime mortar prior to rendering the walls with a suitable lime render.

Photograph 11 – North east Elevation
Down takings highlighted in red.

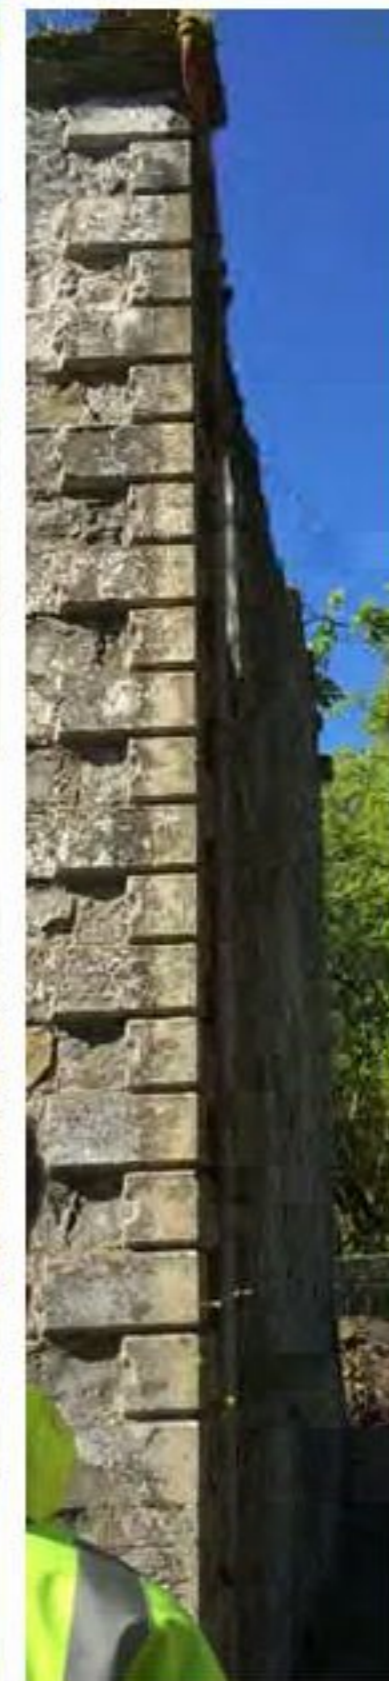
Photograph 12
– bulge in
North east
elevation

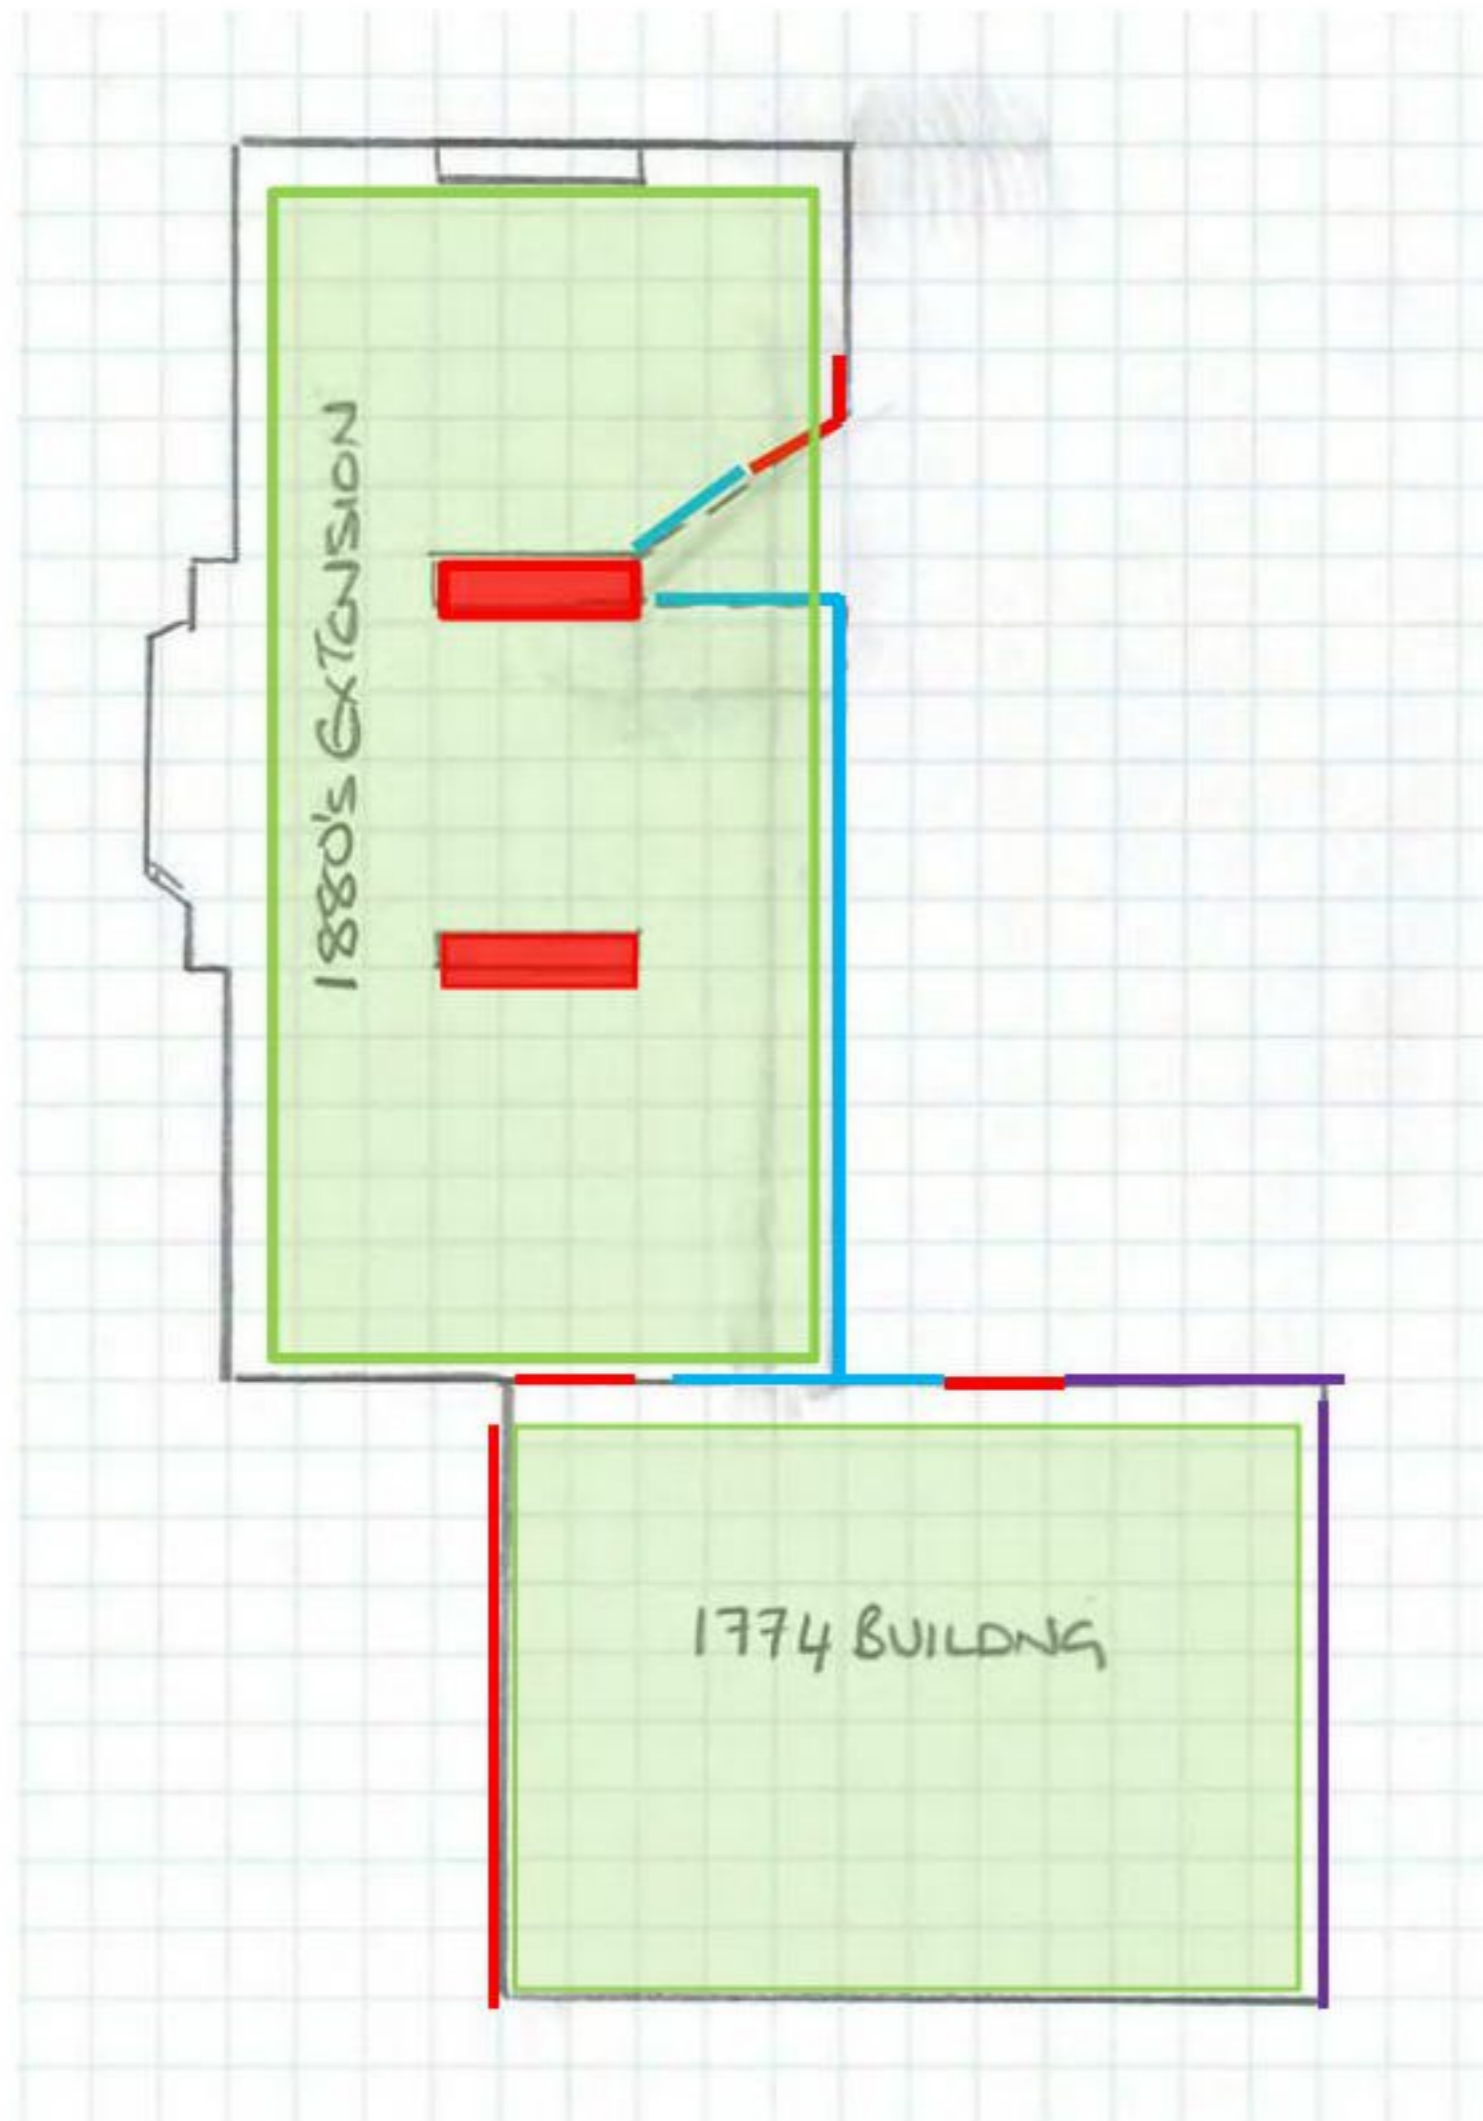
Figure 2 – Main House Summary Plan

- 2.11.1 Some urgent demolition works are required in order to render the building safe, due to the instability of the building. The undernoted plan highlights the most significant areas of demolition required.
- 2.11.2 Red highlights urgent demolition, the purple highlights partial demolition and the blue shows areas already partially demolished/collapsed. The green shows areas which are to be demolished in an agreed sequence once proposals are known. Once this has been carried out and the rubble removed a further inspection can be carried out.

- 2.11.3 The internal walls and floors are in poor condition, as such we recommend that only the elevations are worth saving. The extents of elevations to be saved can be agreed taking consideration of the future proposals and the Conservation Architect's report.
- 2.11.4 The demolition will need to be carried out in a sequence to be agreed between the structural engineer and the demolition contractor. The demolition will require temporary works design to prop/support the walls which are to remain.
- 2.11.5 We recommend that the earlier partial demolition debris is cleared to allow access. The extents of clearance and demolition will need to be limited to consider the areas of unstable structure, Specifically, the chimneys and the free-standing masonry doorways, as highlighted on the photos.

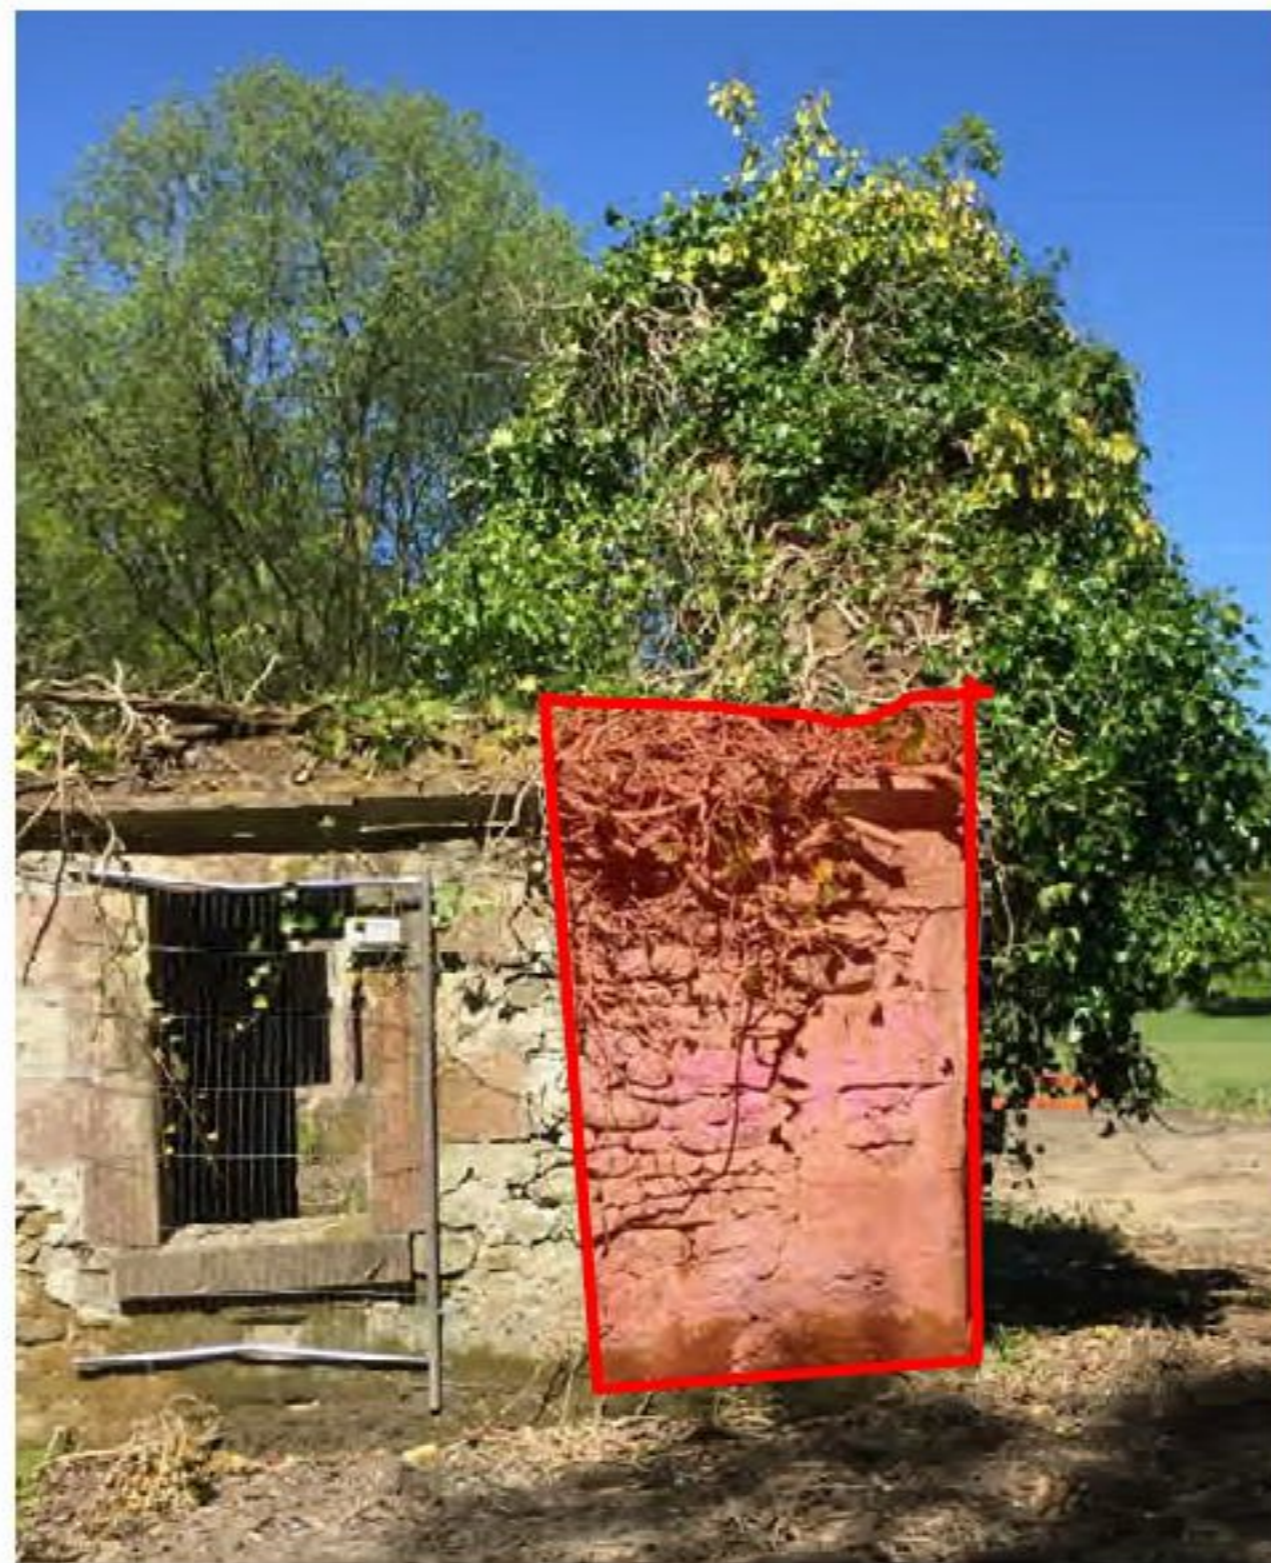
- 3.2.2 The east wall of the south block has rotated out from the building, see the undernoted photo. This is likely caused by the vegetation which is growing on the east wall. We would recommend that the vegetation is carefully removed and that the bulging wall is demolished, as highlighted below.

Photograph 21 – East end of South elevation of south block
Showing bulging wall and down takings in red

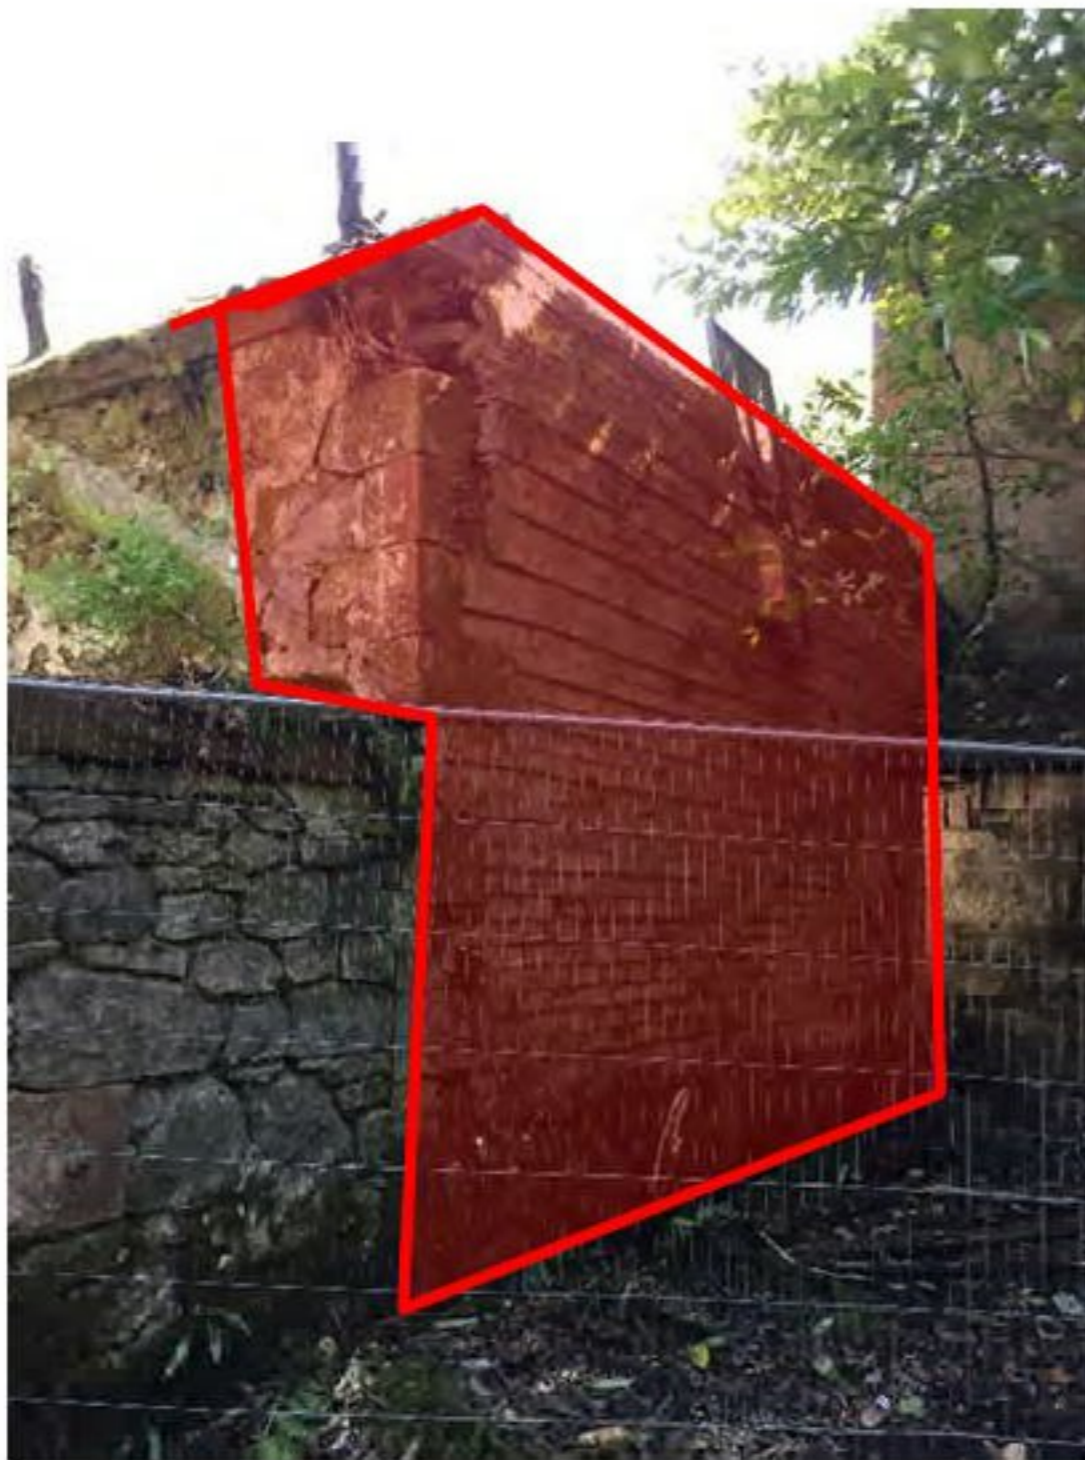
- 3.3.1 The rear section is constructed in masonry, single skin brick in most areas. These sections are in poor condition and should be demolished.
- 3.3.2 The West wall of the North block has failed and is being held up by the corroded steel plates within the mortar beds. See the photo's below. For safety, this section of wall is demolished.

Photograph 22 – West wall in north block
Showing failure and down takings in red

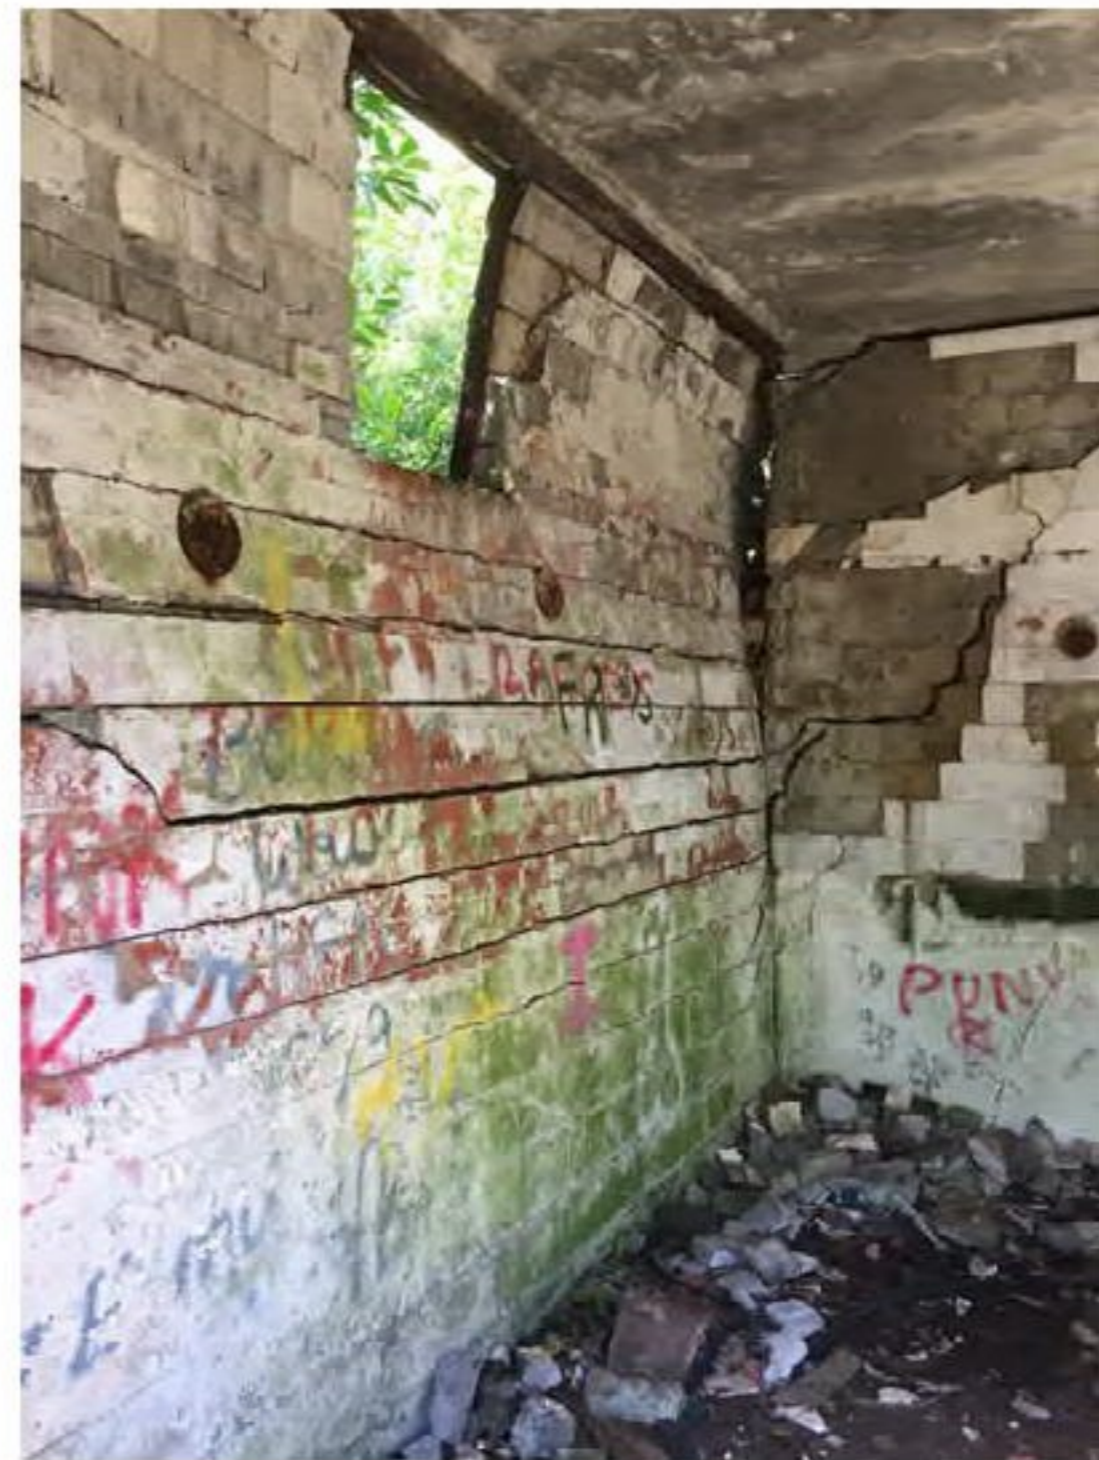
Photograph 23 – internal view of west wall in north block
Showing failure
