Structural Inspection Report Woodbank House & Stables Luss Road Balloch

On behalf of **TSL Contractors Ltd**

Project Ref: 35854 | Rev: 1 | Date: May 2017

Report Title: Woodbank House & Stables Structural Inspection Report

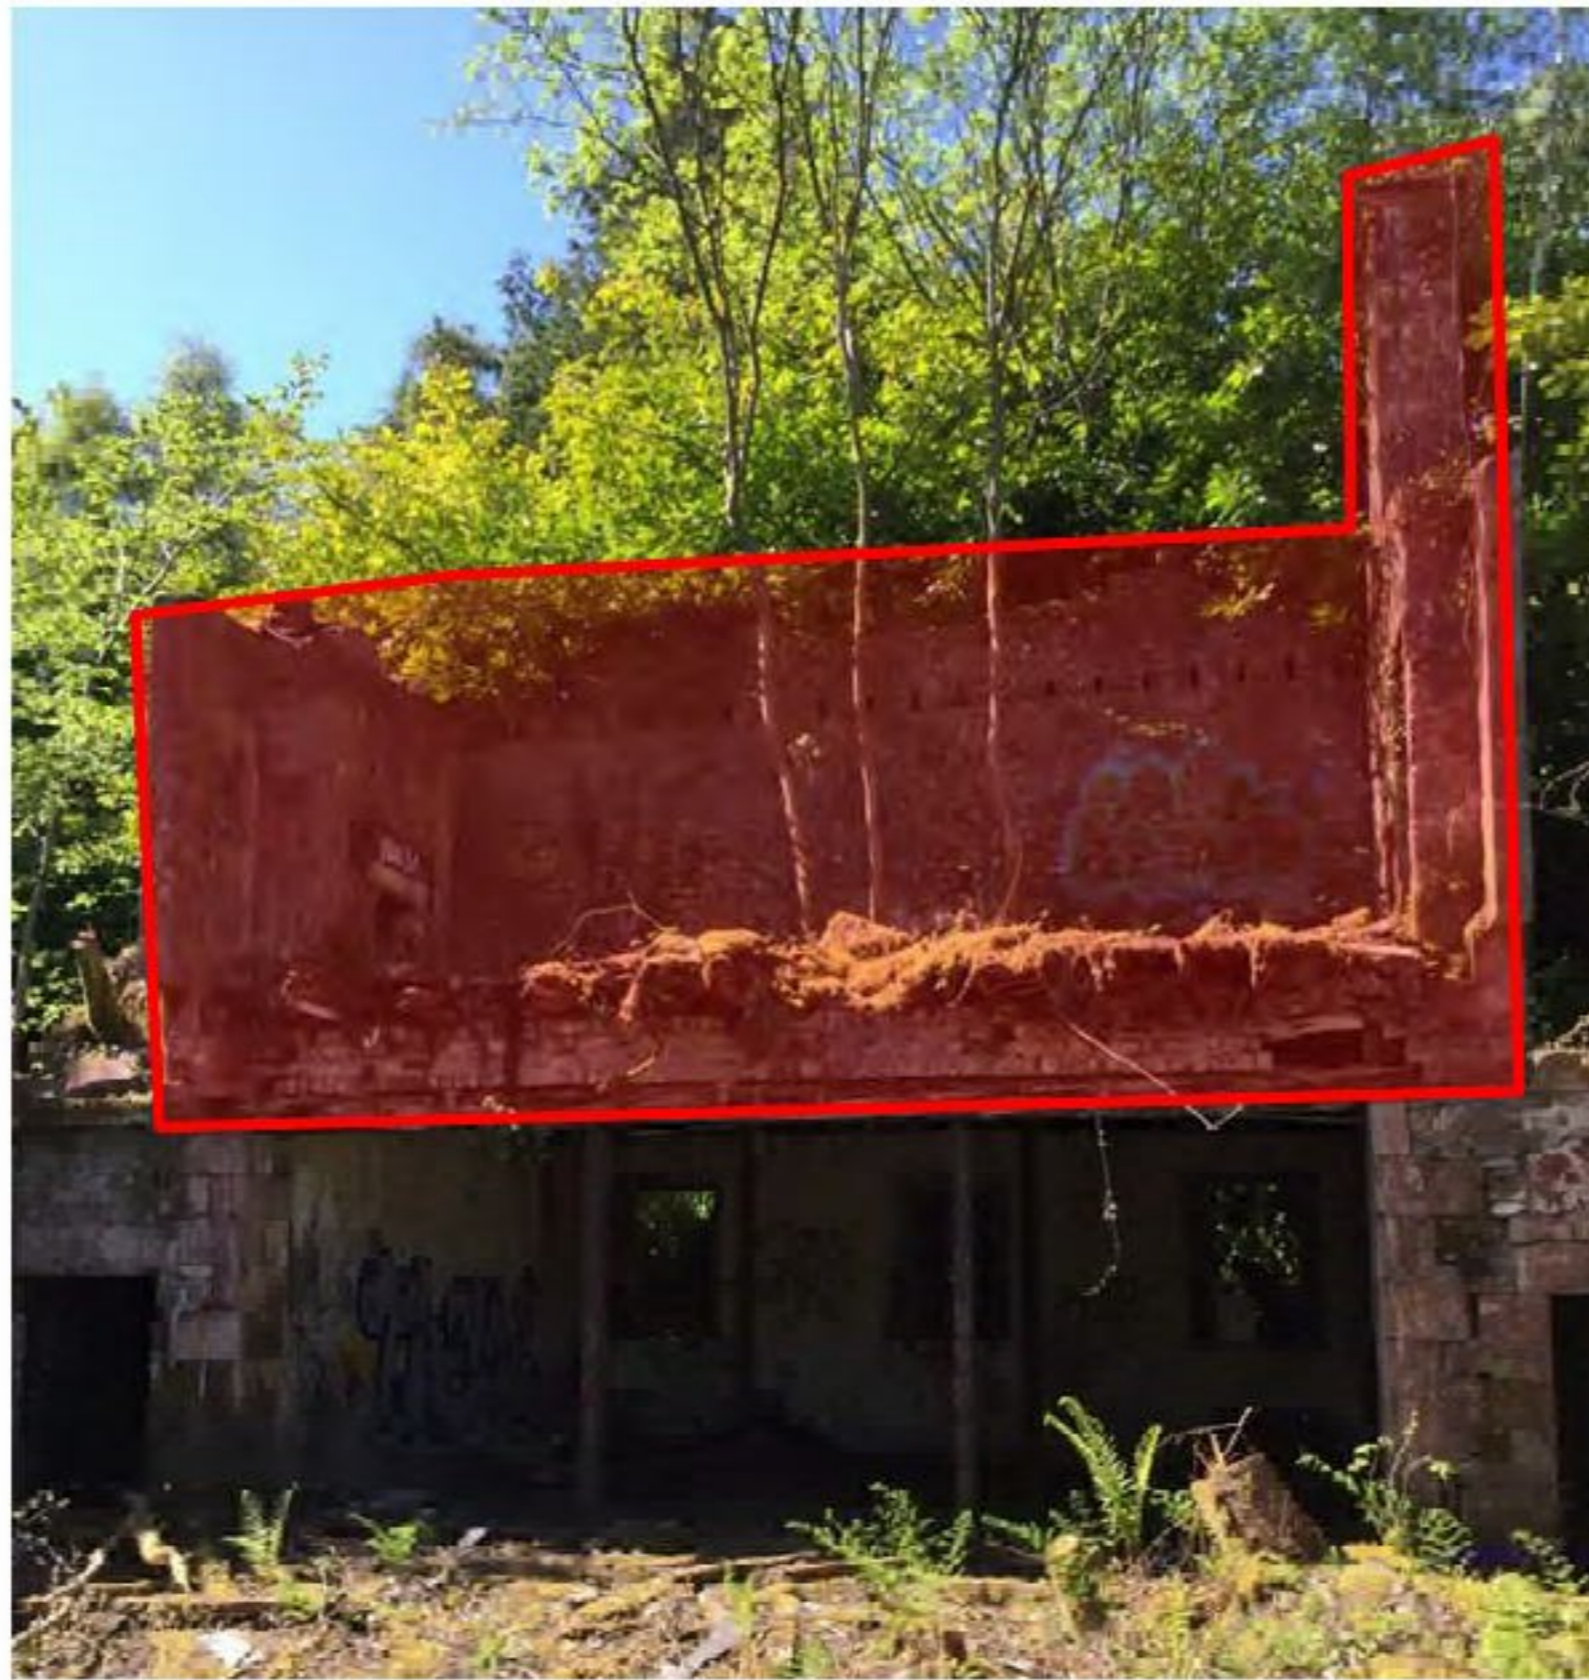
- 3.3.3 The first floor to the rear is timber joists supported on steel beams on steel circular columns. A central masonry wall approximately 3m high is also supported on the steel beam. The structure in this area is unstable, the rear wall is being supported by some trees. The timber is rotten, the steel beams and connections are very corroded and the south column has fully sheared, this risk of collapse is exacerbated by the masonry over and a large tree growing on the suspended first floor. We would recommend that the structure is removed down to at least the underside of the suspended floor, for safety, as soon as possible.

Photograph 24 – first floor of rear section
Showing priority down takings for safety in red

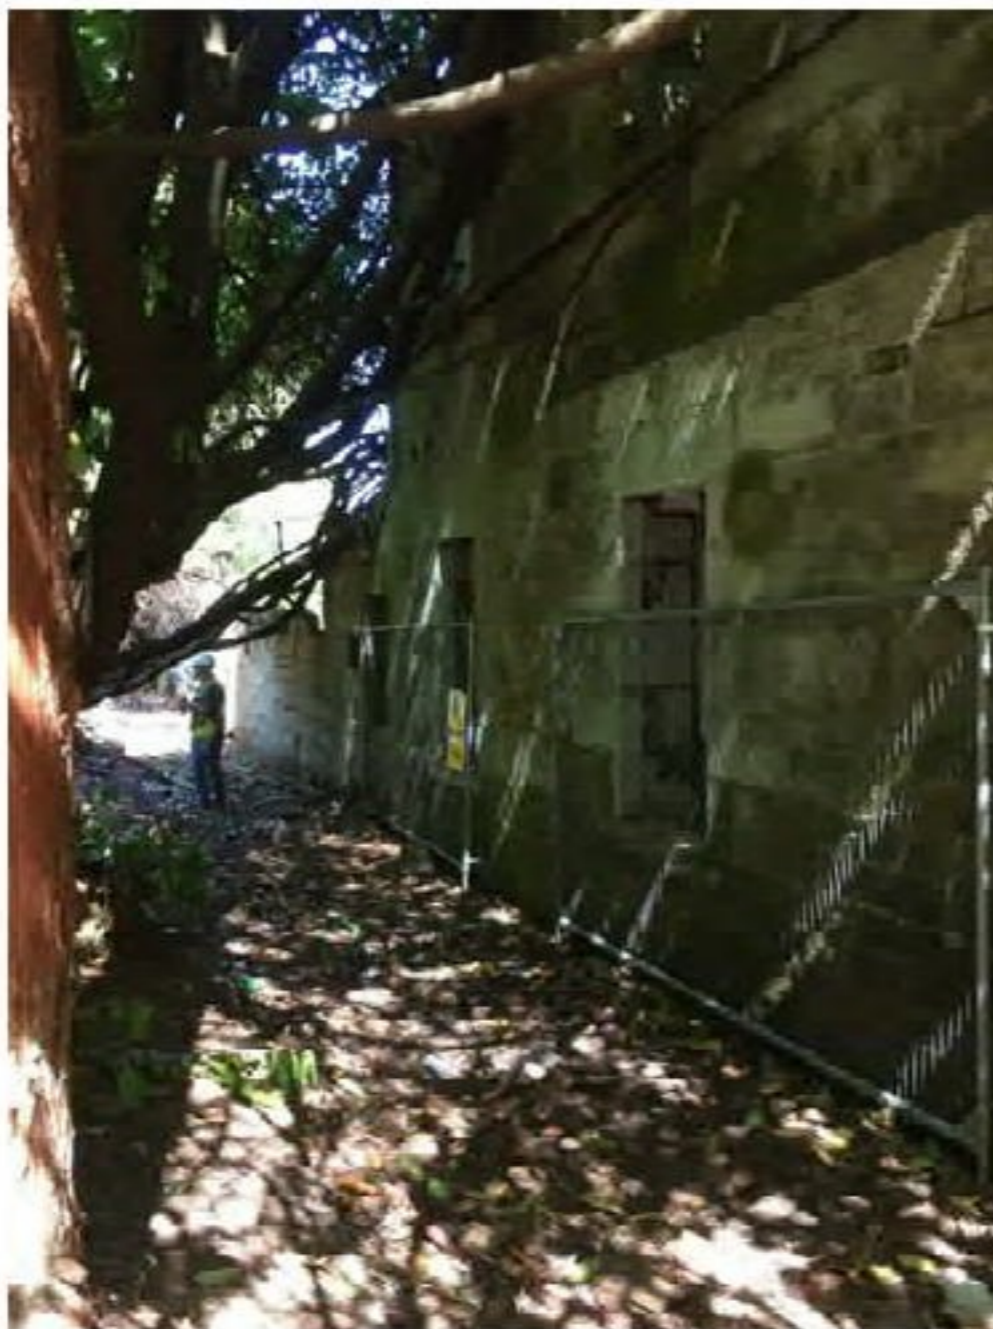
Photograph 25 – West wall of rear section
Showing unstable walls and trees.

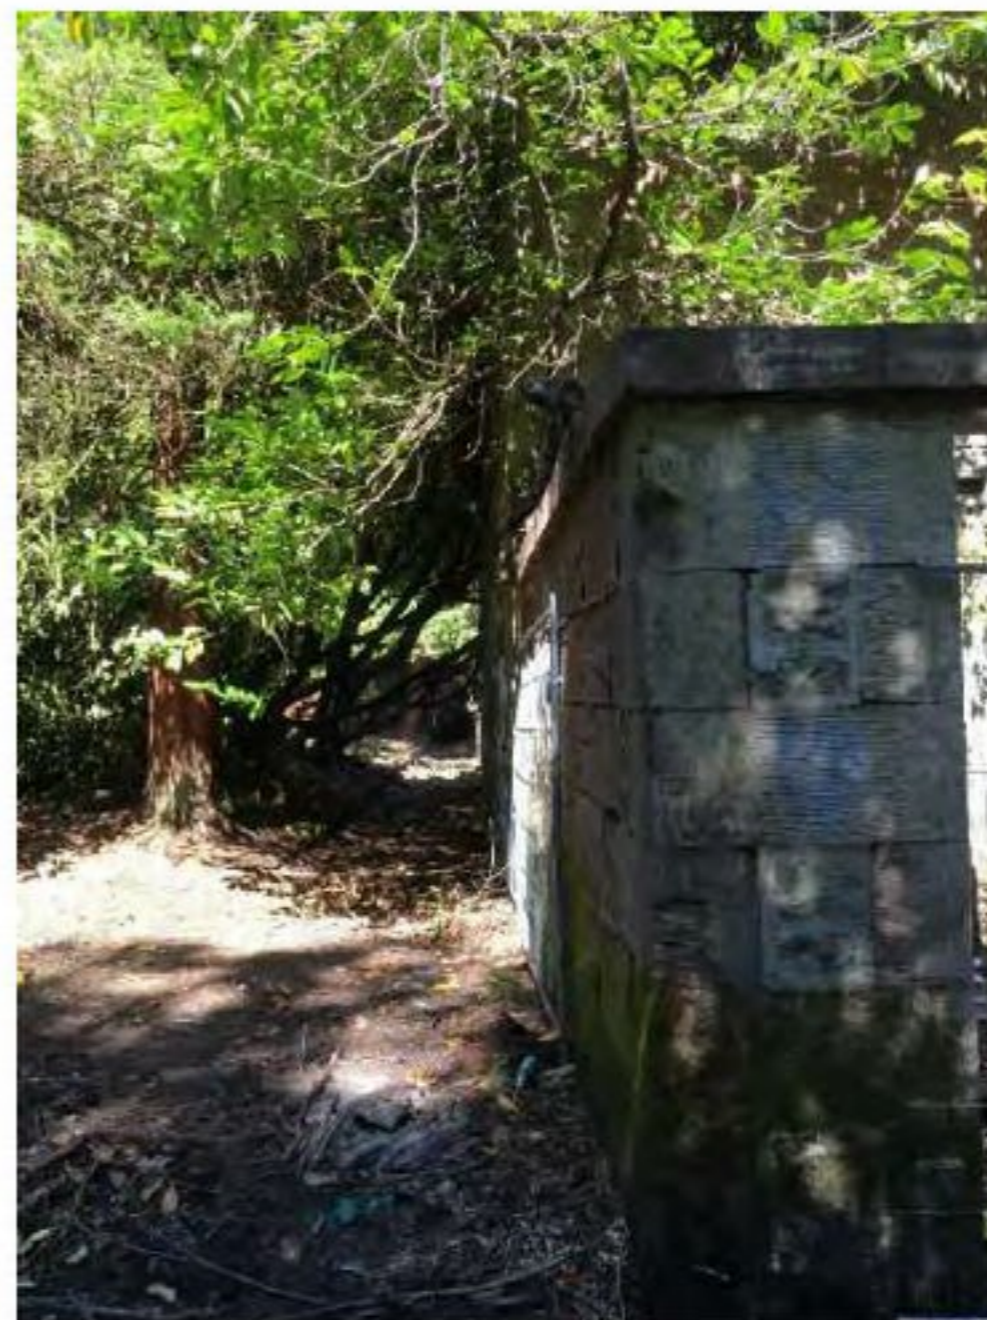
Photograph 26 – West wall of rear section
Showing unstable walls and trees.

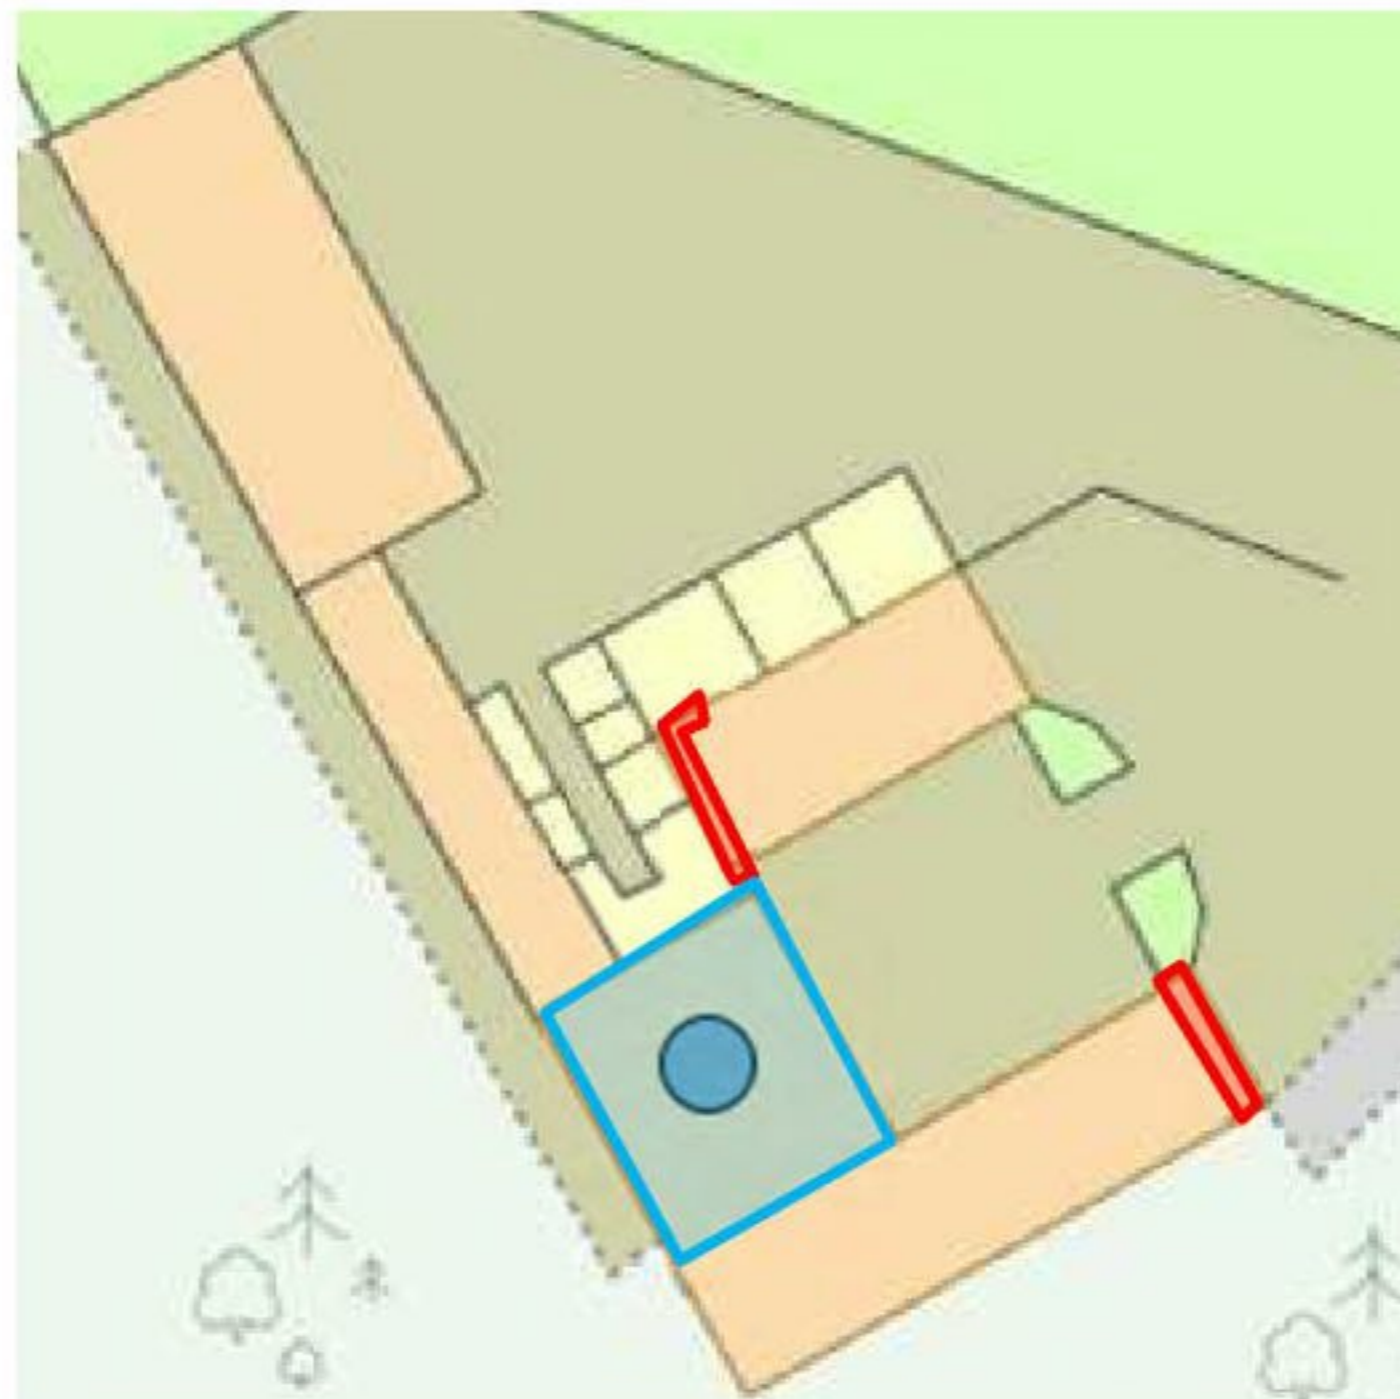
Figure 4 – Stable block summary plan

3.4.1 Due to the poor condition and lack of stability, a considerable area of the building must be demolished for safety reasons. It is debatable whether the remaining sections of the building are significant enough to be retained and renovated.

- Demolition to Ground level, shown red.
- Demolition to at least the underside of first floor level, shown in blue.

3.4.3 Once the partial demolitions have been completed further investigations can be carried out to assess the remainder of the structure.

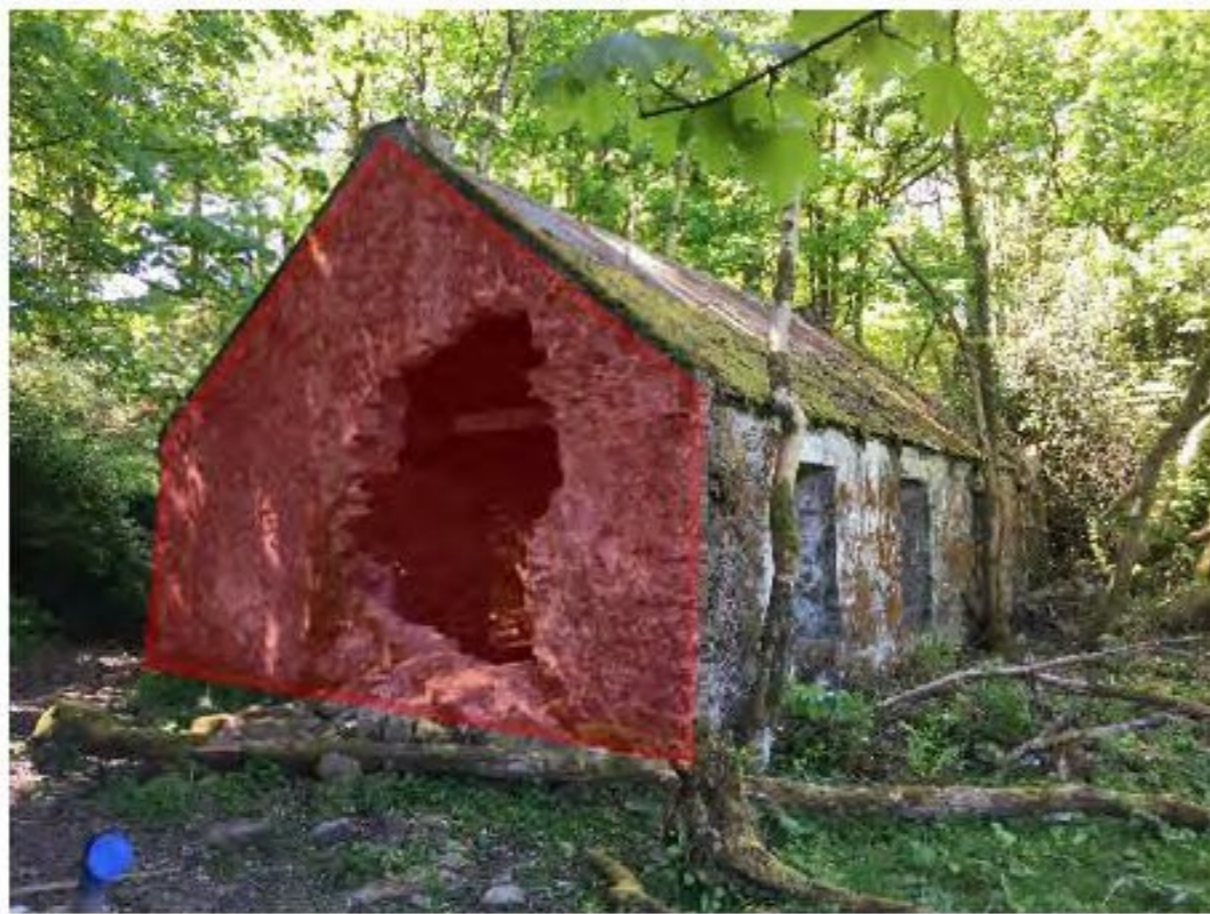
- 4.3.1 The building is small with no floor slab and has a large section of the south wall missing. The walls are in poor condition and a chimney collapse has exposed the single stone skin sections that form the flue and the wall is unstable, as shown in photographs 27, 29 and 32. Due to the instability of the south wall we would recommend demolishing the wall.
- 4.3.2 The corroded lintels are formed with steel rails and would need to be replaced if the building is to be refurbished.
- 4.3.3 Due to the instability of the south wall we would recommend demolishing the wall.
- 4.3.4 We would recommend that the building is demolished given the state of repair. If the full building is not demolished the east and west walls will need propped prior to the demolition taking place.

Photograph 27 - South wall showing collapse
Priority down takings for safety highlighted red.

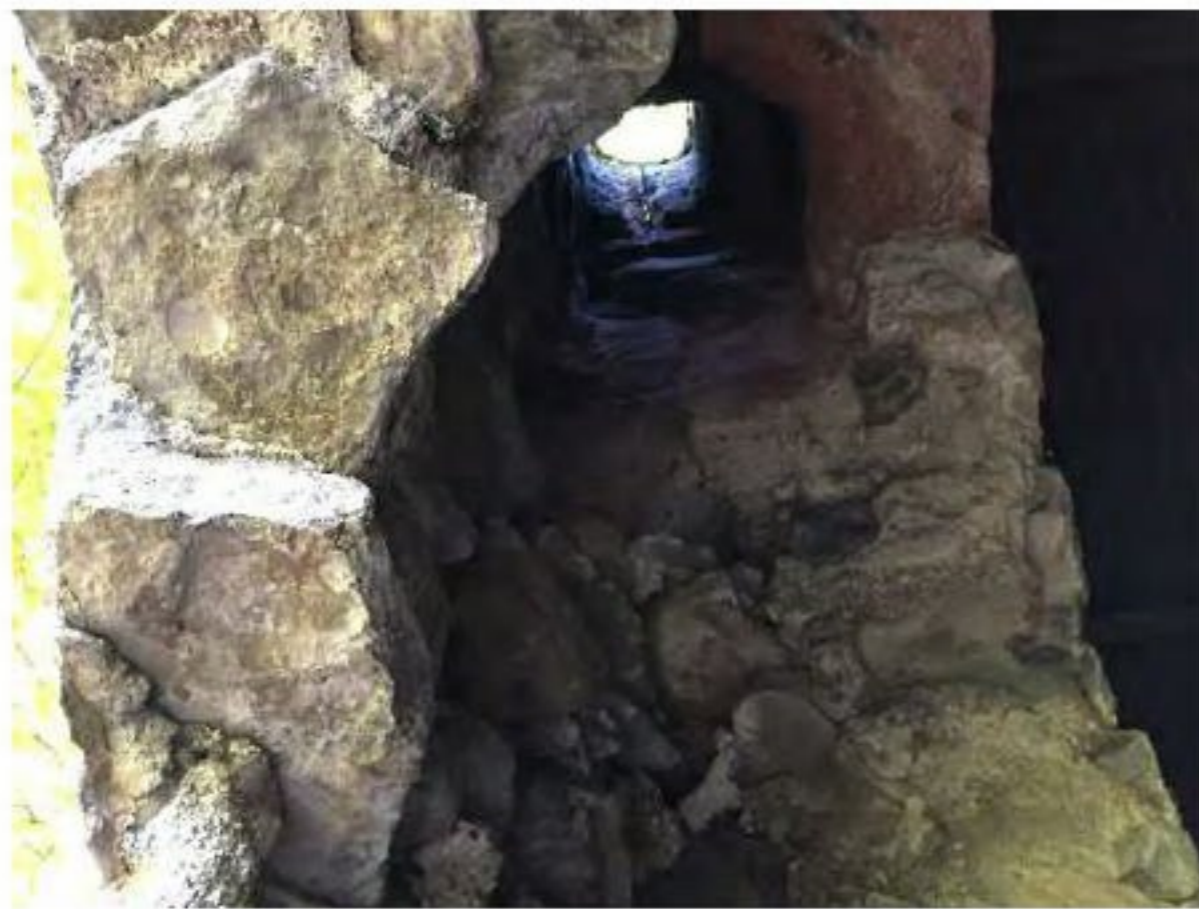
Photograph 29 – South wall, showing unstable flue.

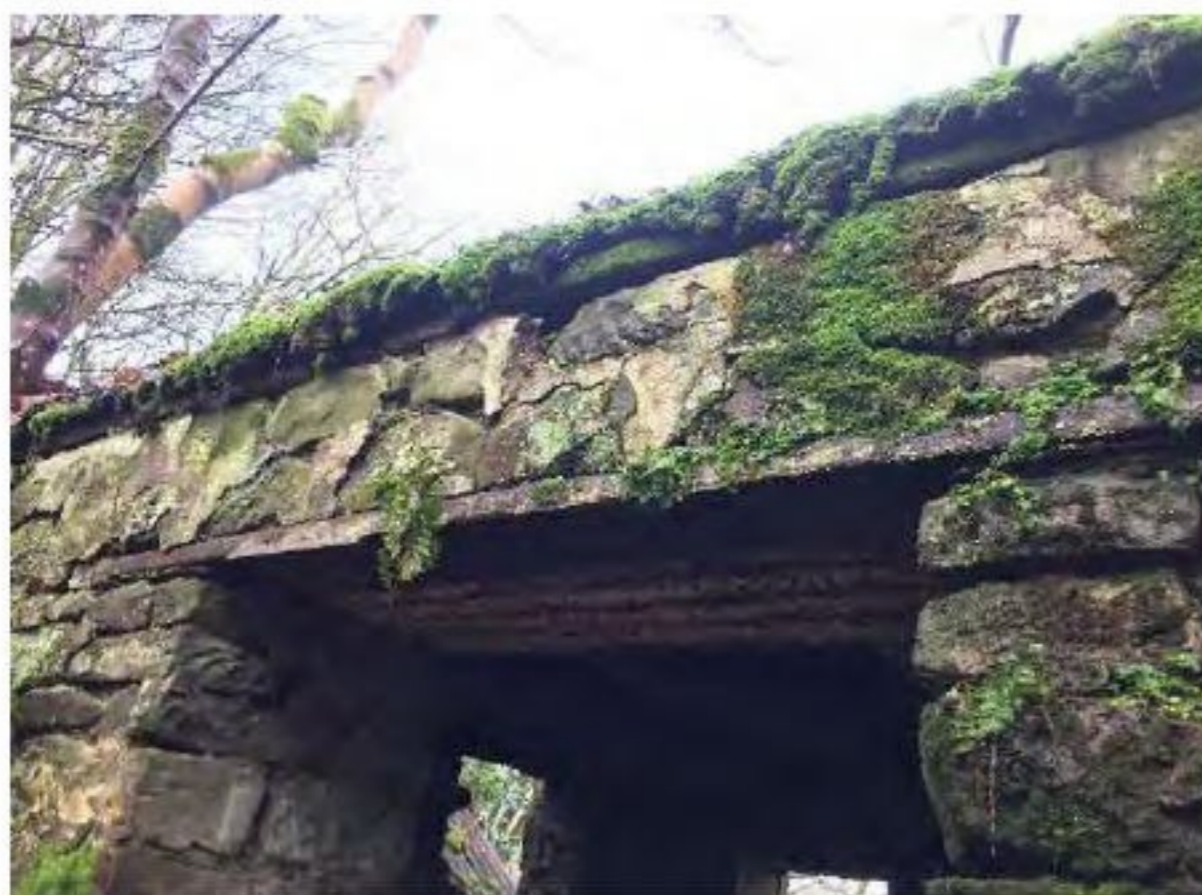
Photograph 31 – West wall lintel, formed with rails

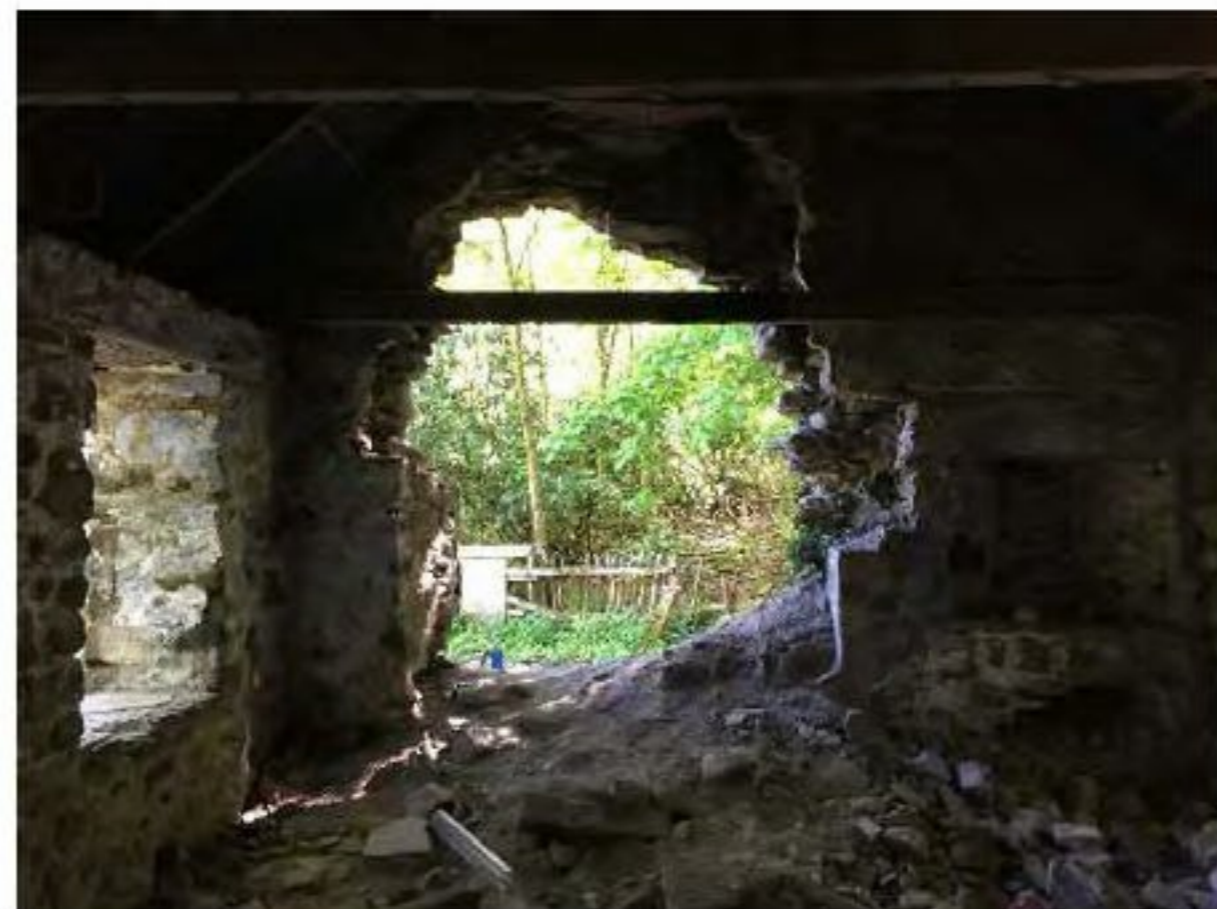
Photograph 32 – South wall, showing collapse.

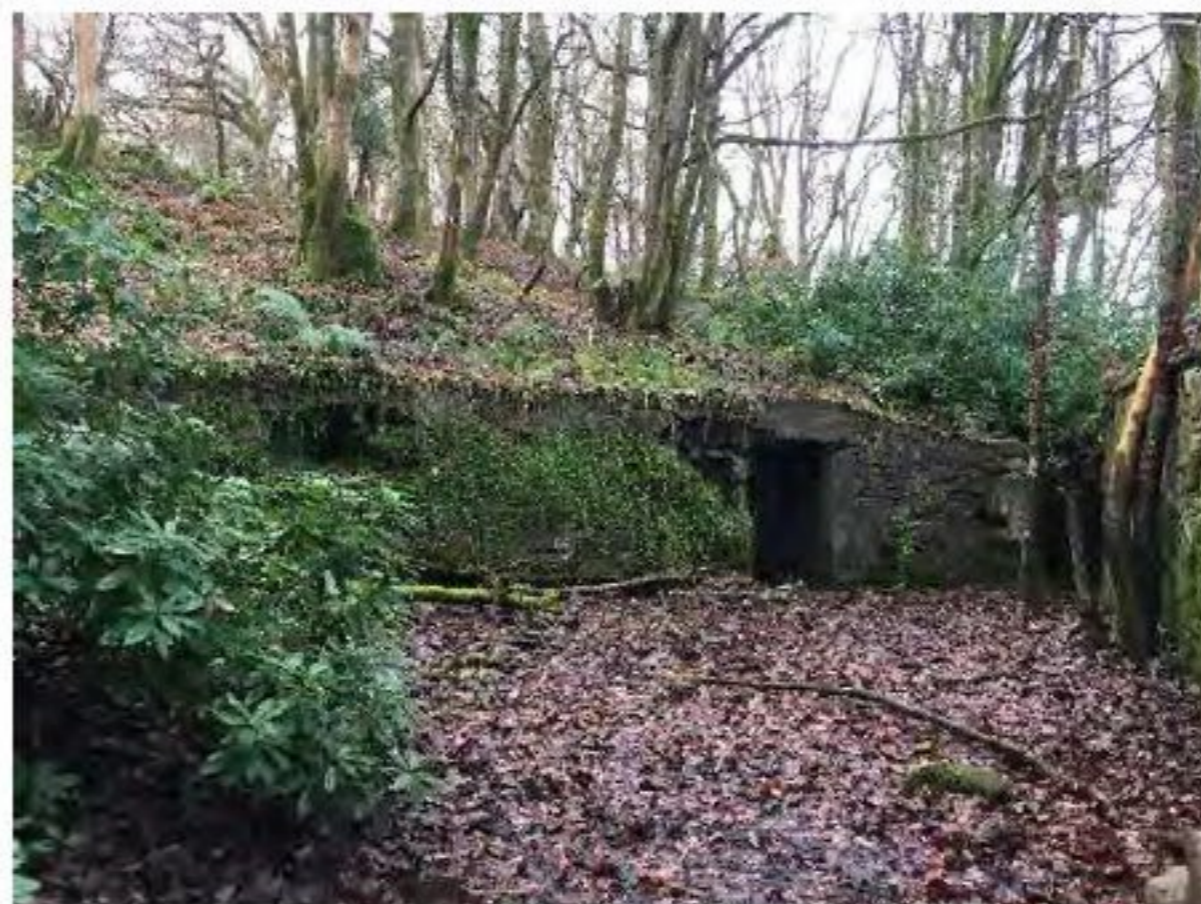
- 4.3.5 The retaining wall to the west of the building(as shown below) is in poor condition with numerous holes along its length. If the building is being demolished re-grading should be considered to avoid the need to replace or remediate the retaining wall.

Photograph 33 – South West Retaining wall
