INFORMATION FOR HISTORIC BUILDING OWNERS

Domestic Chimneys & Flues

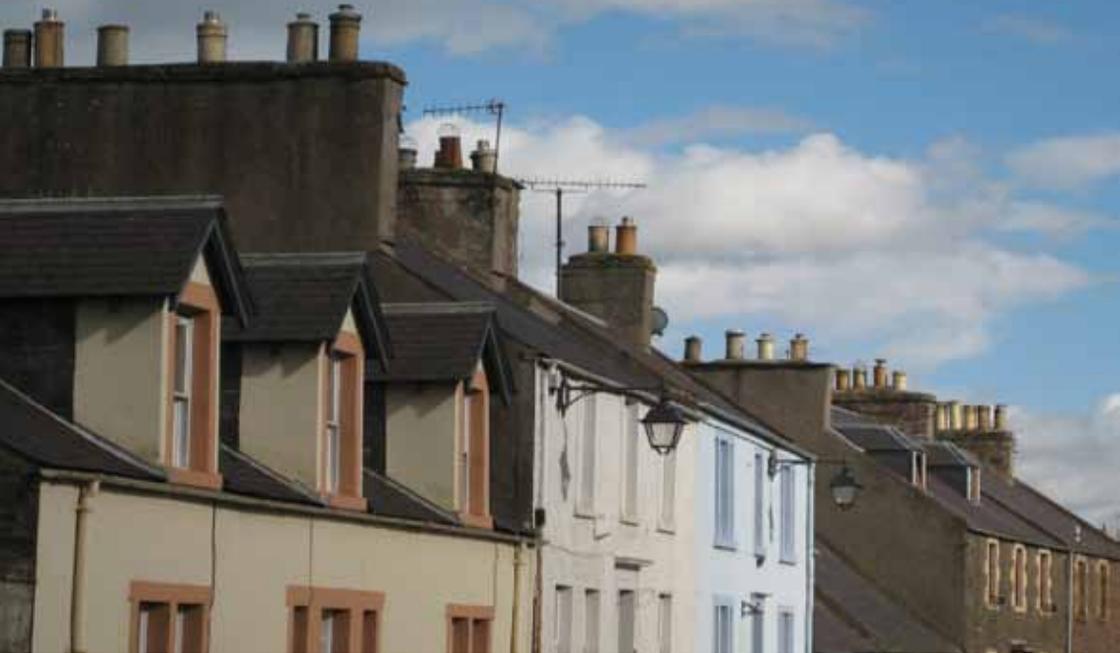
Fig. 1 Chimneys and cans are a dominant and distinctive feature of the urban environment.

Chimneys have long been part of domestic construction, and have come to be part of the urban and rural standard (Fig. 1). Originally homes did not have chimneys, and fumes were vented through the roof. Since the early middle ages high status buildings were fitted with effective fireplaces and flues; sometime later domestic dwellings adopted the chimney and flue system, although many Hebridean blackhouses continued without a chimney well into the 20th century. The design of flues and chimneys has in part developed due to the type of fuel burnt in them – generally, lower calorific value fuels such as wood and peat require bigger openings and flues; fuels such as coal and anthracite can burn effectively through narrower bore flues and chimneys - although most types of fuel will work in most hearths.

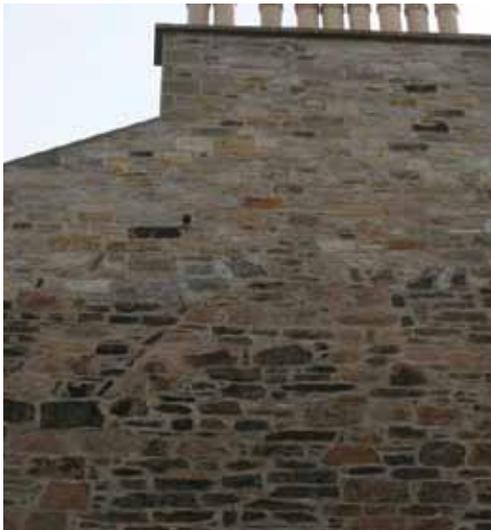
Fig. 2 Diagonal bridges made from stone slabs, visible on the gable end of this tenement in Edinburgh, indicate the presence of flues within the wall.

As fuels became more energy intensive, flues tended to become smaller and more effectively lined. Where the builders had to fit a large number of flues within a gable, such as a tenement, stone slabs were used to separate flues. The pattern of these slabs can sometimes be seen on gable ends of tenements (Fig. 2).

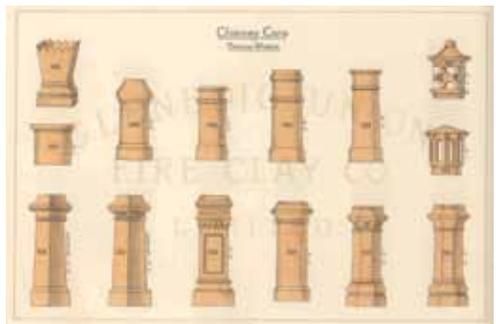
Fig. 3 Victorian trade catalogue showing the wide variety of styles available.

Until the late 18th century, chimney heads were finished with a cope only, but from the 19th century onwards all but the largest chimneys were finished with additional clay pots or cans. They developed in many styles, with some 19th century ones being very decorative indeed (Fig. 3). The pot is sometimes set into a slight recess in the cope, and mortared in or “haunched” with mortar.

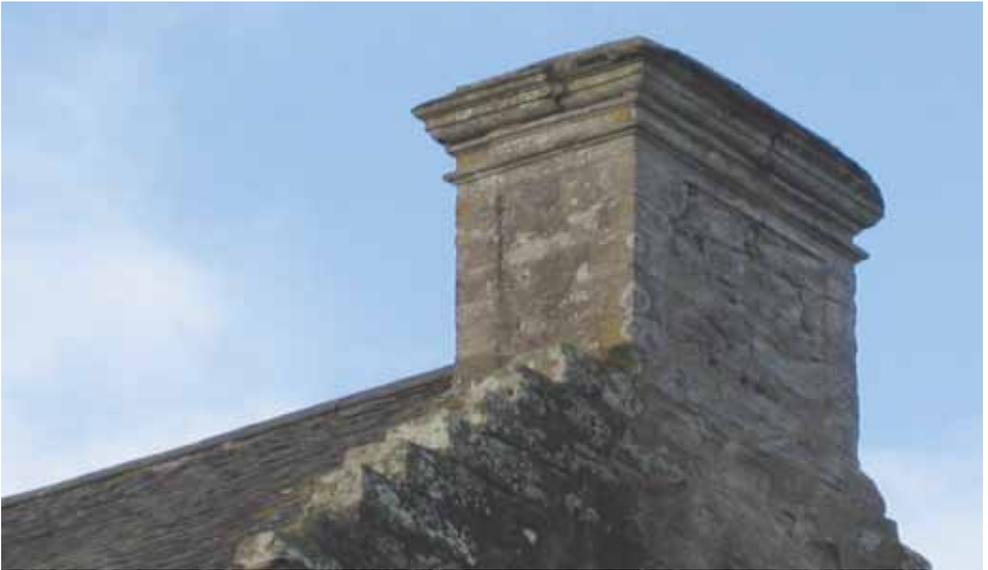
Fig. 4 Banding on this late 17th century chimney.

cope; a single stone, or several dressed stones providing the level top. Patterns have varied over time, from sloped copes with rolled edges of the 16th century, to very square tabulated corncicing and drip details on some 19th century chimney heads. Banding (raised margins) on the chimney quoins can give clues as to the original surface finish of the chimney and any elevation in height (Fig. 4). Sometimes the cope stones are held together with iron or bronze cramps which are secured with hot poured lead.

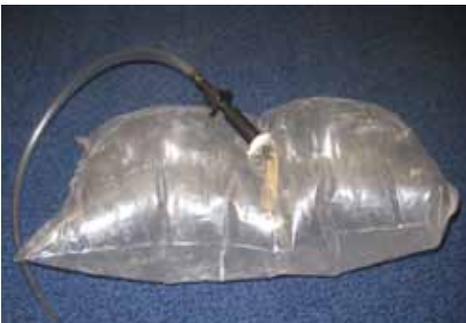
Fig. 5 Chimney balloon used to close a flue.

Even when no fire is lit, ventilation is an important function of the chimney system in a traditional structure. The rising air in the chimney draws new air into the room from under the floor and behind plastered surfaces, keeping void spaces and hidden areas dry. Flues should not be closed off. To reduce draughts from unused flues they should be temporarily closed off with a chimney balloon (Fig. 5).

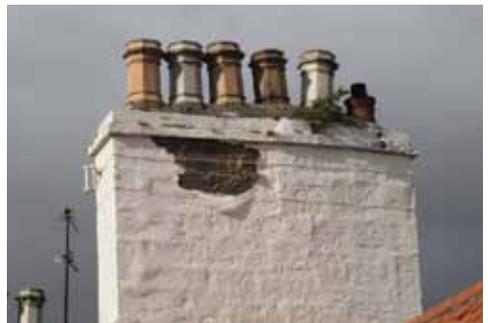
Fig. 6 A mid 19th century chimney and cans showing dislodged cans and other problems.

Over time, as the haunching washes out or becomes cracked, the chimney cans (or pots) can become loose (Fig. 6). In this instance re-bedding in fresh mortar will be required. Occasionally the can itself becomes cracked and broken and should be replaced. Invariably replacement styles are limited, but cans should be matched where possible - in height and colour as a minimum. If the flue is not used the can should be covered, preferably with a conical galvanised cover fitted with bird netting, allowing adequate ventilation (Fig. 7). Ceramic or conical covers are available (sometimes called 'elephants feet'), but these do limit ventilation somewhat; where there is evidence of damp in the chimney they should not be used.

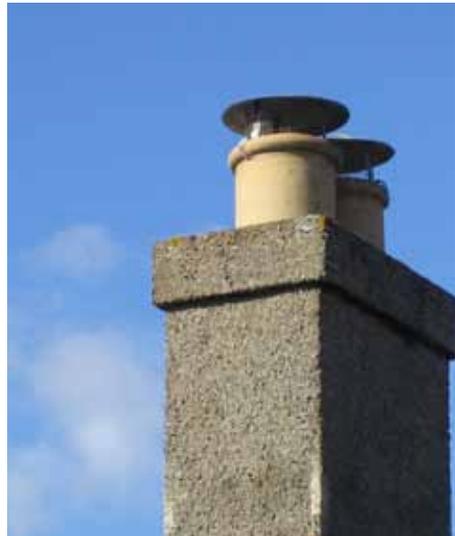
Fig. 7 Conical cover for a chimney can.

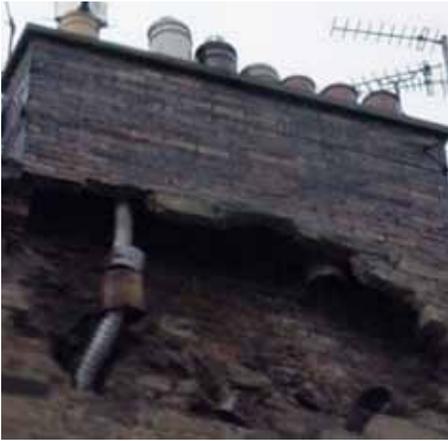
Fig. 8 Collapse of parts of a gable due to washed out mortar.

Fine ashlar joints and thicker joints in rubble chimneys become washed out over time, leading to water ingress and progressive loss of structural stability. In extreme cases this can lead to the collapse of the chimney (Fig. 8). Repointing and sometimes re-rendering is necessary, as well as checking the condition of the cope stones.

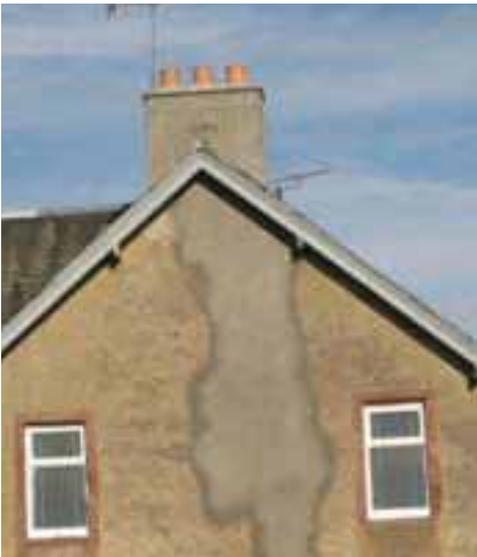
Fig. 9 A flue relined from the outside.

This process is continued up the wall until the chimney is reached. If the flue can be accessed from the outside the level of disruption is reduced, but will require a scaffold (Fig. 9). It is also possible to rebuild the flue in the original manner, with stone bridges and slab lining, although this is more time consuming and expensive.

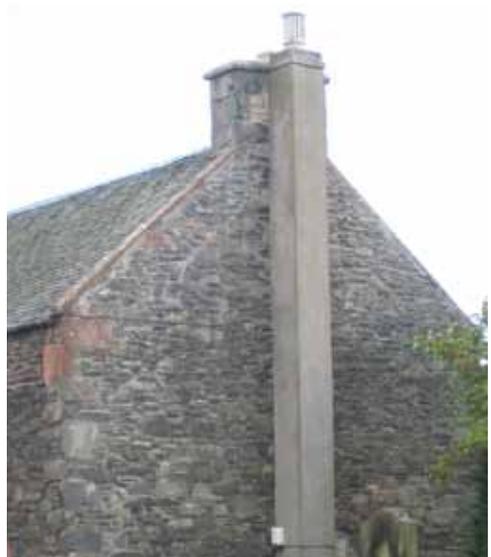
Fig. 10 A new flue built onto the exterior face of a gable.

- Poured cement based re-lining. There are many contractors offering this option, it should however be noted that the process is irreversible. It involves the creation of a cement lining, temporarily held within a removable rubber former. Care needs to be exercised as the poured lining fills all voids within the flue, including holes into rooms. This method also reduces the bore of the flue and due to the impervious nature of the cementitious material, does not allow proper movement of water vapour within the wall. If the wall and flue are dry or internal, it can be effective, but caution should be exercised when considering this method for external gables or exposed chimneys.
- In some cases an additional flue and stack may be built adjacent to the existing gable. Whilst presenting a solution of sorts, it is likely to be visually intrusive (Fig. 10).
