Woodbank House, Balloch Structural & Conservation Summary 29.01.2019

Woodbank House - As Existing

This is a brief report prepared for LLTNP to clarify the extent of building fabric to be retained.

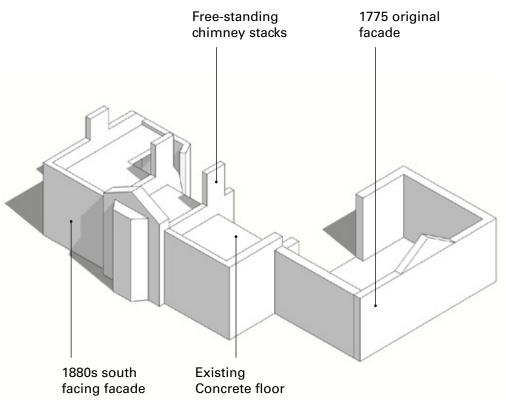
Structural and Conservation reports were produced in Spring 2017 and their findings are summarised on the following pages. Diagram to show extent of existing facade - Woodbank House is in a ruinous state

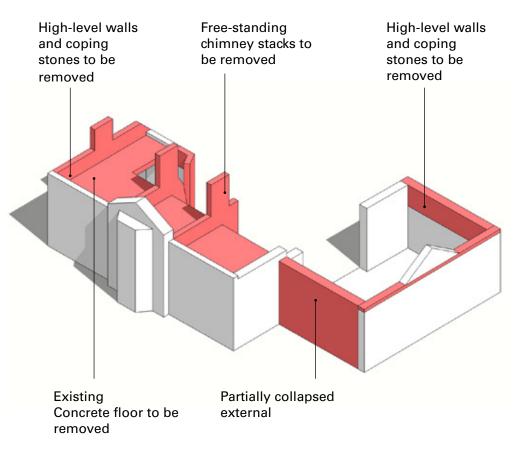
Woodbank House - Structural Recommendations

- Recommended Downtakings on Safety Grounds
- The Structural Inspection Report produced by PBA made several recommendations for the demolition of unsafe elements of the house including walls, chimneys, coping stones and lintels.
- These elements are highlighted red in the adjacent image.
- The purpose of these demolitions are to mitigate dangerous elements of the structure which may cause harm to the public or further deterioration of the wider structure.

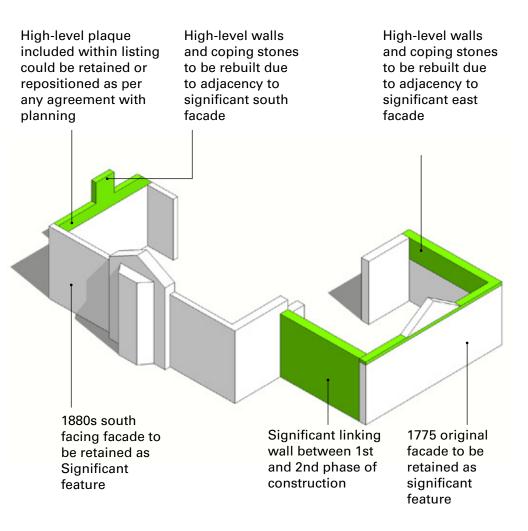
Woodbank House - Conservation Recommendations

- Recommended of Full Retainment & Rebuilding on Conservation Grounds
- The Conservation Inspection Report produced by Barham Glen Architects highlights the significance of certain features of the building which they argue should be retained/rebuilt after necessary safe demolitions are carried out.
- Some of the items recommended by BGA could be also be required by Planning because of the building's A listed status.
- The report from BGA was based on retention of as much of the building fabric as possible to facilitate potential future use and redevelopment of the building.

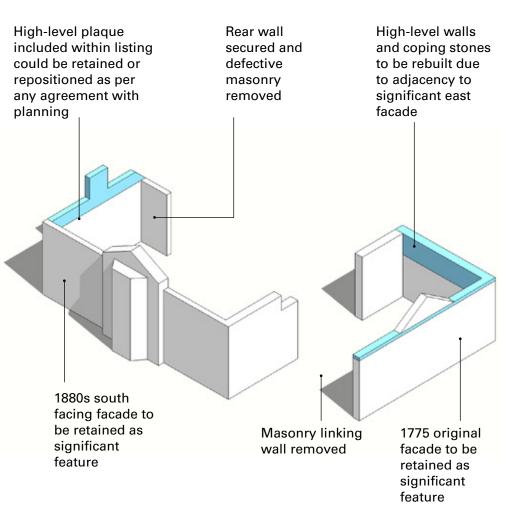
Woodbank House - Anderson Bell & Christie Proposals

It is proposed to proceed with an intermediate approach between demolitions and full reinstatement as a way to ensure Woodbank does not suffer further deterioration.

The proposals would be to carry out the demolition recommendations made by the structural engineer in order to make the structure safe. The appropriate rebuilding works would then be carried out to strategic areas of the building (as shown in blue in the adjacent image.

The principle would be to initially secure the building's shell consolidation, allowing for future development to restore and re-use the building.

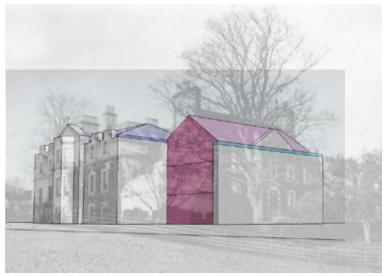
Proposed Massing

Following on from facade retention works, the current proposals would be to infill the historic footprint with residential units. The height of these unit storeys would carefully considered to not detract from the significance and cirtically the heights of the remaining historic external walls.

The historic entrances (located centrally on the existing facades) would be used as the primary entrances to the esidential unts.
