# Callander Burial Grounds Conservation Management Plan

*AOC Project No: 25947*

*Date: 31st January 2022*

## Callander Burial Grounds: Conservation Management Plan

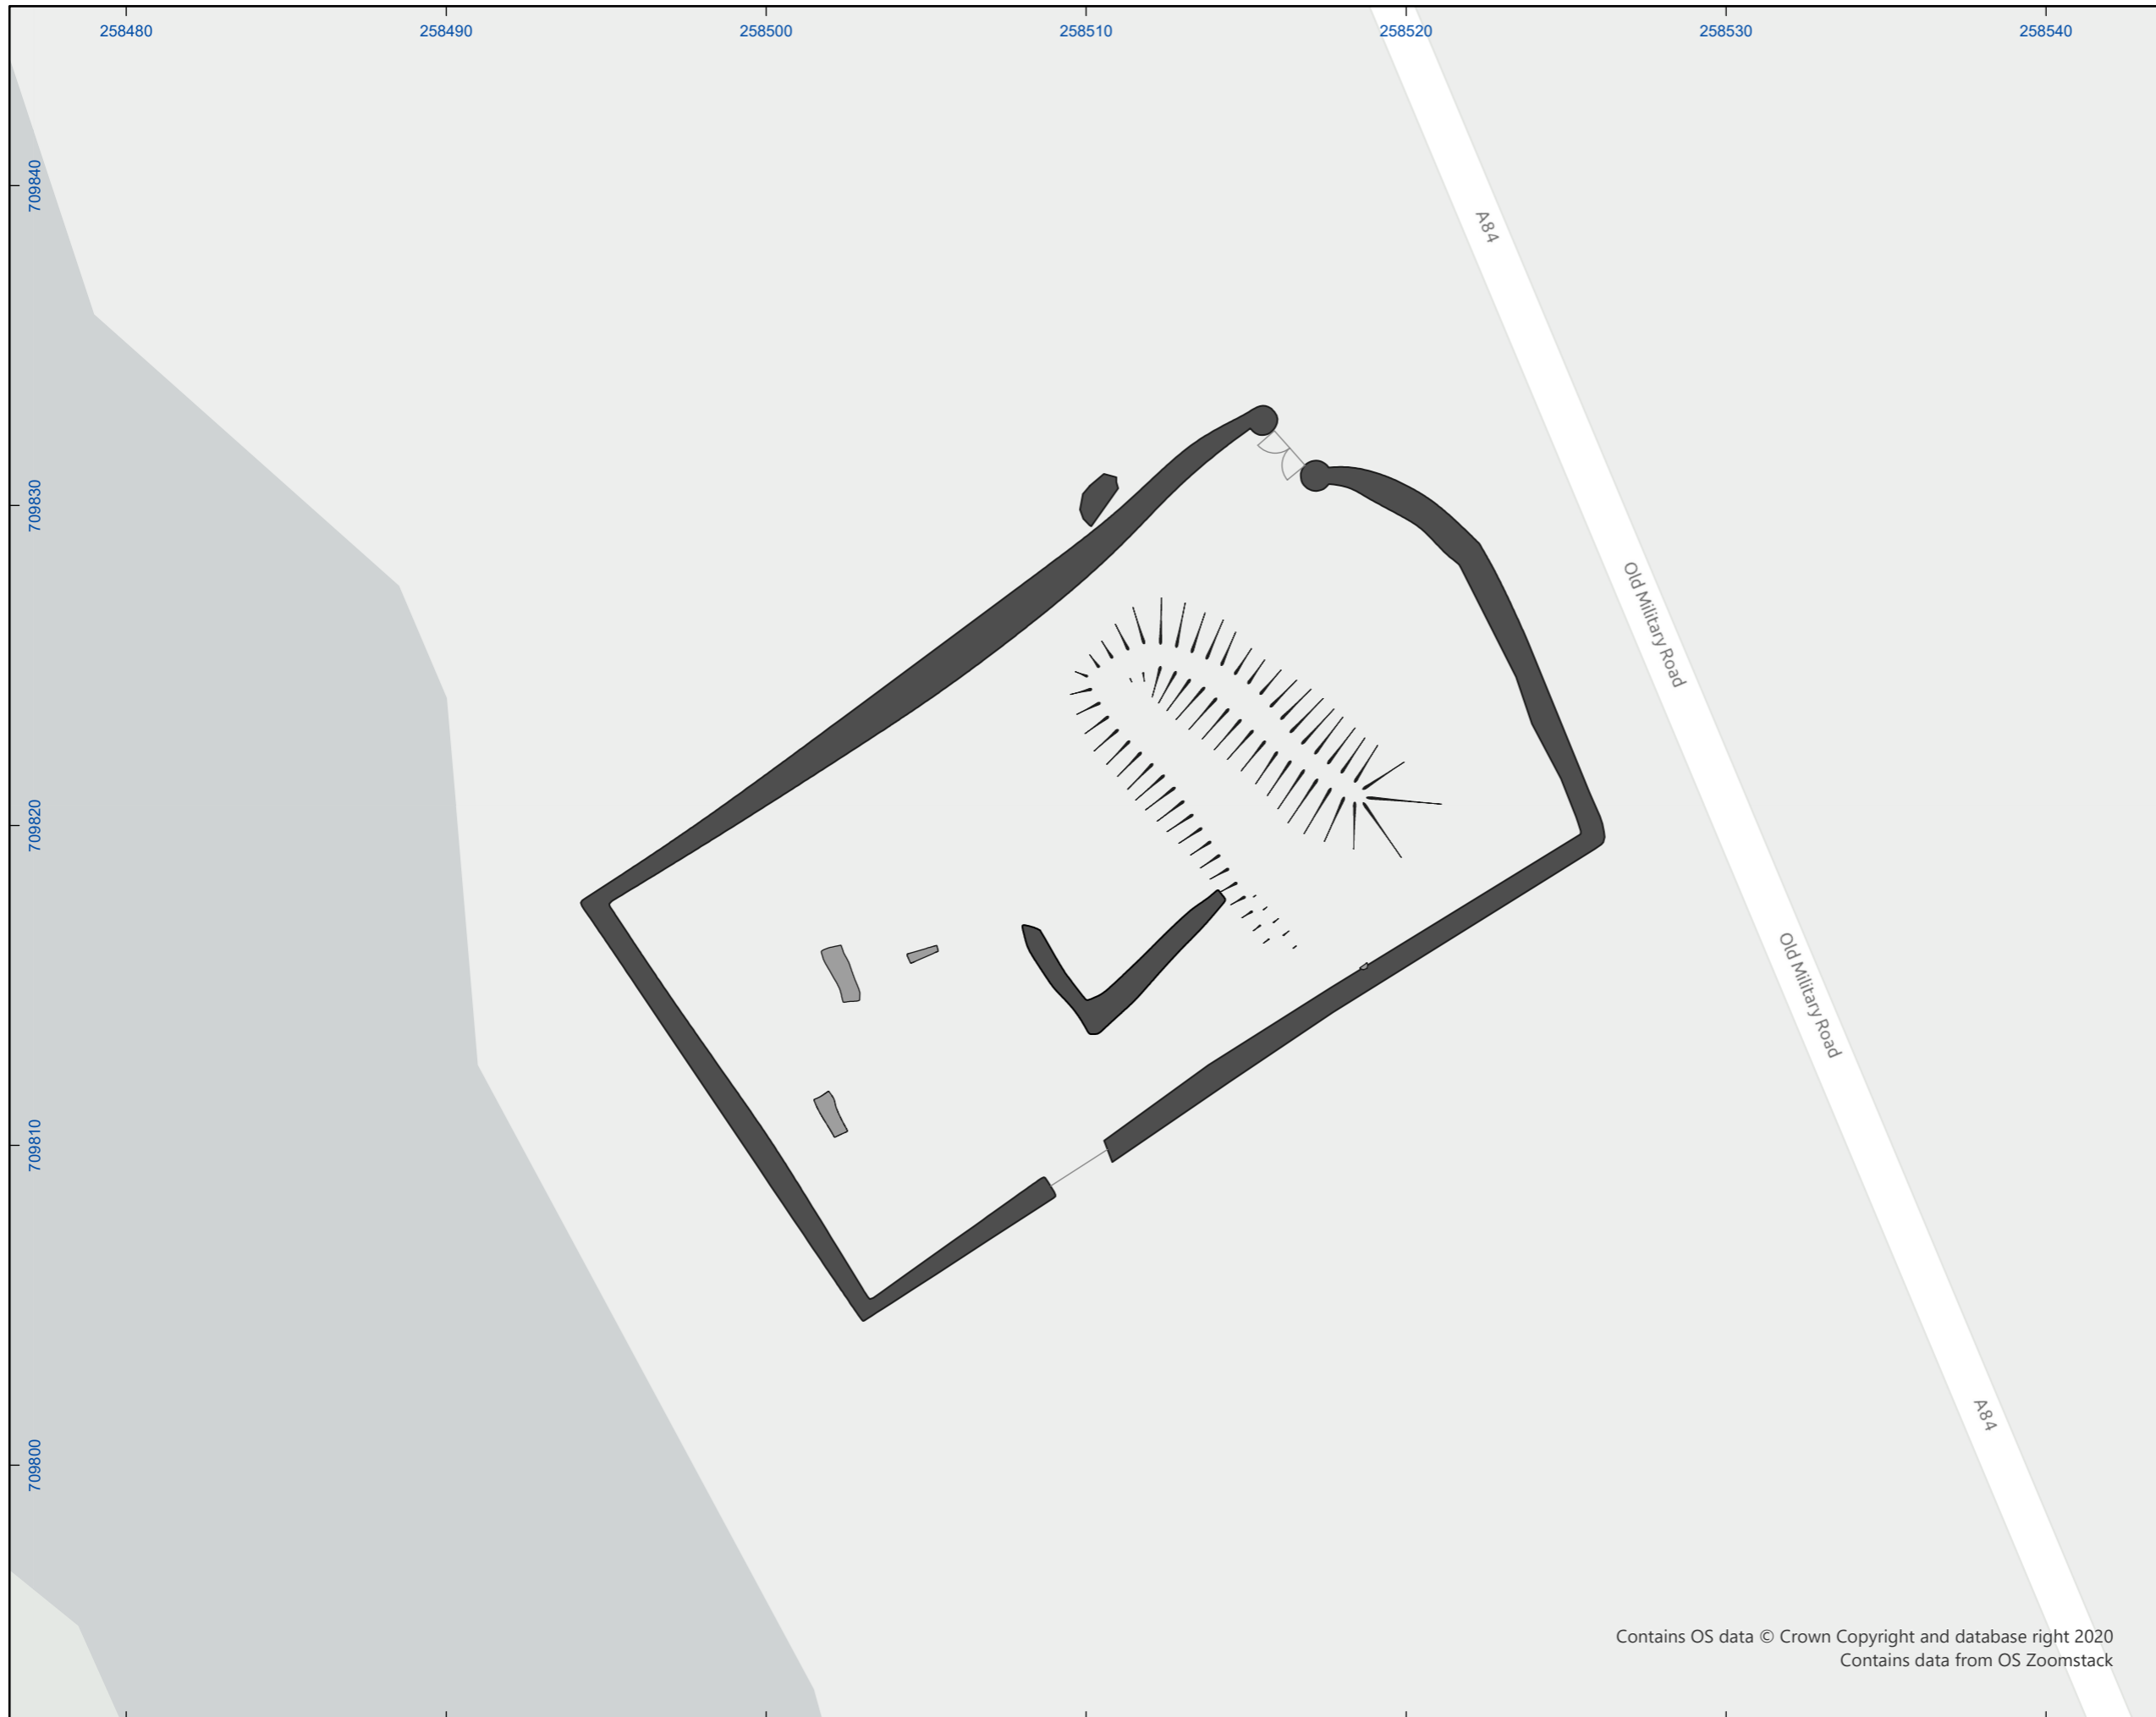
- 3.3.1 This section should be read in conjunction with Figure 18 and Appendices 1 – 4. St Bride's Chapel is the northernmost of the three sites, located just to the south of Loch Lubnaig and comprises a walled enclosure approximately 460m<sup>2</sup>. The site is enclosed by a boundary wall measuring between 0.7m and 1.2m in height constructed from randomly-coursed stone rubble with narrow stone copings (Plates SB1 – SB4). Most of the wall remains in good condition with only minor damage to the top of the wall in various positions around the enclosure, although there is heavy moss growth in the shorter sections of the wall. The main entrance to the site is from the east via a decorative iron gate at the north end of the east wall (Plate SB5). Flanking the gateway are two circular gate piers, 2.1m in height constructed from randomly-coursed stone rubble with a small pile of rounded stones on top (Plate SB6). Towards the west end of the south wall is a cast-iron gate with arrowpoint railing points (Plate SB7). This appears to be an original entrance to the site and contemporary to the entrance from the east with similar metalwork to both gates.

- 3.3.4 The front upper section of the gravestone has an angel decoration, whilst the back has two rams depicted at the top left and right corners (Plates SB14 & SB15). Also, on the rear face is a carving of a flower with an inscription in Gaelic beneath; due to lichen growth and general deterioration, this was impossible to decipher, however (Plate SB16). There is a possible grave marker set within the south wall which is 0.75m in height and has no visible inscription (Plate SB17). It is possible that there are further graves located within the enclosure which could not be seen at the time of the survey due to the level of the vegetation growth. The remains of the chapel were identified just beneath the grass which was orientated north-east/south-west before turning at a right angle to the north-west (Figure 18).

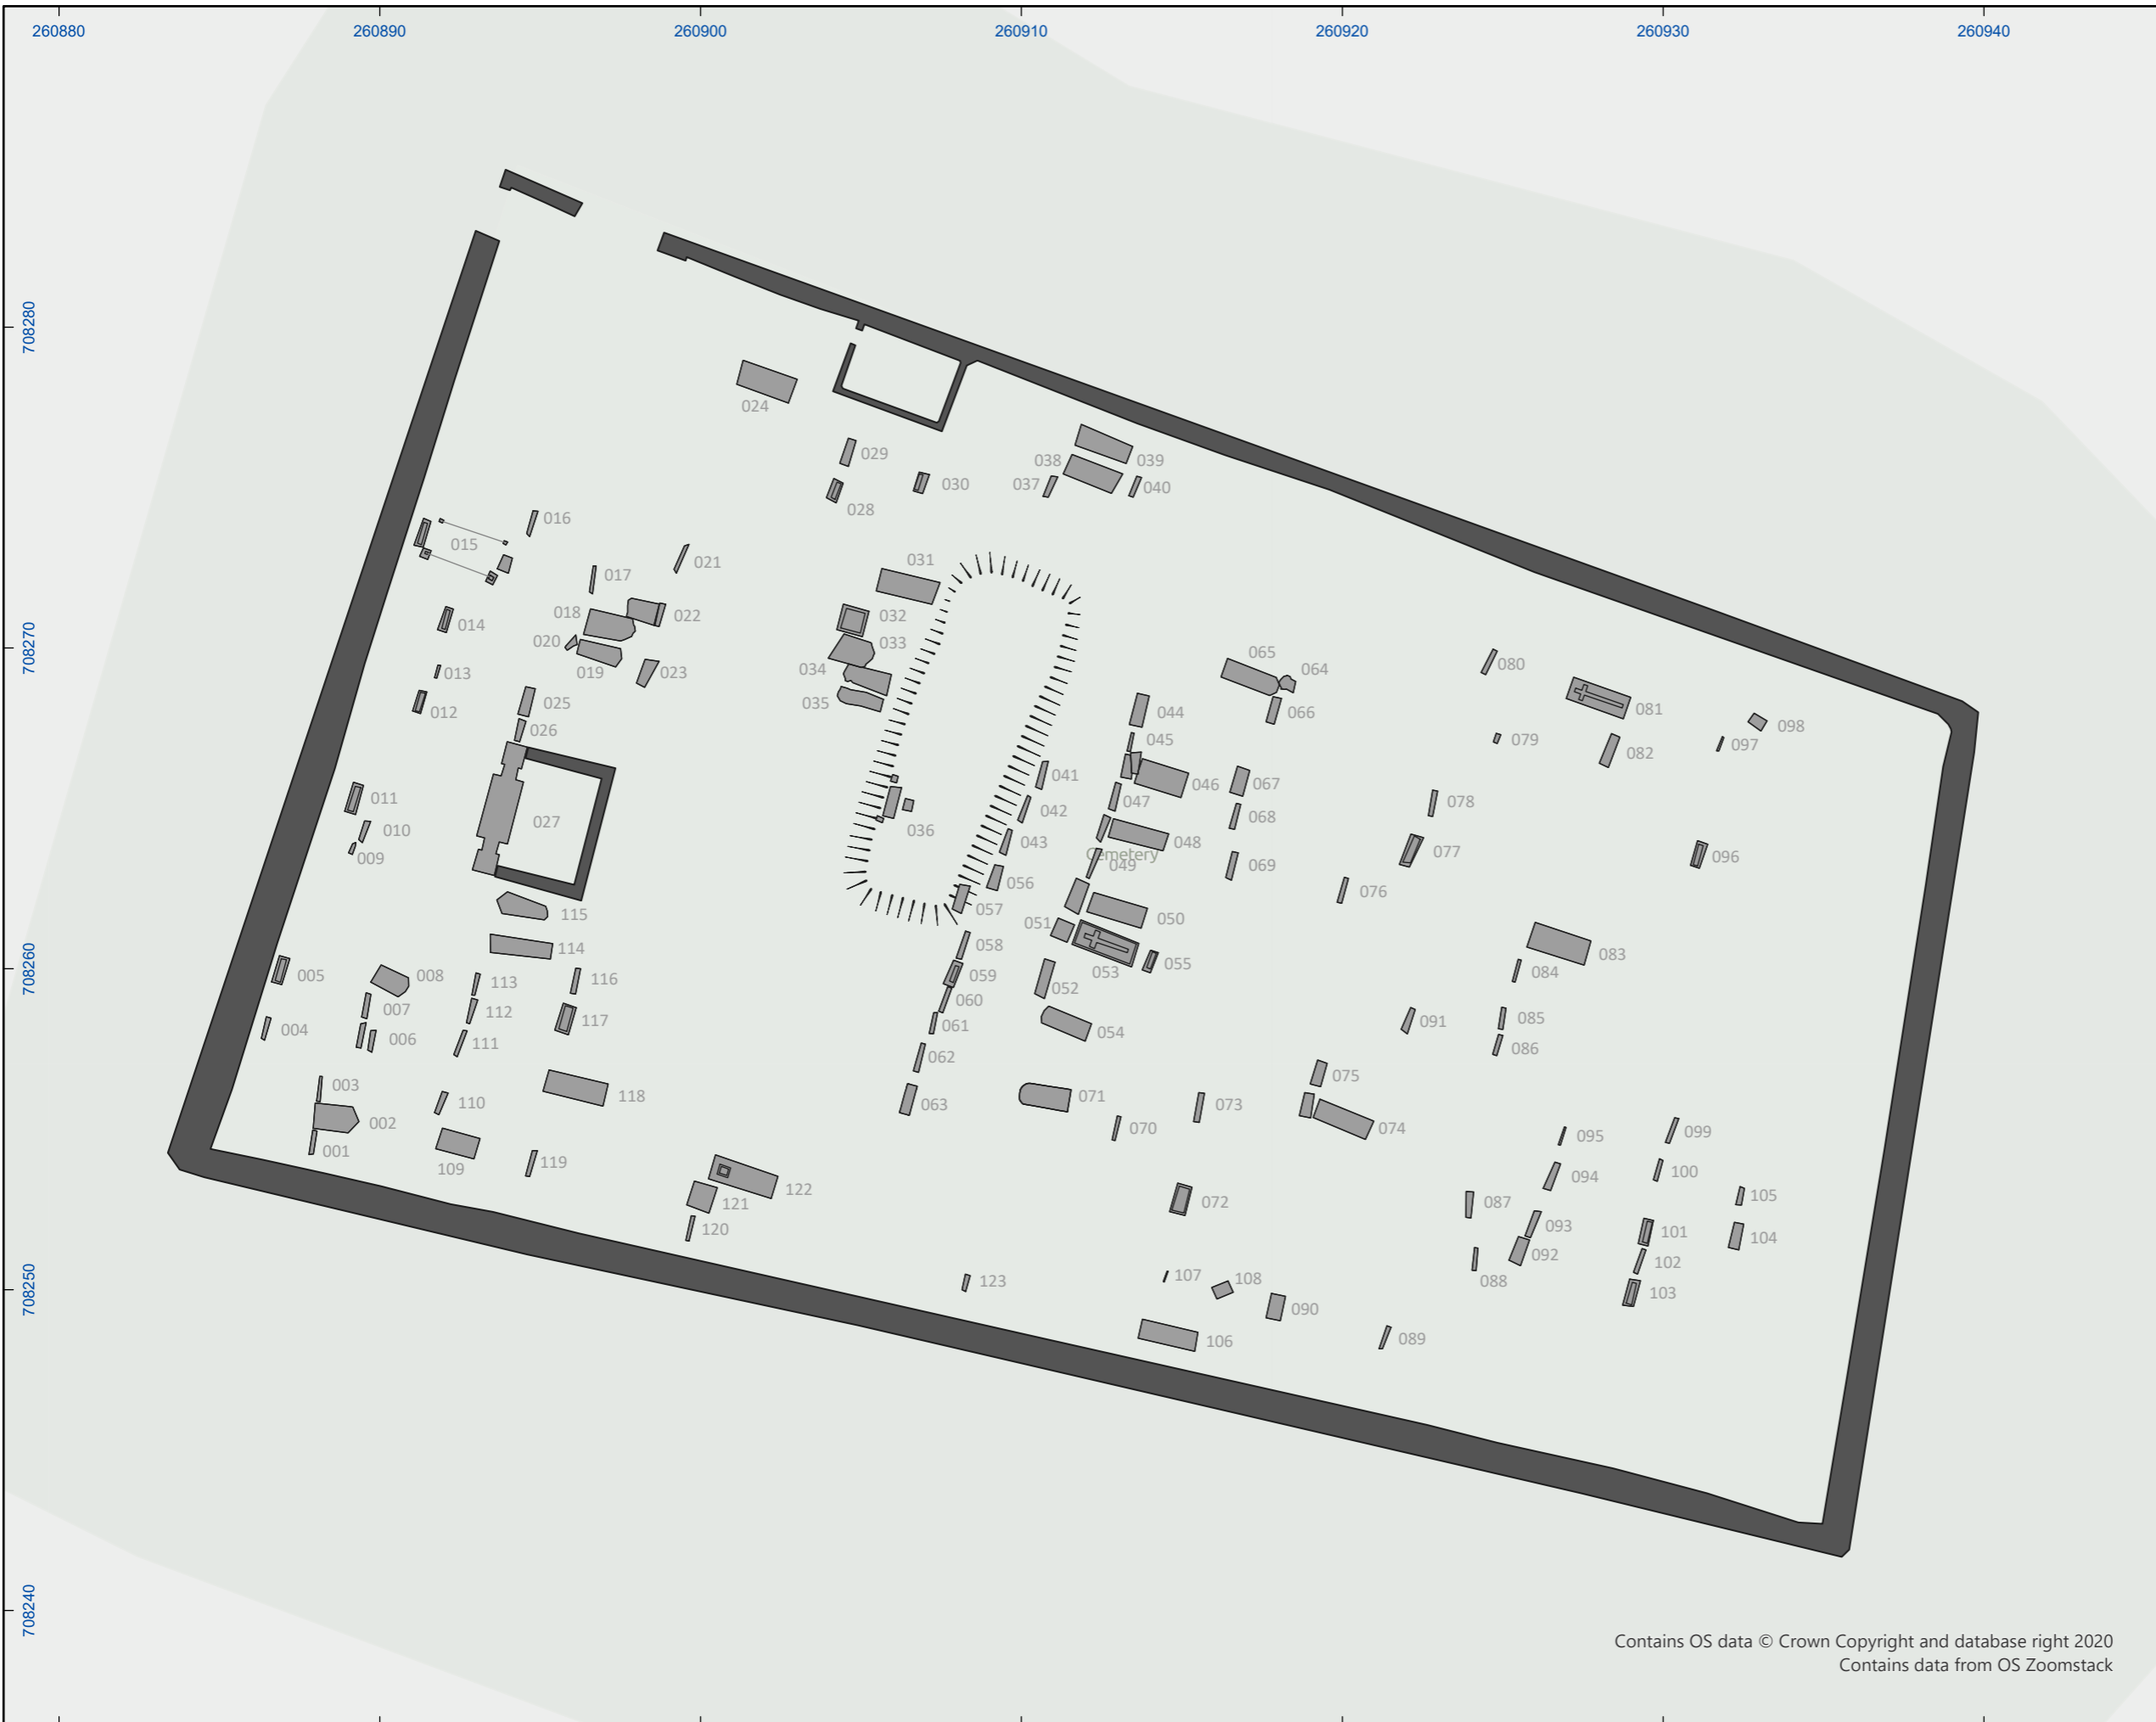
19

- 3.4.3 The overall condition of the graveyard's structures is generally good, notably the entrance archway and Mort House. However, the graveyard's boundary wall has been damaged in several places and has collapsed outwards; the north wall has a single area of collapse approximately 2.5m in length which has been partially blocked with fencing (Plate KG11). There is also an area of damage measuring 3m in length in the east wall towards its north end and an area of slight damage to the south wall towards its west end (Plate KG12 – KG14). Finally, there is an area of collapse at the centre of the west wall (Plate KG15). To the south-east of the Mort House and surrounding Grave Number 36 there is a roughly rectangular earthwork that likely relates to the position of the original chapel (Figure 19).

- 3.4.4 As noted above, Kilmahog Graveyard contains a large number of grave markers with 123 visible at the time of the survey (Figure 19; Appendix 5). The grave markers date from the 18th – 21st century, however it is possible that some grave markers date from the 17th century. These are most likely to be the flat grave slabs seen across the site that bear no clear text or dates having been worn by time and weather (Plates KG16 – KG18). It is also likely that more of these graves exist in the graveyard but have subsequently been covered over by grass and vegetation. The majority of the upstanding grave markers consist of pedimented and arch-topped gravestones dating from the late 18th century and early 19th century. Several the graves have *memento mori* imagery carved into them; these appear to be 18th and early 19th century graves, however many of these have worn illegible text. Common *memento mori* imagery depicted on these graves are skulls, crossed bones and hourglasses (KG19 & KG20). The traditional purpose of this imagery was to literally remind those who viewed the grave of their own mortality. Other common symbology includes the crest of Clan Stewart, with multiple Stuart burials within the graveyard dating from the 18th to 20th centuries (Plates KG21 – KG24). Because the clan has no direct chief, the Earls of Galloway are now considered to be the principal branch of the clan and the crest and motto of The Earls of Galloway's arms are used in the Clan Stewart crest badge. The crest of The Earls of Galloway's is 'A pelican Argent, winged Or, in her nest feeding her young, Proper' and the motto is *virescit vulnere virtus* (courage grows strong at a wound).

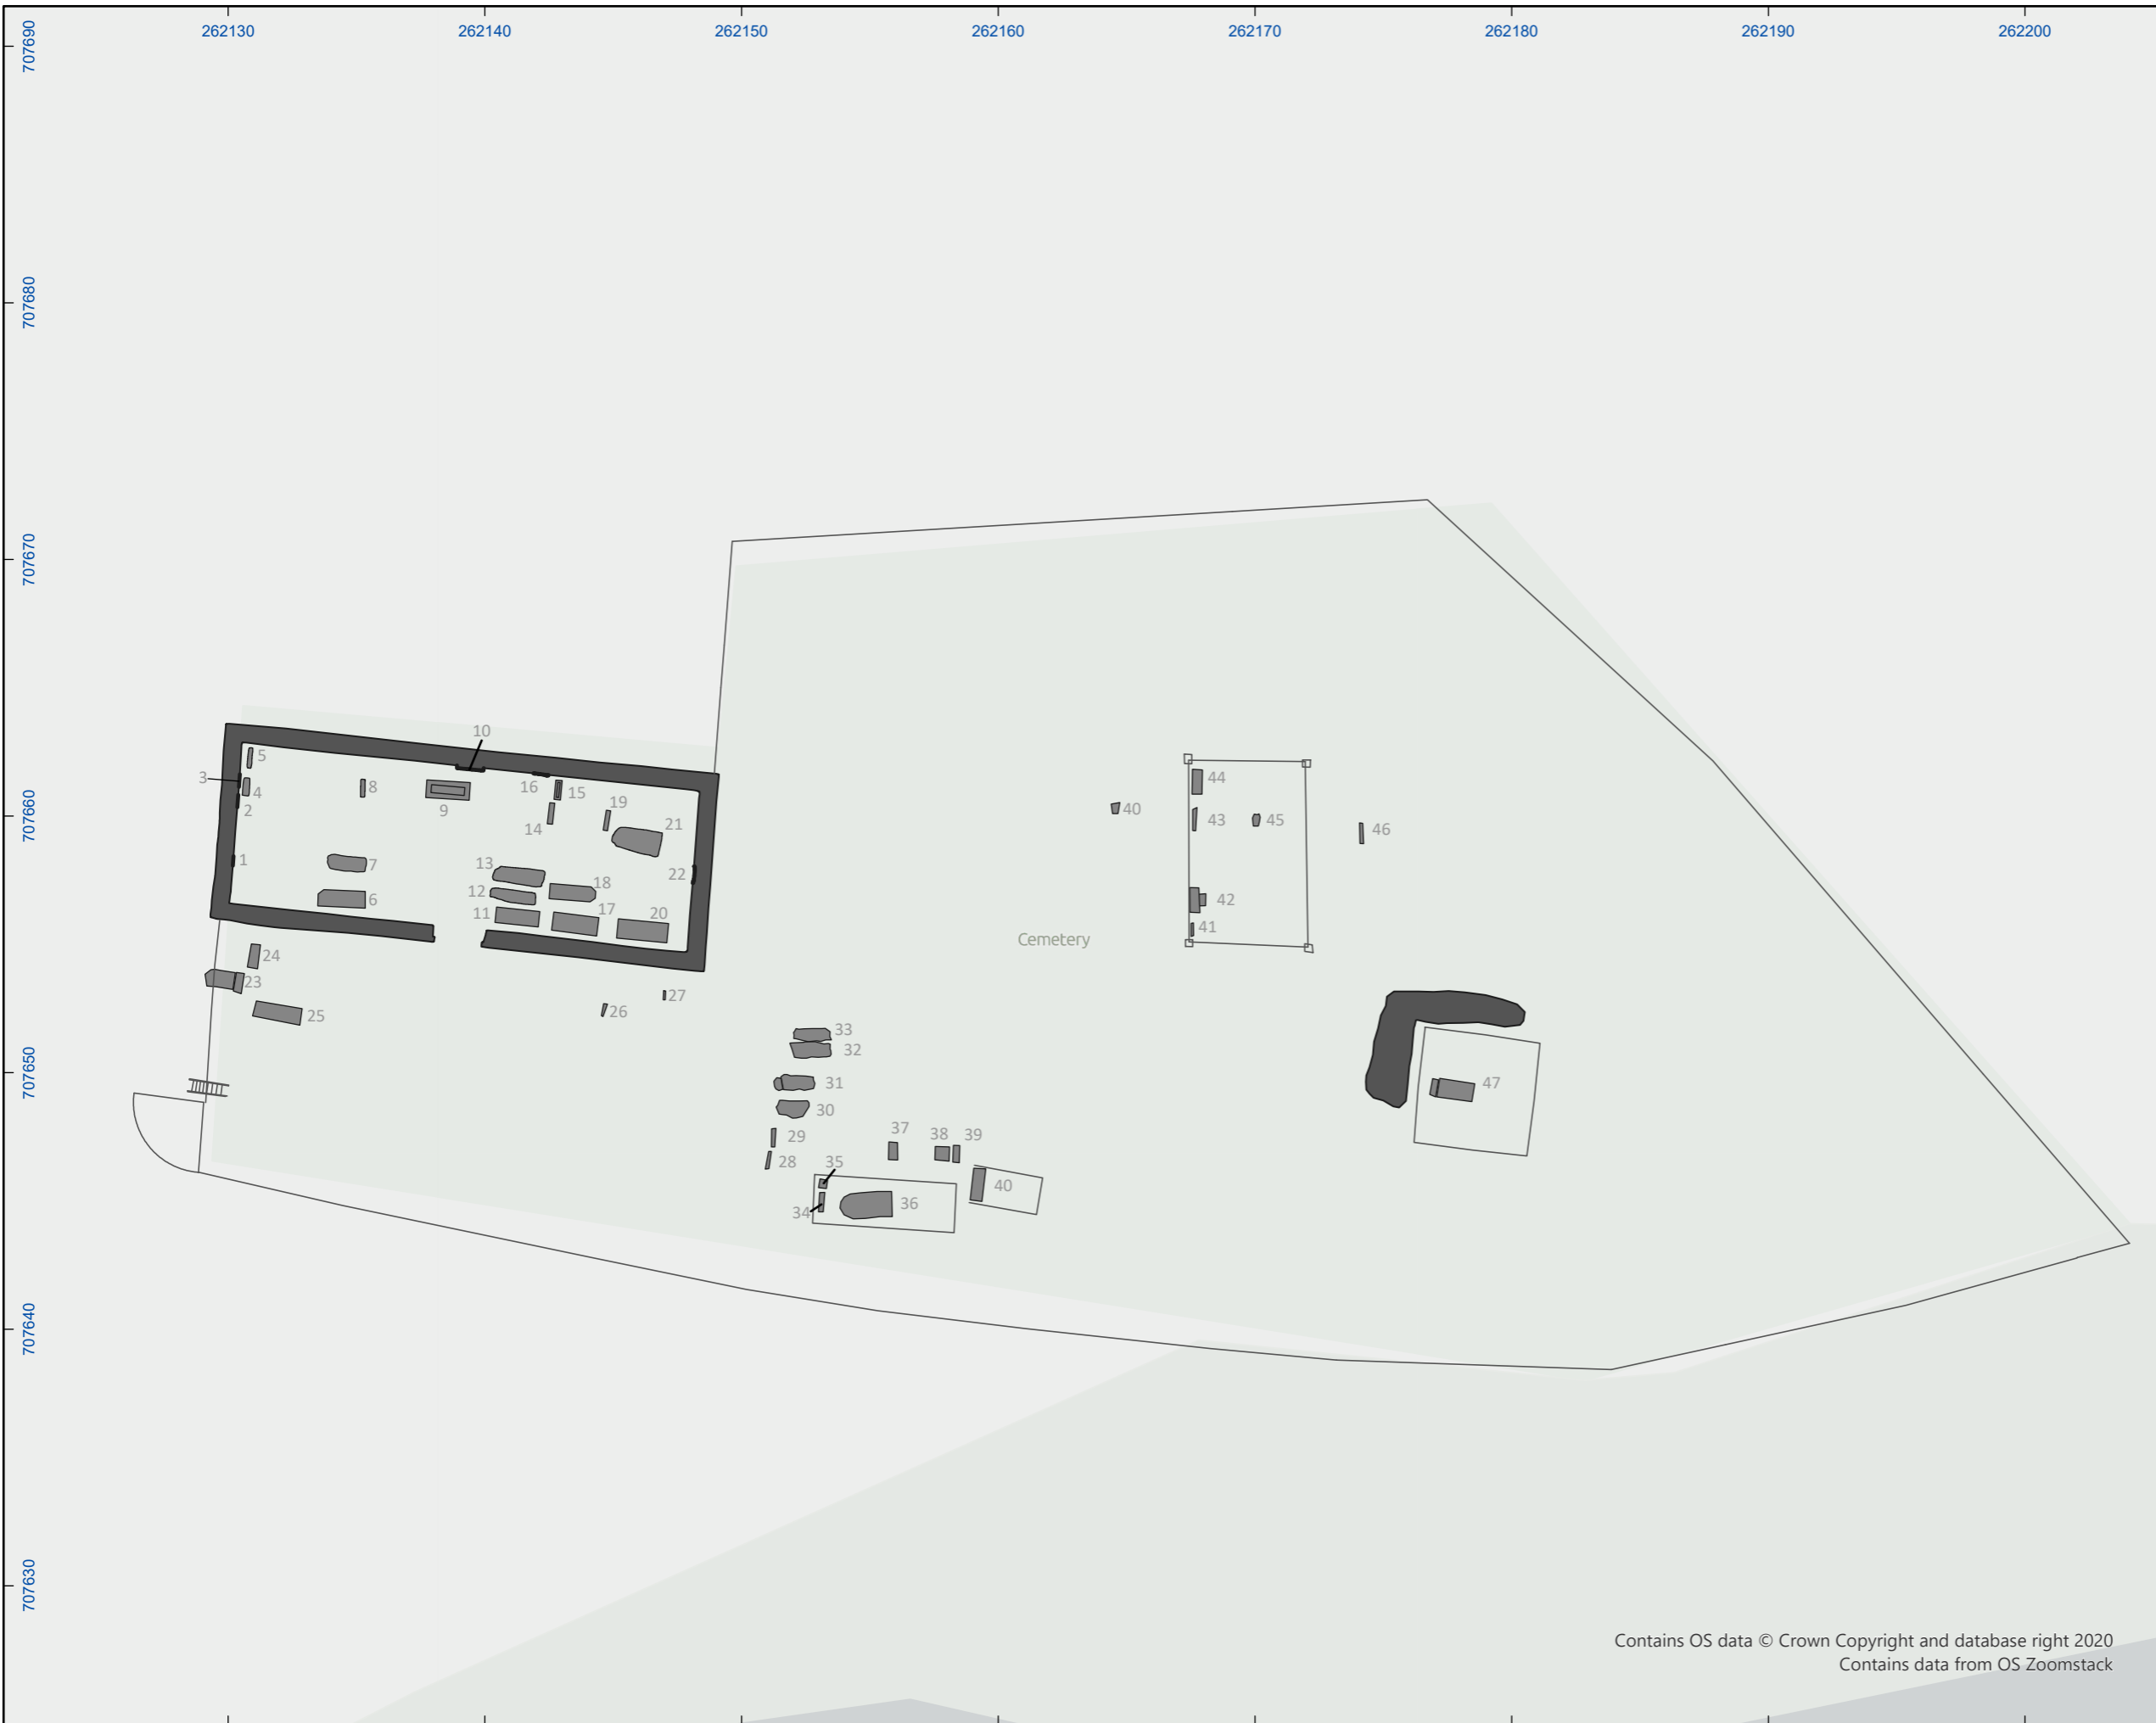
Figure		20	
Kilmahog Burial Ground			
<p>Key</p> <ul style="list-style-type: none"> <li>— Fence</li> <li>■ Gravestone</li> <li>■ Wall</li> </ul>			
FOR			
Callander Landscape Partnership

- 3.5.4 The surrounding burial ground has a number of 19th and 20th century gravestones, the majority of which remain upstanding and in good condition. There are also three smaller grave plots demarked by metal railings (Figure 20; Plates LBG19 – LBG21). To the south-east of the burial enclosure there is a cluster of six grave markers including four flat grave slabs that appear to date from the 17th century given the general wear and coverage by vegetation (Plates LBG22 – LBG25). Only one of these graves has any legible text with the letters 'IB' etched at the top left (Plate LBG25). To the high ground at the east end of the site (and just to the west of the central railed grave plot) is a lone upright gravestone (Plate LBG26 & LBG27). It has no visible dates or texts and differs to other grave markers in the burial ground in both its shape and proportions. As mentioned above, the remainder of the grave markers

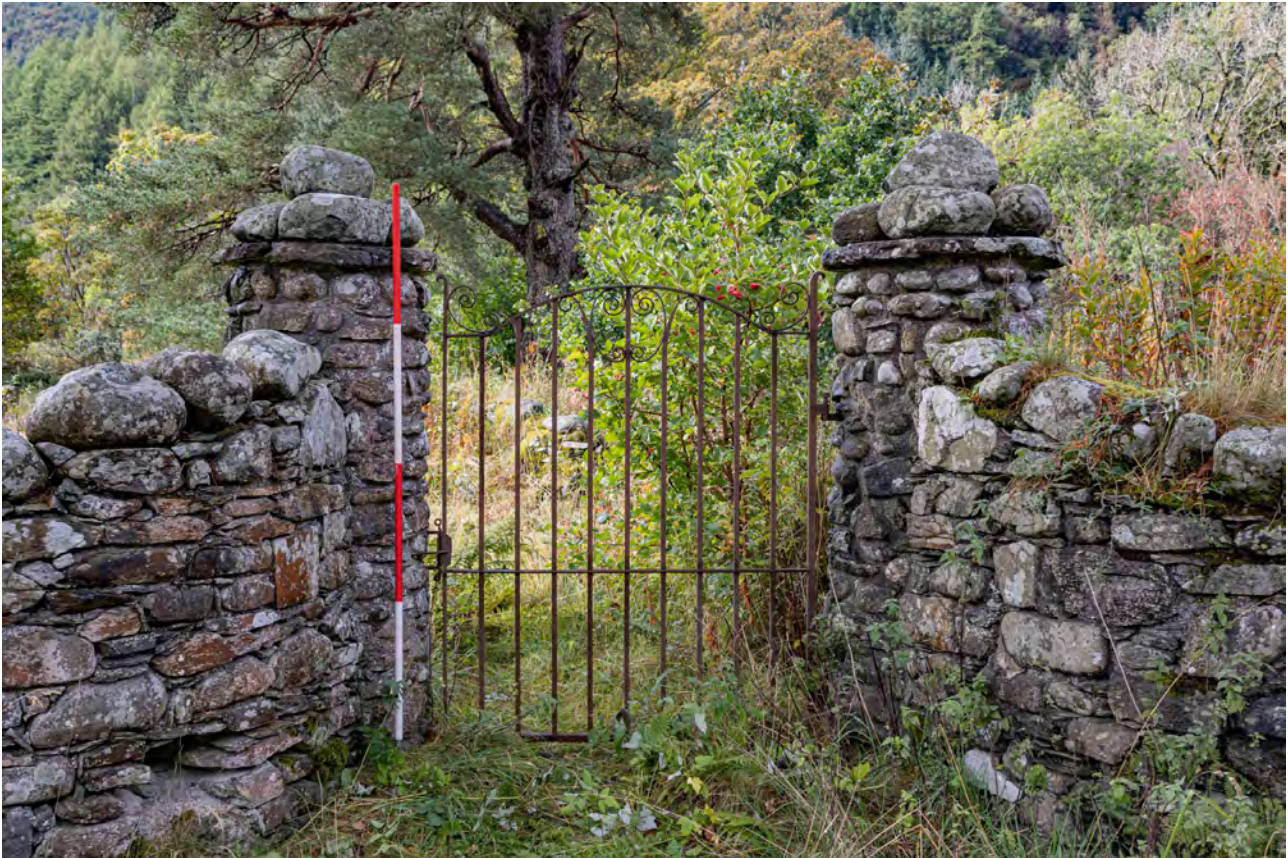
Plate SB5: Saint Bride's Chapel, detail of the main gate from the west

The iron gates at the entrances to the burial ground are rusted (Plates SB5 & SB7) but otherwise appear to be in a stable condition.

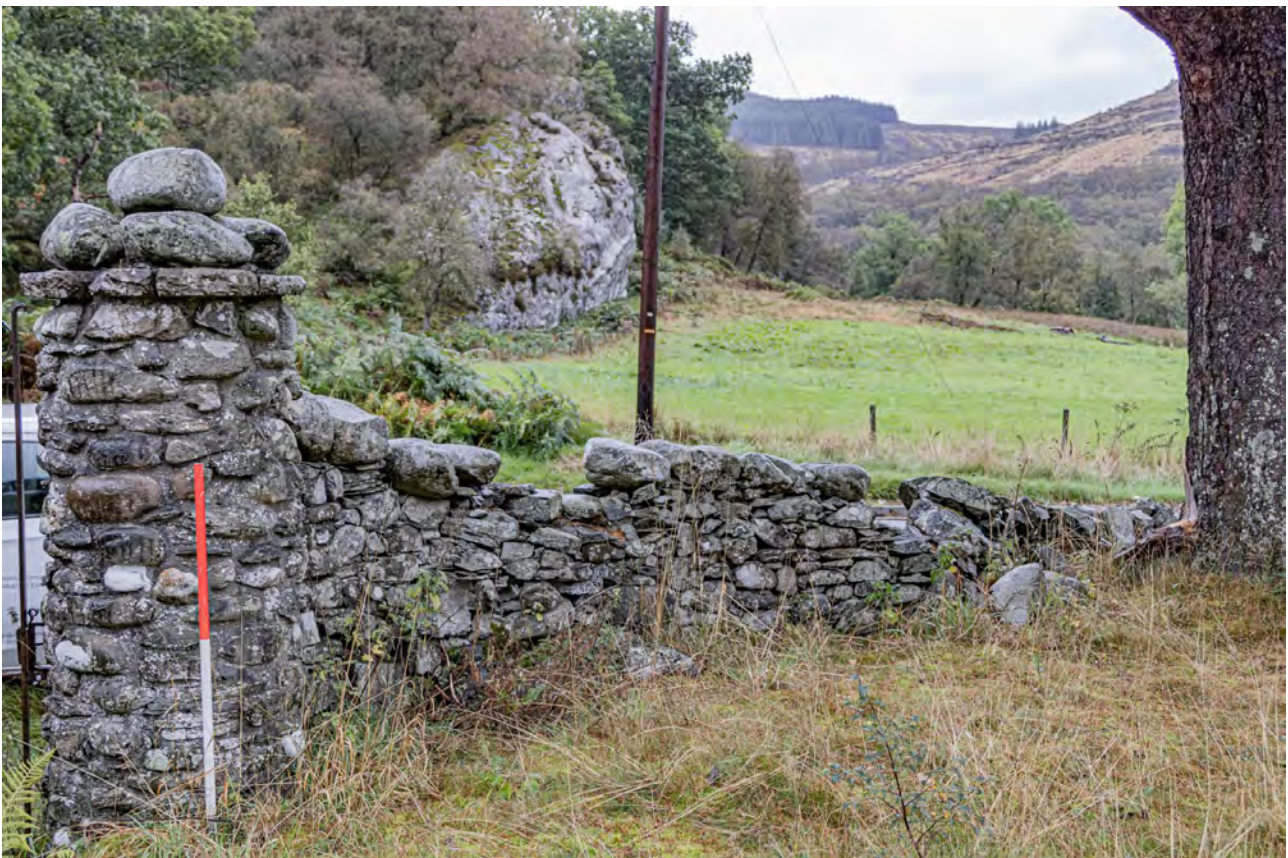
Plate SB6: Saint Bride's Chapel, detail of the gate pier from the west

The condition of the boundary wall is variable. It survives to full height for much of its length although some areas of missing stones are recorded around the gateway (Plate SB6) and an area of wall collapse was also recorded (Plate SB8). The boundary wall is located very close to the edge of the River Leny on its eastern side (Plate SB3) where it is at risk of erosion of the riverbank beneath the outer wall (Callander Heritage Society 2020b).

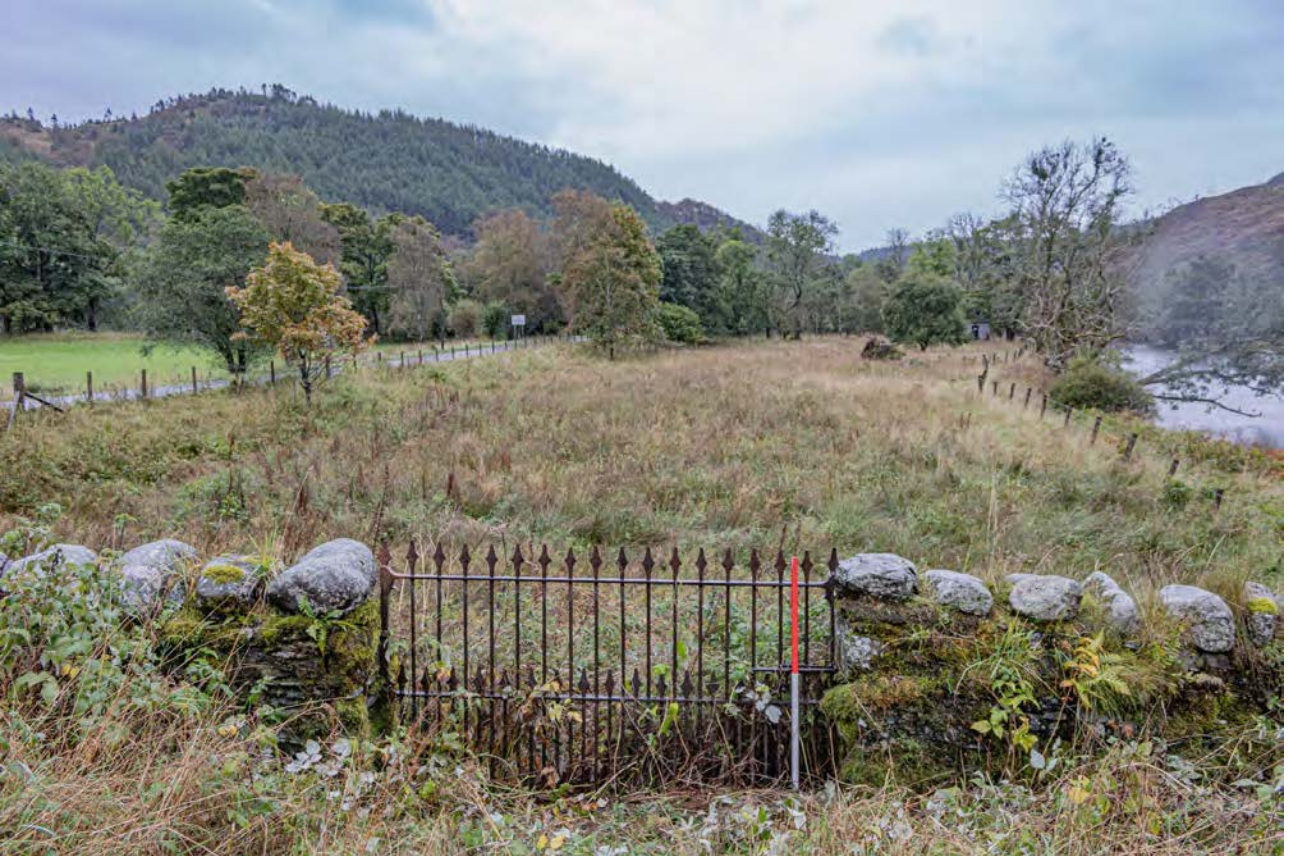
Plate SB7: Saint Bride's Chapel, detail of iron gate in the south wall from the north

Several of the grave markers and areas of boundary wall are overgrown with vegetation (Plates SB7 & SB10) while the eastern grave marker is partially buried (Plates SB8 & SB9). In some cases, vegetation is growing out of the stonework and will be causing structural damage. Numerous gravestones also feature extensive lichen growth (Plate SB12 – SB14).

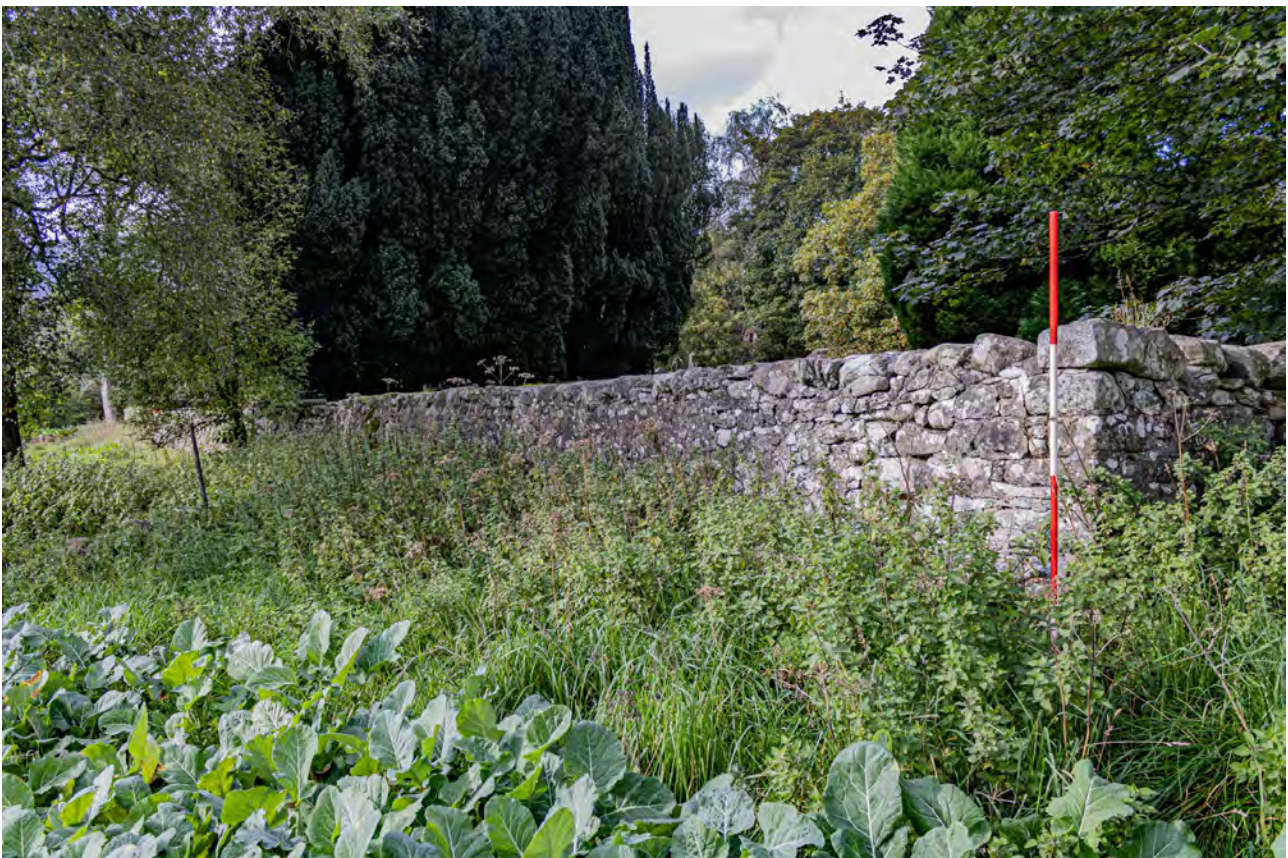
Plate KG3: Kilmahog Graveyard, south boundary wall, general view from the south-east

The overall condition of the graveyard's structures is generally good, notably sections of the boundary wall (Plate KG3) and the entrance archway (Plate KG5). The stonework of the Mort House is also in good condition although it has been evidently repaired and repointed at some point (Plate KG8). The wooden door to the Mort House is also rotted and partially broken at its base (Plate KG9). The boundary wall has been damaged in several places and has collapsed outwards; the north wall has a single area of collapse approximately 2.5m which has been partially blocked with fencing (Plate KG11). There is an area of damage measuring 3m in length in the east wall towards its north end and an area slight damage of the south wall towards its west end (Plates KG12 – KG14) and an area of collapse at the centre of the west wall (Plate KG15).

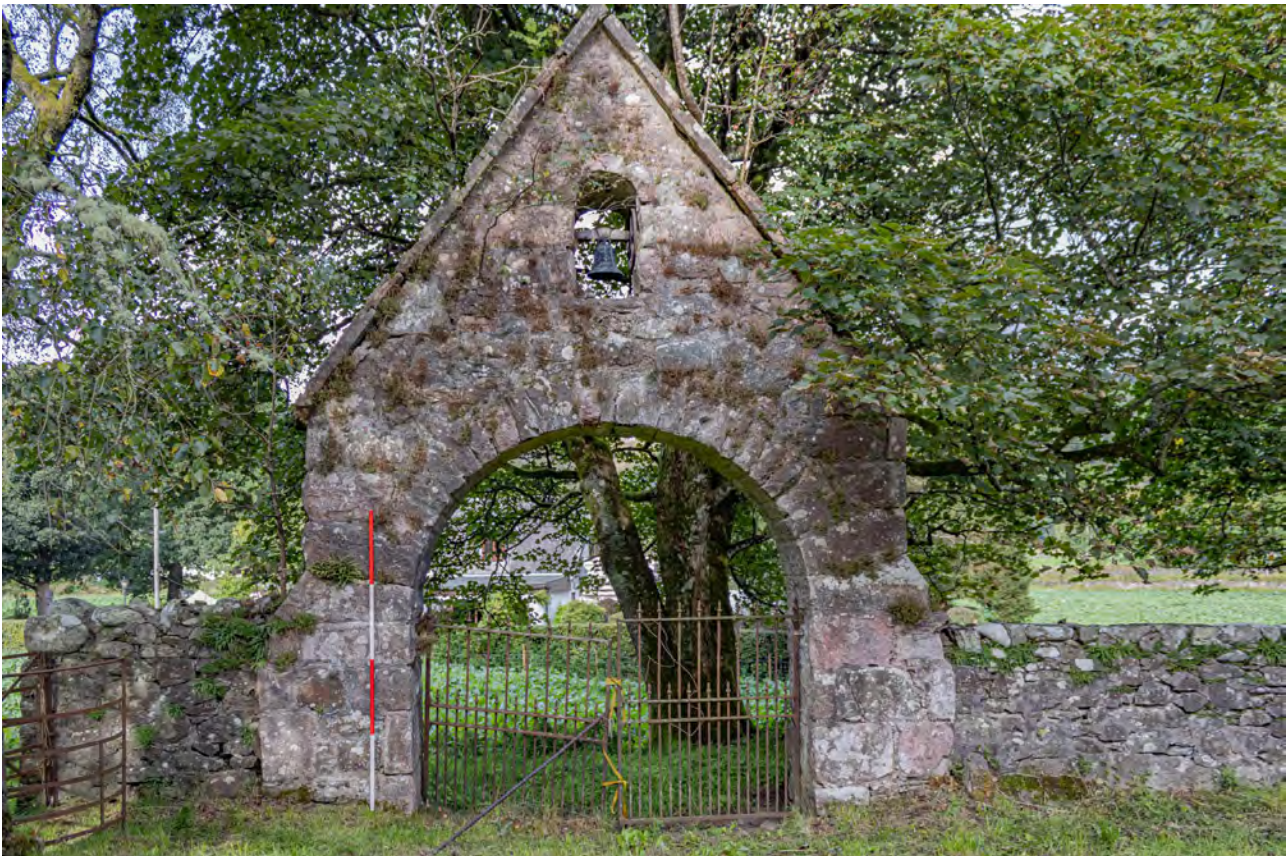
Plate KG5: Kilmahog Graveyard, gateway, general view from the south

The iron gateway at the entrance porch appears to be rusted and has become detached from the stone on its upper western side. The gate is being held in place and closed by yellow strapping (Plate

KG5). The iron kissing gate is rusted but otherwise appears to be in good and stable condition (Plate KG7).

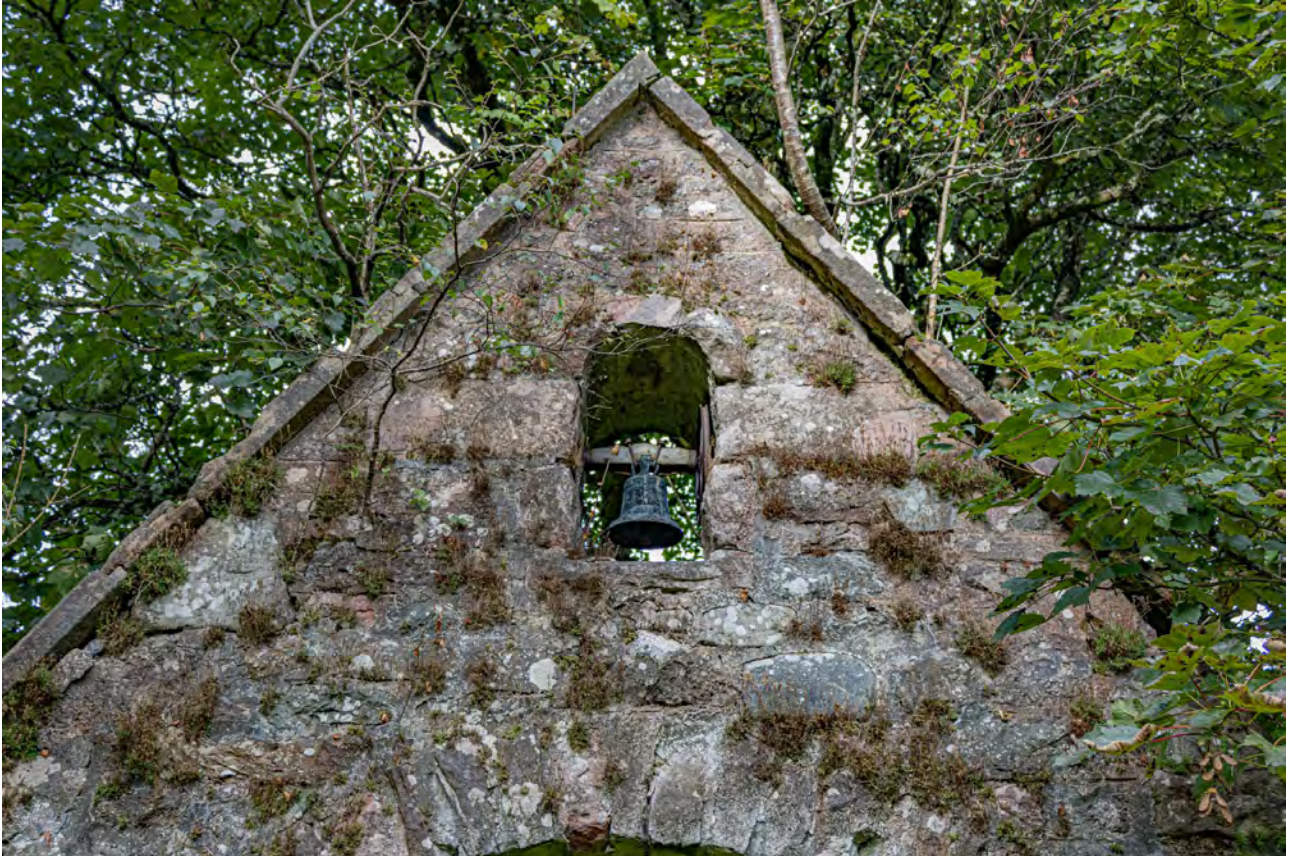
Plate KG6: Kilmahog Graveyard, gateway, detail of bell and housing from the south

Vegetation growth is also a potential issue and may be causing structural damage to the entrance archway where small tree branches appear to be growing out of the stonework (Plate KG6). Grave Number 79 is located in close proximity to a large tree which is obscuring the upper part of the stone (Plate KG26). Roots of the tree may also be causing damage to below-ground remains here. Areas of moss and lichen growth are common across many of the grave markers (see Plates KG20 – KG24) but do not appear to be causing any structural damage. Weathering to the stone of the MacFarlan Monument is also evident (Plate KG29).

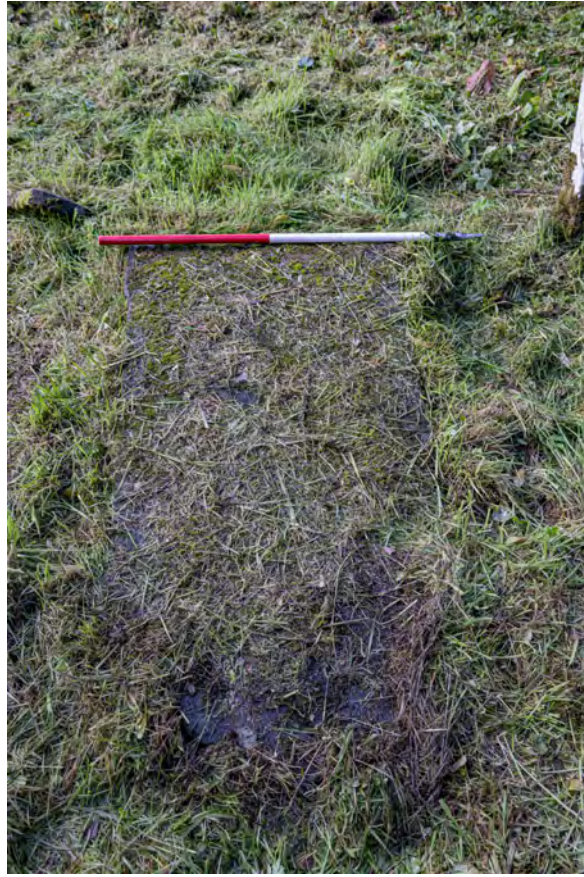
Plate KG16: Kilmahog Graveyard, grave marker 19, detail of grave marker from the east

Grave Numbers 12, 19, 36 and 83 are recumbent and partly overgrown with grass vegetation (Plates KG16 – KG18). Grave Number 19 appears to be covered with recently mown grass (Plate KG16) which indicates that it may be at risk from damage due to mechanical mowing.

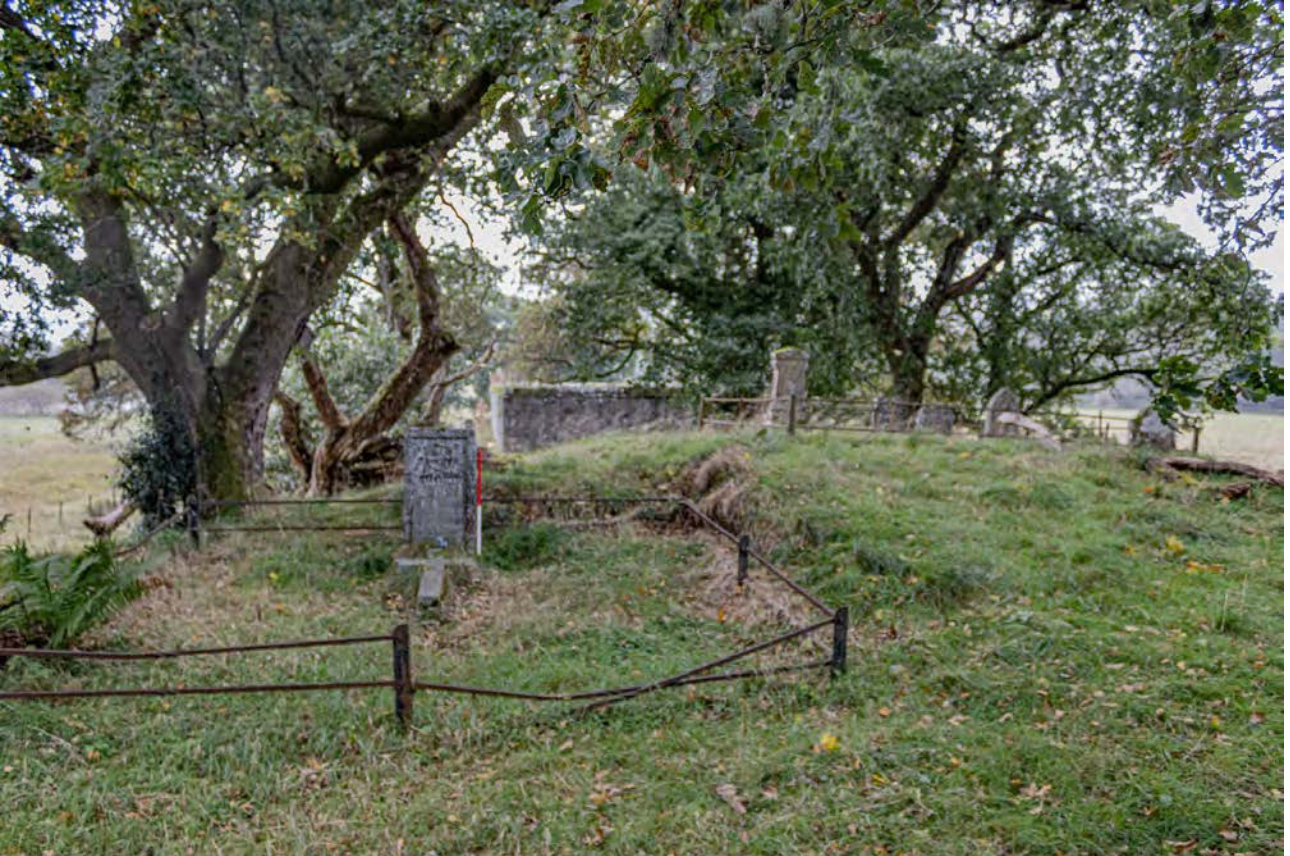
Plate LBG10: Leny Burial Ground, general view of the east end of the site from the east

The ironwork is generally rusted, although the gates are in good condition. However, some of the railings around grave markers are broken (Plate LBG10).
