LLTAF Update: May 2024

Strategic Updates

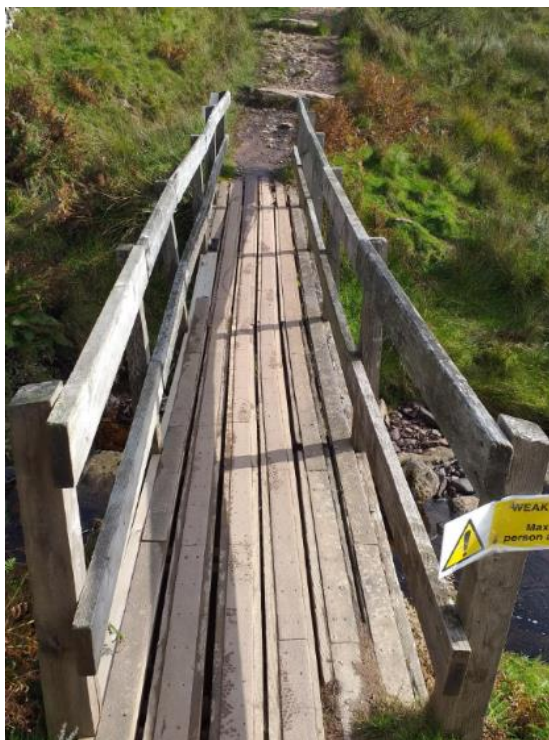
Kilandan Burn

The replacement project was completed in March, on time and on budget. The WHW through this area has been re-opened and favourable comments have been received by the NPA. The new bridges feature concrete abutments, a zinc-galvanised sub-structure, recycled non-slip decking, treated Oak timberwork, stainless steel fixtures and fittings and should serve WHW users for many years to come. Images of previous conditions and the new bridges are included below.

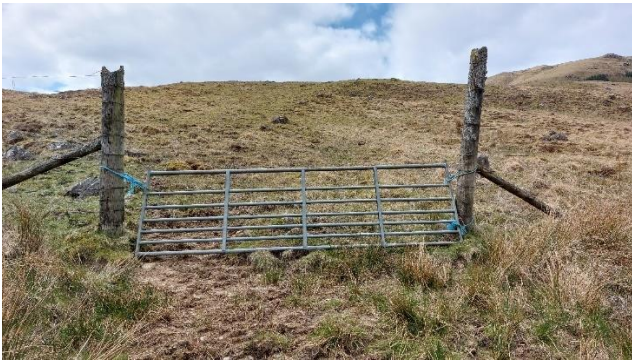
On 7 December 2023 we sent out an informal officer letter to the landowner outlining the ongoing access issues, how they could be resolved and the legal options we have if they are not. We requested that either the padlocks were removed from the relevant gates or the diversion route agreed in 2016-17 opened up by replacing a broken gate and providing access in a deer fence. The

Before: broken gate and deer fence

landowner contacted us on 14 January 2024 to say he had opened the diversion route, and a site visit on 1 February confirmed this (see photos).

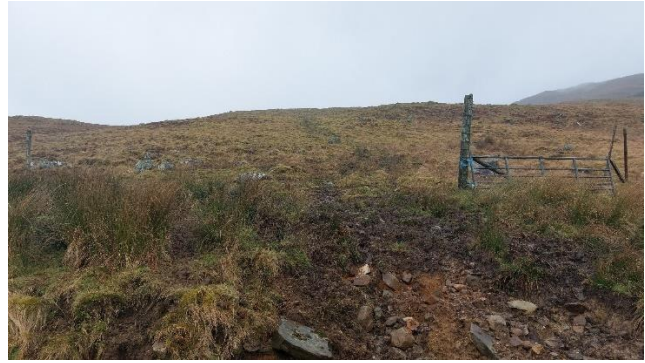
After: 5m wide gap in deer fence

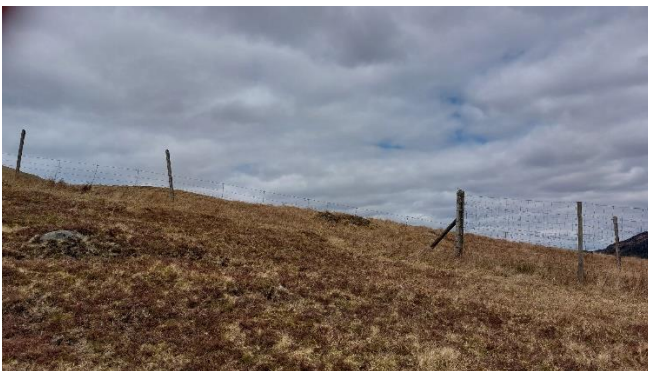
Before: half height deer fence obstruction

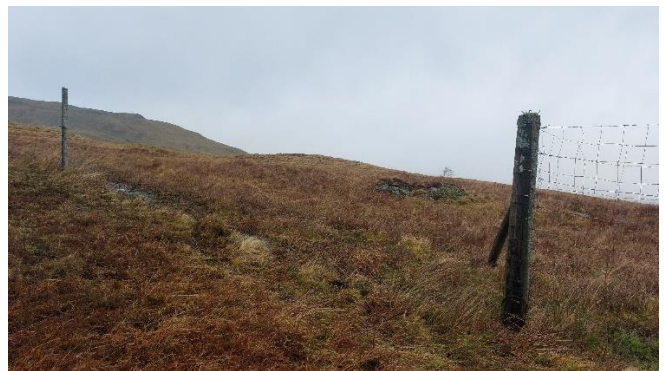
After: 5m wide gap in deer fence

We have developed advisory signs for either end of the diversion and the landowner has agreed with these. We will get them manufactured as soon as possible and the Land Operations Team has agreed to install them with some additional waymark posts to keep people on route.

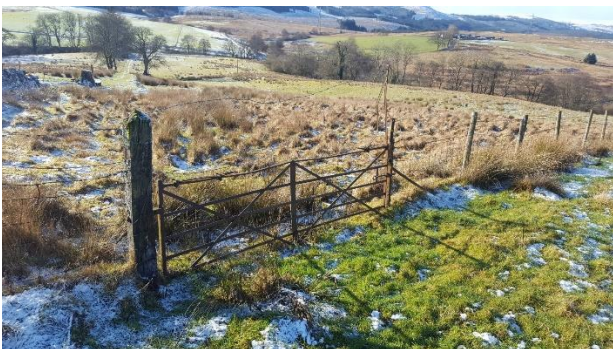
We are still waiting for a response from one of the landowners despite attempts to contact him through email, telephone and a visit to the farm with a hard copy of all previous correspondence posted through the letterbox. We have discussed the work required with the Land Operations Team and we have agreed to install gates already purchased and in stock at our depot and stores to open up the route.

Previous gate in 2019, blocked with barbed wire

We have drafted a letter to the landowner explaining the current situation and that if he doesn't contact us by the end of May, we will use the powers available to us to enter his land and replace all the padlocked and broken gates.

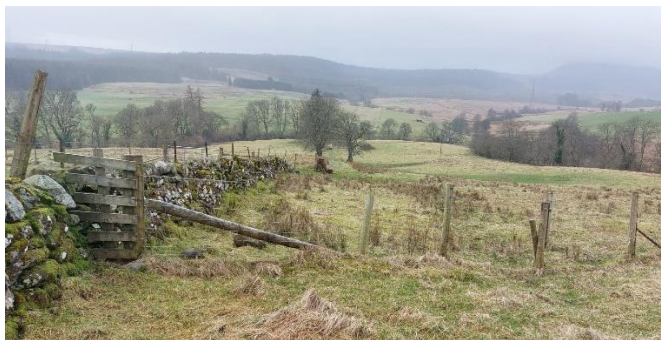
Gate replaced by fence, 2023

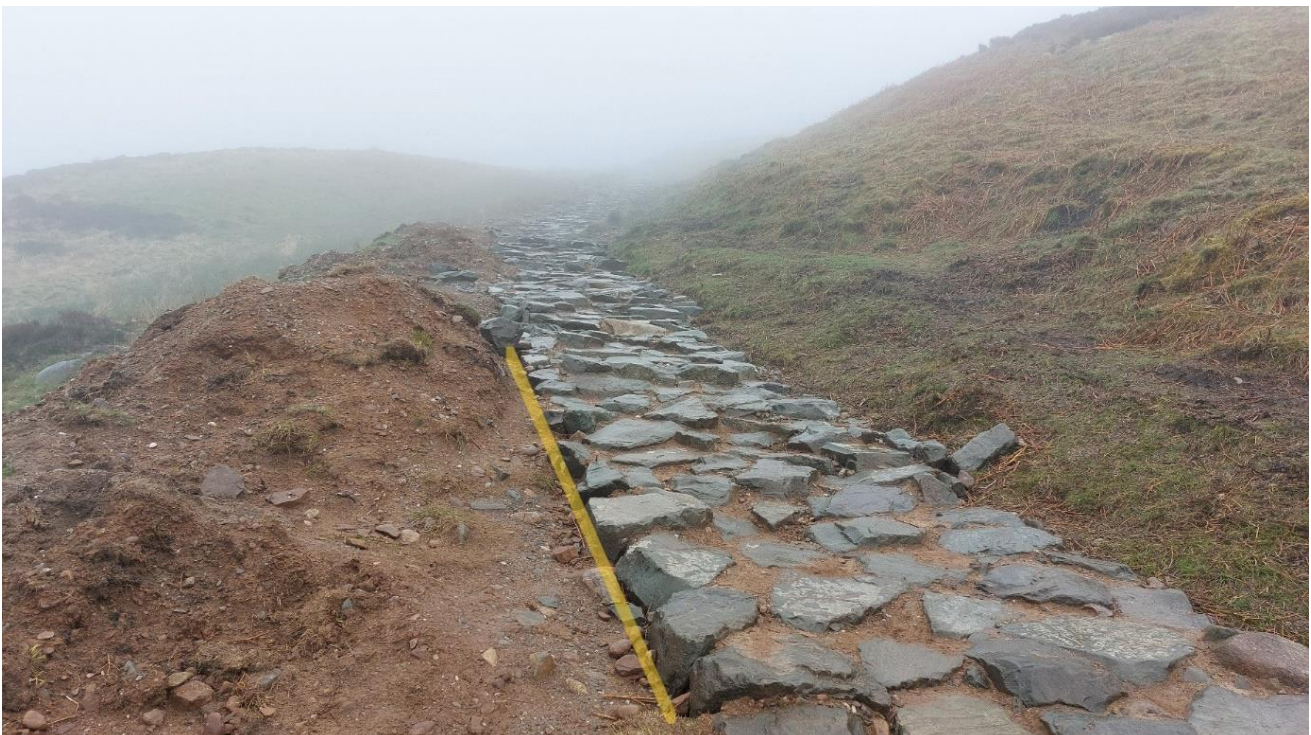
- 312 metres of main stone pitching on path section 4 was installed by 31 March 2024. This was not completed with only a short section of 20 metres at the start fully packed and pointed with cobbles and spoil won from site excavations. The contractors stated that this would all be complete before

Photo 1: Packed and pointed pitching. Spoil to be reformed to revet downslope side of the path (yellow line).

- Extend and deepen the side ditches.
 - All landscaping of path edges including resetting of loose stone and formation of spoil mounds to revet the path

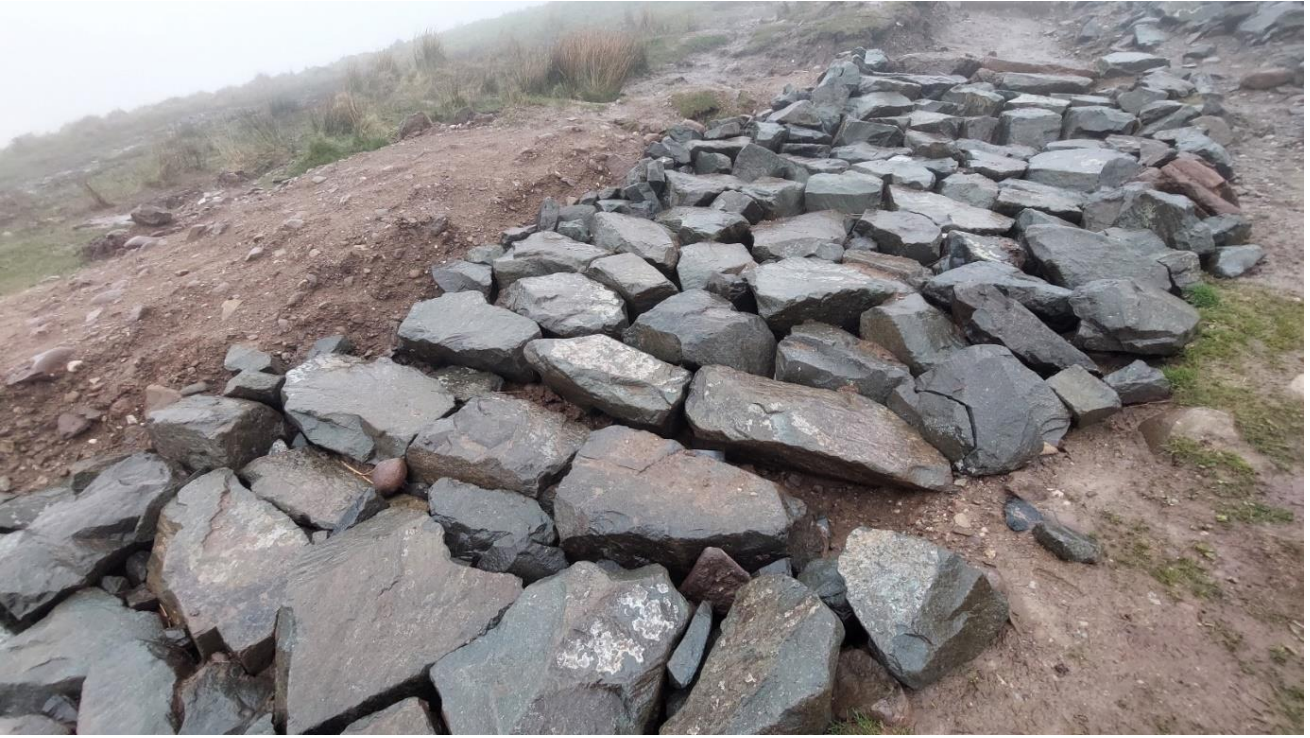
the helicopter flights on 22 April, but this did not happen and by 25 April only 165 metres had been packed and pointed with spoil. In addition, 12 cross drains were incomplete which resulted in large gaps between the stones which made it awkward to walk on.

Photo 2: Large gaps between stones, April 2024

- 12 cross drains completed.
 - Packing and pointing of remaining 147 metres of pitching. This will be done using a combination of spoil won from site and aggregate brought in during the helicopter flights.

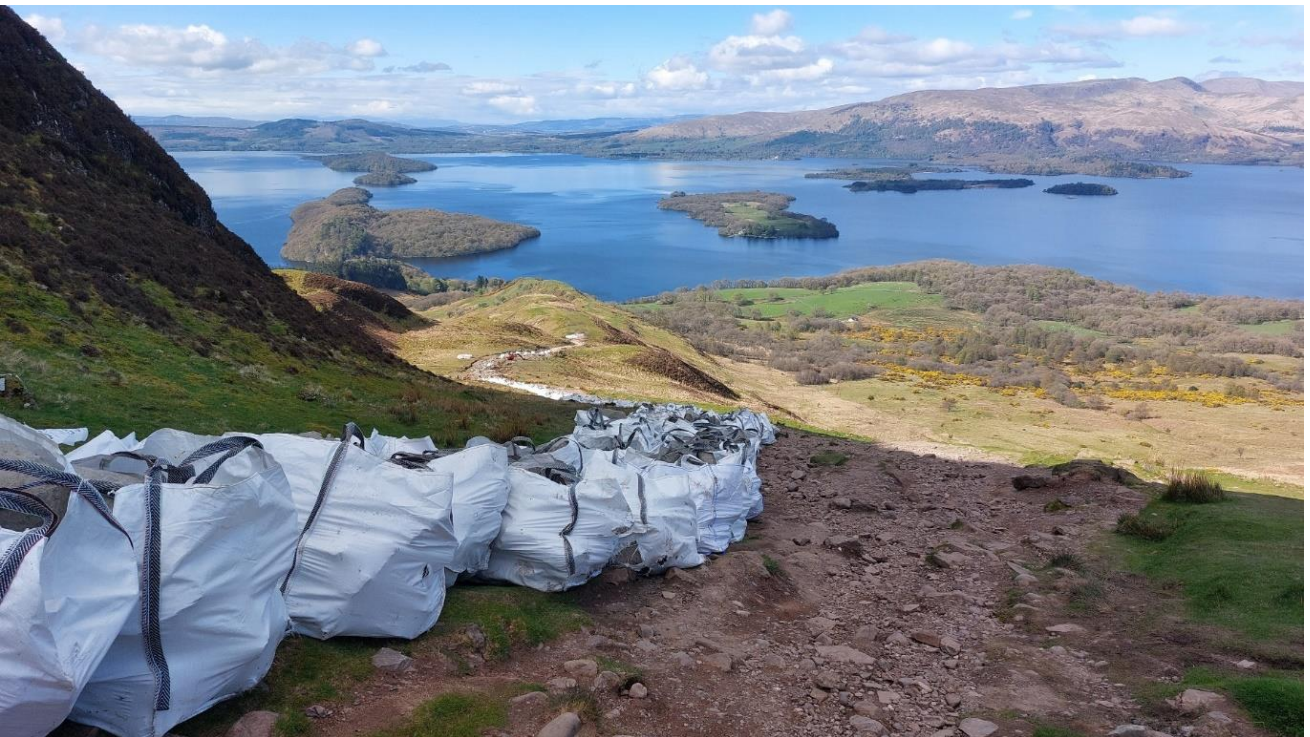
- Remaining stone delivered to stone storage site early April 2024.
- 15 to 22 April stone bagged ready for flying.
- Helicopter flights week 22 April 2024 – all remaining stone for path section 4 and stone for path section 5 is now on the hill. In ideal flying weather 450 bags were flown in three days (see photos below).

Photo 3: Stone bags on the upper path, 25 April 2024

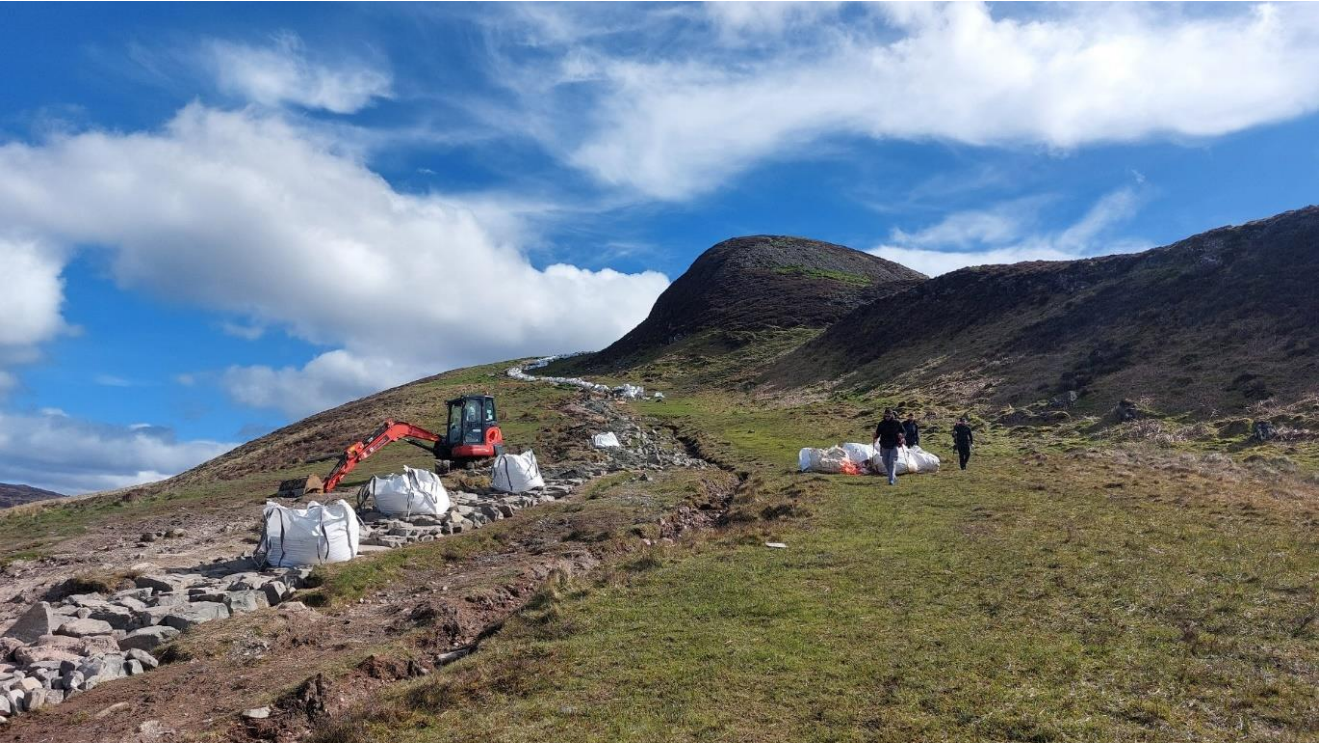
Photo 4: Stone bags on upper path and aggregate for packing already pitched path, 25 April 2024
