Structural Inspection Report Woodbank House & Stables Luss Road Balloch

On behalf of **TSL Contractors Ltd**

Project Ref: 35854 | Rev: 1 | Date: May 2017

Report Title: Woodbank House & Stables Structural Inspection Report

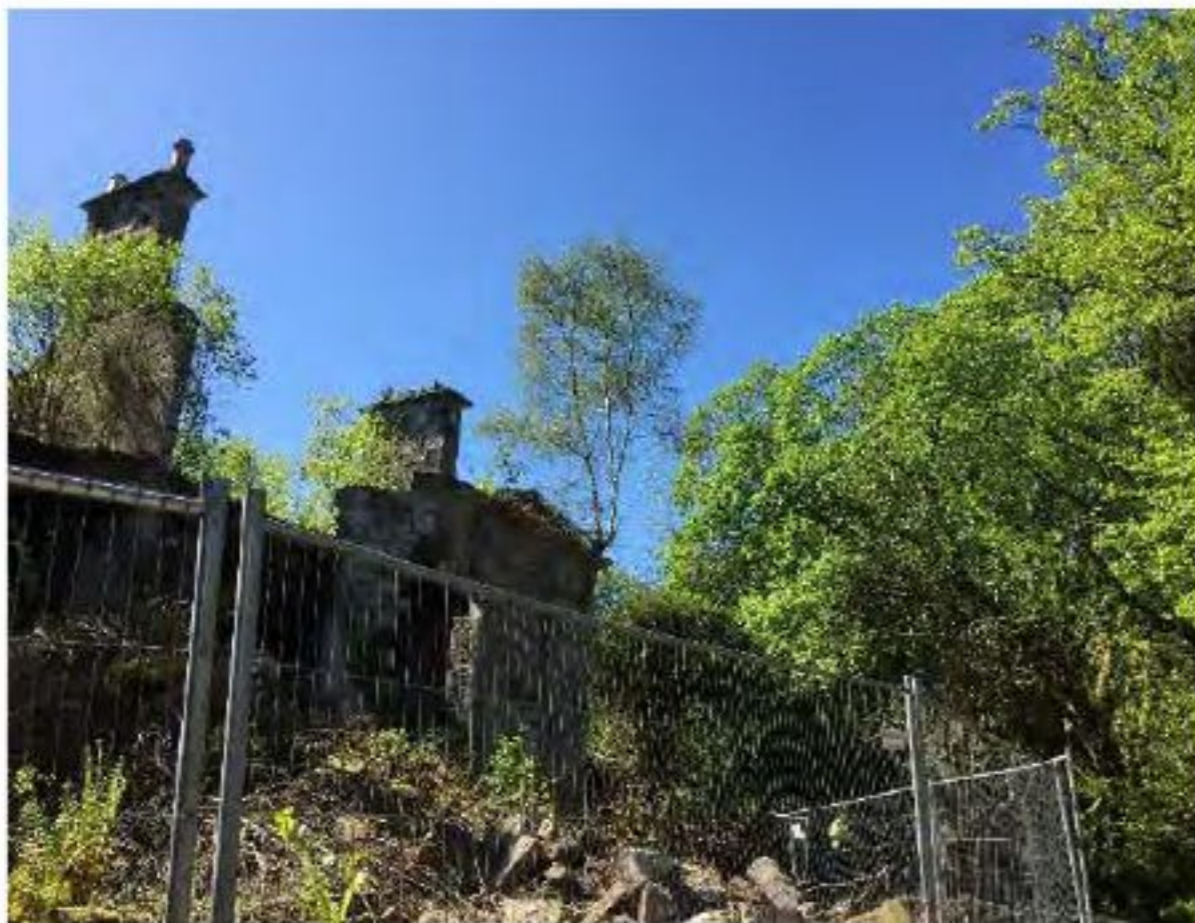
Photograph 13 - Internals from North east

- 2.10.1 Following the 1996 partial demolition the central internal area is piled up with stones, timber and other materials, which makes the area unsafe for inspection.
- 2.10.2 The internal walls and floors are in poor condition and we recommend that only the elevations are worth saving.
- 2.10.3 The demolition will need to be carried out in a sequence to be agreed between the structural engineer and the demolition contractor. The demolition will require temporary works design to prop/support all walls which are to remain.
- 2.10.4 We recommend that the earlier partial demolition debris is cleared to allow access. The extents of clearance and demolition will need to be limited to consider the areas of unstable structure. Specifically, the chimneys and the free-standing masonry doorways, as highlighted on the photograph 6.

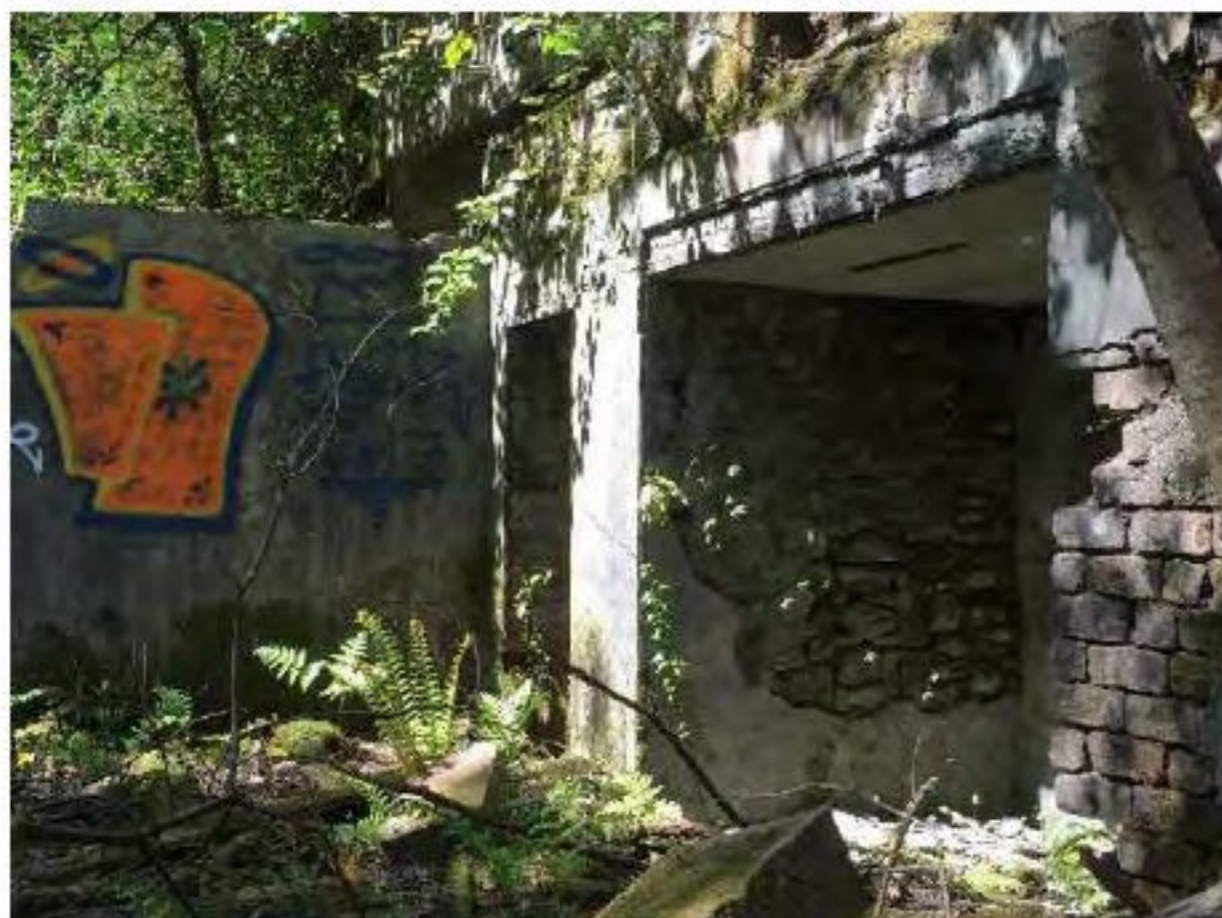
Photograph 17 – Internal views of south block

- 3.2.1 The North and South blocks are built with single storey stone walls and there appears to have been some additions throughout the life of the building, carried out in masonry. The single storey stone sections are generally plumb; however, they are in poor condition and in areas the stone is eroded. If the building is to be kept the masonry will need repairs and all joints would need to be fully raked and re-pointed with suitable lime mortar.

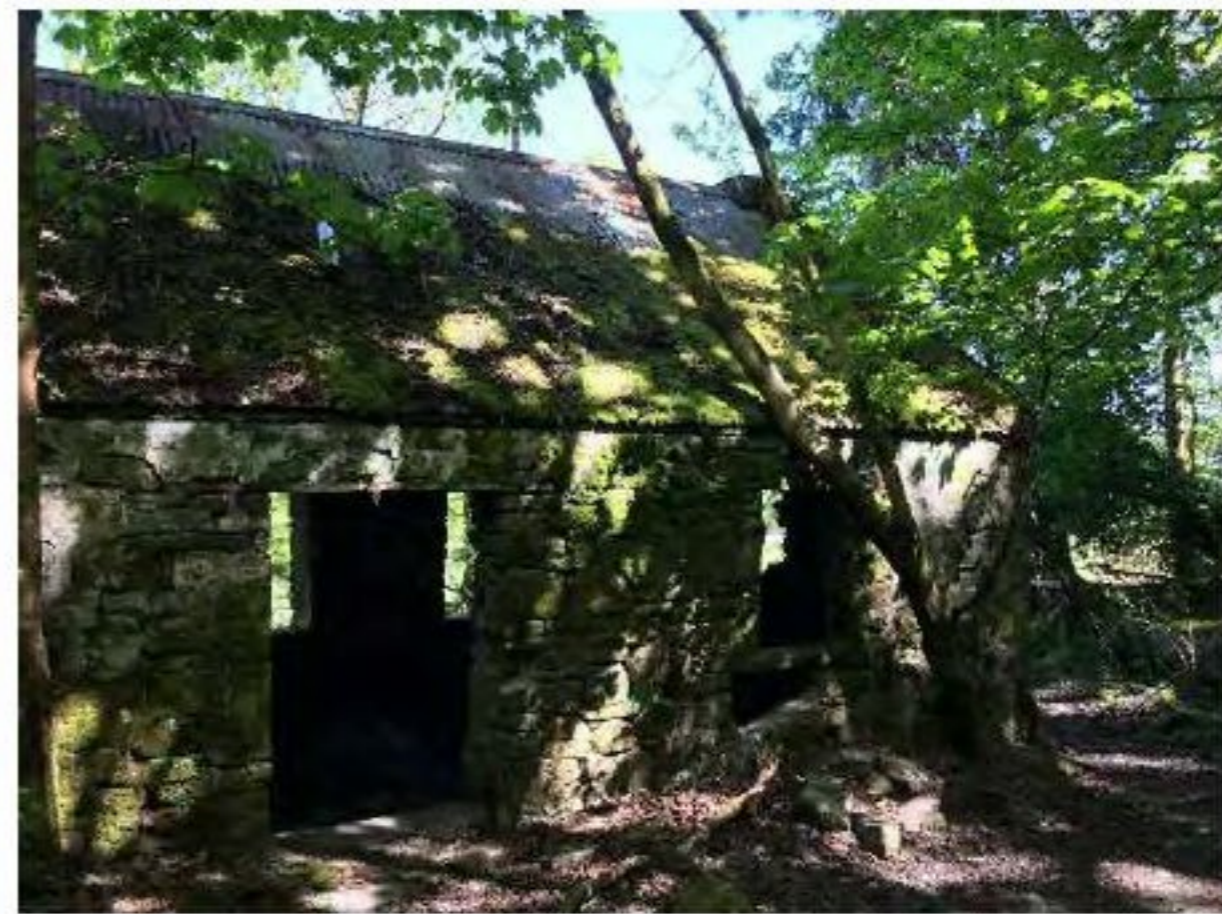
Photograph 28 – West wall

- 4.3.1 The building is small with no floor slab and has a large section of the south wall missing. The walls are in poor condition and a chimney collapse has exposed the single stone skin sections that form the flue and the wall is unstable, as shown in photographs 27, 29 and 32. Due to the instability of the south wall we would recommend demolishing the wall.
- 4.3.2 The corroded lintels are formed with steel rails and would need to be replaced if the building is to be refurbished.
- 4.3.3 Due to the instability of the south wall we would recommend demolishing the wall.
- 4.3.4 We would recommend that the building is demolished given the state of repair. If the full building is not demolished the east and west walls will need propped prior to the demolition taking place.
