INFORM

INFORMATION FOR HISTORIC BUILDING OWNERS

Domestic Decorative Glass

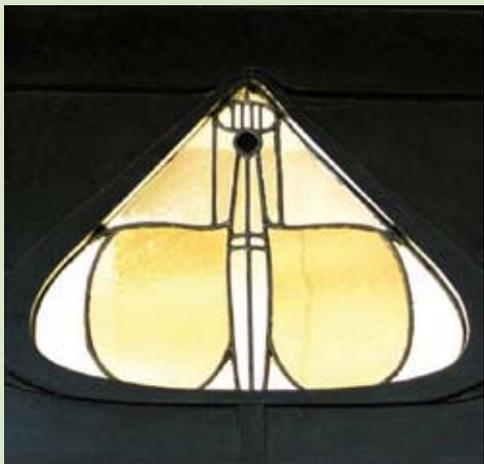
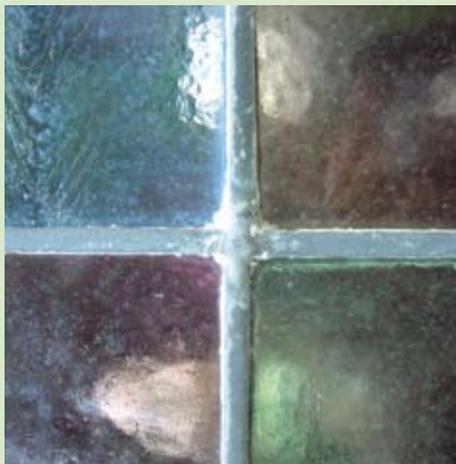
Glass can be coloured in the original manufacturing process. This is achieved through the addition of chemicals to provide specific colours, for example Cobalt produces blues, whilst Manganese produces a purple colouration. To ensure depth of colour and consistency, this involves a highly skilled process.

Stained glass has a coloured material applied to its surface and it was usually fired in a kiln to ensure a more robust finish. From the 14th Century there is a long history of using silver stain (silver sulphides and nitrates) to give yellow and orange colours on clear glass. Enamels were also used as early as the 6th Century. By the 16th Century the processes started to incorporate a range of metal oxides to give a much broader colour palette.

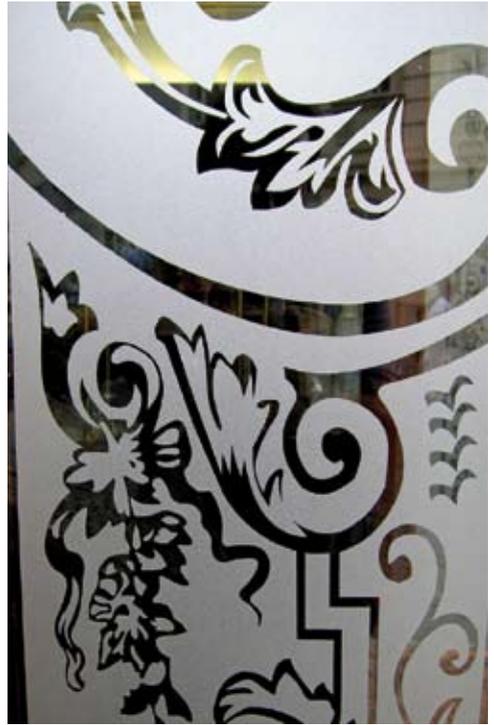
Etched glass was introduced in the latter half of the 19th Century and was developed to provide a highly detailed decorative finish. These etching techniques are commonly still in use today. Etching is undertaken by blasting an abrasive material against the surface of the glass, the designed element being etched through a stencil. Etching can also be achieved by using hydrofluoric acid, protecting those areas which are not to be etched by the application of a stencilled layer. The emerging frosted surface from both techniques allows for a degree of privacy, whilst also creating a diffuse lighting effect to the interior.

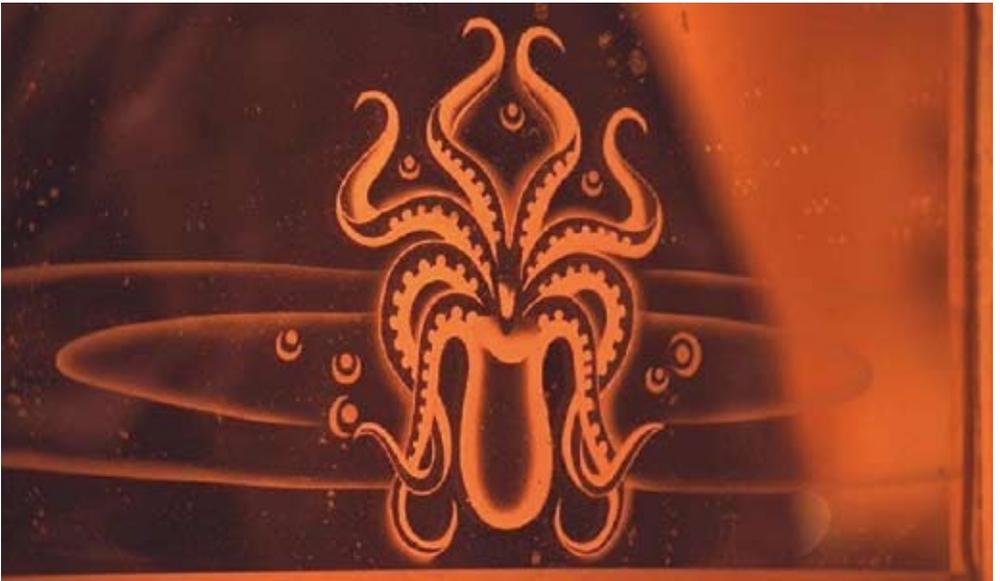
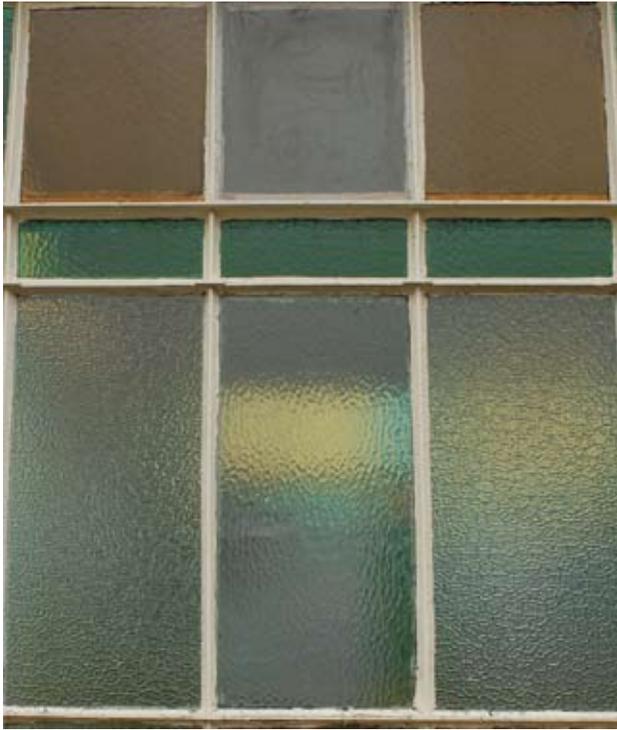
Exercising a high degree of skill, engravers used rotary grinding wheels to create various profiles (square, round and mitred) to be cut into the glass. This approach was particularly popular in the late 19th Century, and was often used in conjunction with etched glass.

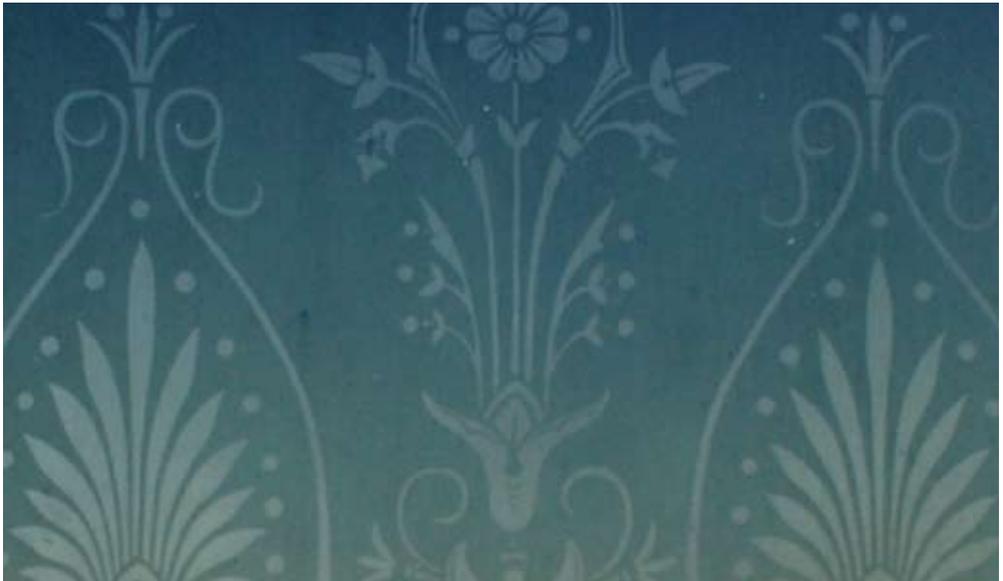
The technique of running hot glass through shaped rollers enabled a variety of regular patterns to be formed on the surface. This allowed many geometric forms, and natural themes of leaves and plants to be easily created and mass produced. As original glass should be retained whenever possible, care needs to be taken not to mistake the original material for modern replacement glass, and being aware of the various manufacturing techniques helps in this identification. It is recognised however that some patterns may not be available if there is a need to replace broken panes. In such circumstances the nearest pattern to the original should be chosen.

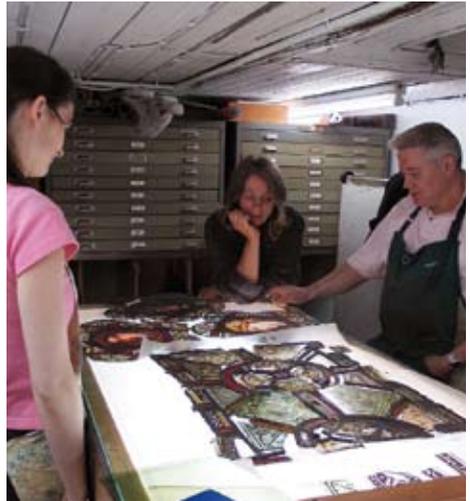
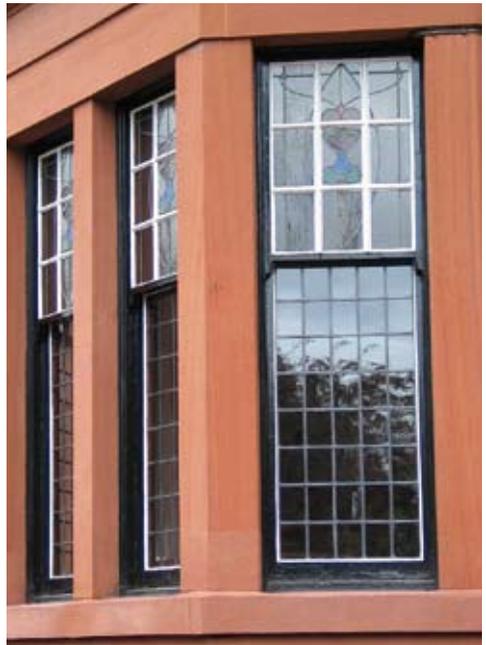
The joints between the lead comes were then soldered together, which was a highly skilled job. Once assembled, a sealant was applied over the panel to seal all the flanges between comes and glass. Copper wires were then soldered to the comes to allow the panels to be fixed to horizontal supports called saddle bars. These bars were then built into the surrounding timber frame or masonry to secure the panel. Saddle bars were traditionally made of iron, but increasingly

craftsmen and craftswomen now utilise more corrosion resistant materials, such as bronze. In a domestic dwelling, the entire assembly was normally fixed into a wooden frame to be secured as a window or as a decorative door panel.

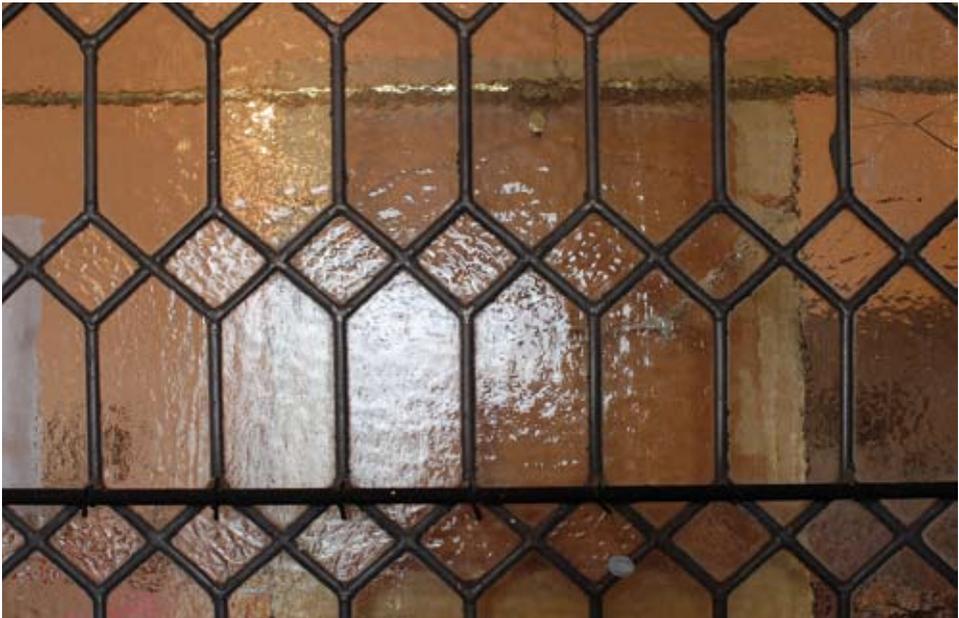
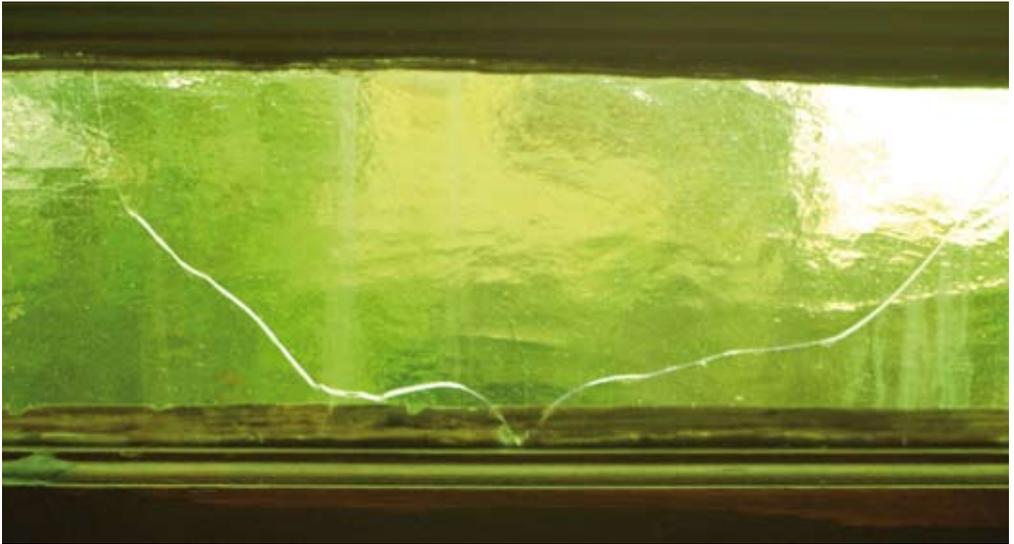
Loose or rattling glass is an early indicator of a potentially more serious problem and should be fixed as soon as possible – particularly where

the glass is part of a door or opening sash window and subject to regular movement. Slamming doors shut should be avoided. If a door or window is tight or swollen, the fit should be corrected by a competent joiner before damage to the glass occurs.

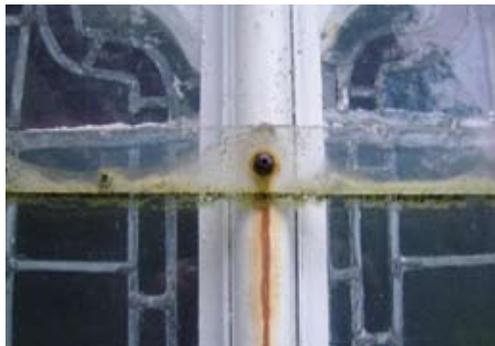
As a method of attempting to protect historic glass and improving energy efficiency, secondary glazing is not an ideal solution. The addition of a secondary layer of glass or polycarbonate material can cause significant problems by creating a microclimate where the environment between the glass and the secondary glazing is altered in comparison to the surrounding atmosphere. Moisture levels and temperature ranges can fluctuate more widely than normal due to a greenhouse effect. This can lead in many cases to accelerated decay. Crude installations are also unsightly and restrict natural ventilation, whilst

providing little thermal gain. The advice of a specialist will be required to help overcome such difficulties.
